# CASE STUDY

## LEEPER BRIDGE

**Owner:** Indiana Department of Transportation Indianapolis, IN

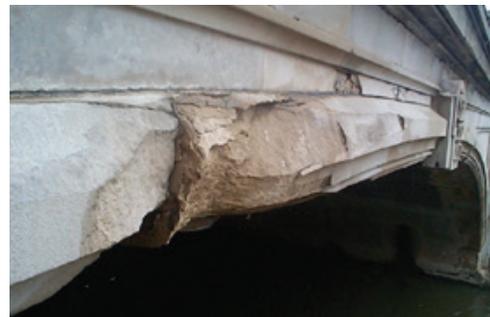
In order to determine the source of the random cracking in the deck, a portion of the new deck was removed down to the top of the arch ring. As a result of the investigation, it was determined that the top of the arch ring was in good condition and the cracking in the deck was a result of improper placement of the slab reinforcement. The reinforcing steel was placed in the bottom of the slab instead of the top. After further investigation and mapping of the cracks on the underside of the arch rings, it was determined that the additional transverse cracks were present at the time of the last repair in 2006. The cracks probably occurred due to the additional settlement of the north pier during a large flood which occurred after field inspection in 2002 and before reconstruction in 2006. It was discovered that very few of the cracks and arch delaminations were epoxy injected as specified in the 2006 contract documents.

*Spalling of the stone façade on the arch ring*

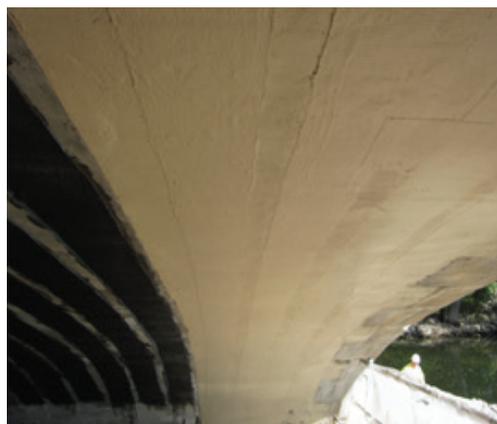
*Partially completed installation*

Due to the cracking and sagging of the arch rings, a full structural analysis was performed on the structure for both the HS 20 truck loading (maximum load without special permit) and toll road truck loadings (heavier loads). The analysis indicated the bridge was adequate for the HS 20 truck loading, but fell short of the toll road truck loading specifications due to settlement of pier #3. Therefore it was decided to strengthen the bridge by pressure injecting all visible cracks in the bottom of the arches with Sikadur® 52 and applying one layer of SikaWrap® Hex 103C to the arch surface. The goal was an anticipated toll road truck loading factor increase from 0.82 to 1.04. Further repairs made in 2012 including the replacement of the existing concrete rail panels between the intermediate stone columns with new, heavily reinforced concrete panels that duplicated the original profile and appearance of the railing. The intermediate stone columns were taken apart and the stone re-laid back to their original, vertical orientation. The last step involved the application of Sikagard® 670W, anti-carbonation coating, to bridge archway in order provide a protective coating to the concrete and to provide an aesthetic cover to the repairs and strengthening.

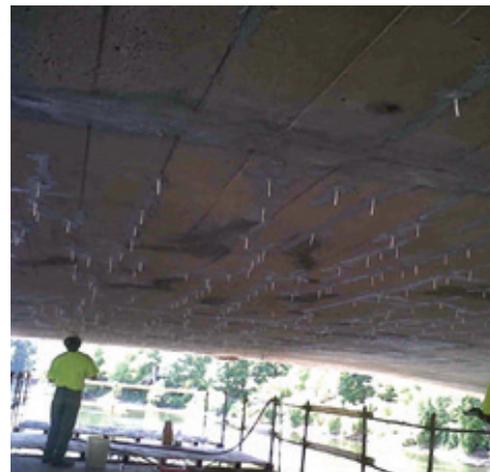
*Epoxy injection of arch ring*
