CASE STUDY

JORDAN COMMONS

Owner: Miller Family Real Estate, Sandy, UT

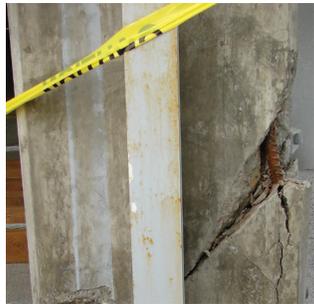
In the spring of 2009, column cracking was observed which raised concerns about the structures stability. One column in the south structure's north east corner near the expansion joint had cracked near the base almost all the way through. The column had slid approximately 1 inch on the crack plane and was caught up on an adjacent curb wall. The reinforcing bar on the northwest corner had also buckled. It was concluded that large (80 °F) seasonal temperature stress cycles of Salt Lake City, causing a 395 foot slab an estimated 2 in of total length change, were the source of collapse and extreme cracking in some columns. In the garages, the sections east of the expansion joint were 395 ft and 359 ft on the north and south sides, respectively. Both of these values exceeded the PTI recommendations of 325 ft maximums for parking structures based on shear walls located at the center. Furthermore, both sections had shear walls at their east end, forcing the structures to act as a much longer slab, explaining why gaps were observed between the double column lines and the expansion joints. With the east end of both structures locked to significant shear walls, most of the slab length change was seen in the expansion joints.

Column Displacement

The most significant remediation necessary to ensure a sound structure was the addition of new expansion joints in the east sections. The anticipated result of the new expansion joints was a decrease in temperature movement from 2" to only 1/2". The 395 foot long east portion of the north structure was transformed into independent sections separated by

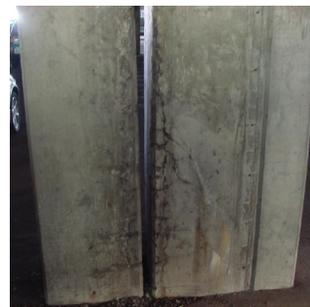
Column Deflection at Expansion Joint

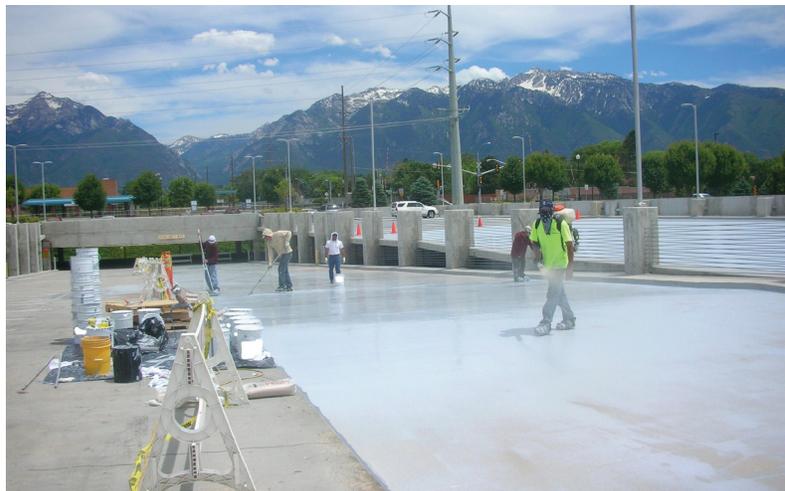
Elastomeric Membrane Top Coat Application with Aggregate

a new expansion joint to significantly reduce the formation of additional column cracking. Existing expansion joints were repaired with SikaQuick® 1000 and 2500 repair mortars. The owner's management team decided to help preserve their investment by applying a traffic bearing waterproofing system to the top levels of both structures. The elastomeric traffic membrane selected incorporated both single and two-component, fast-curing polyurethanes, Sikalastic® 710/715 and 720/745, respectively. In the main entrance aisles a more abrasion resistant epoxy broadcast overlay system Sikadur® 22 Lo-Mod, was selected to minimize maintenance requirements. Any cracks were routed and sealed and a surface applied corrosion inhibitor, Sika® FerroGard® 903, was used to reduce the ring halo effect around spall repairs. Two pedestrian bridges, about 70 feet long, leading from the parking structures to the office tower were also coated with a fast-curing, polyurethane Sikalastic® traffic system. Additional steel columns were installed and the post tensioned parapet wall ends, which had cracked due to thermal movement, were strengthened with SikaWrap® Hex 100 G glass fibers applied with Sikadur® 300 epoxy.

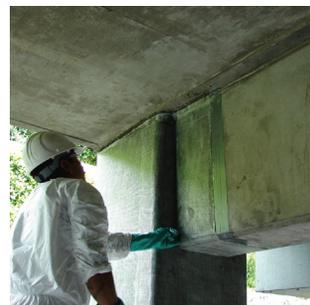
Installation of Glass FRP
