CASE STUDY

LAKE MERRITT

Owner: City of Oakland: Oakland, California

Project Engineer/Designer: Degenkolb Engineers, Oakland, California

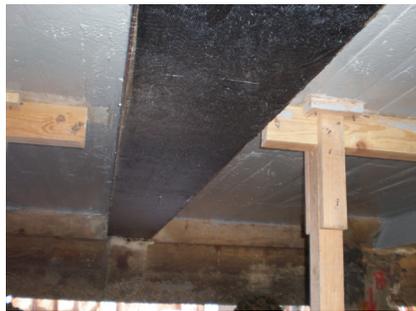
Girder after application of CFRP. Slab after application of epoxy coating. Note areas of shoring required comeback and touchup.

The Owner and Engineer set a goal to properly repair the damaged concrete, protect from future steel corrosion, protect from moisture penetration, structurally upgrade deficient members, and minimal impact on the overall project schedule. The concrete removal and surface preparation was completed in accordance with ICRI Guidelines. Sika® Armatec® 110 was applied to reinforce the steel coating and act as bonding agent to repairs. Pre-bagged Sikacrete® 211 repair materials repaired the slabs, beams and girders. Sacrificial anodes, Sika® Galvashield® XP+, were installed within the repairs around the perimeter and core drilled. In areas where the concrete was otherwise sound, the sacrificial anodes were installed in a grid pattern. Galvashield® CC anodes were installed on piers with monitoring kits to monitor current output. These anodes were patched with SikaRepair® 223 and SikaGrout® 212. SikaWrap® Hex 103C carbon fiber fabric was fixed to the underside of the beams and slabs with damaged reinforcing steel for structural strengthening. For added protection, a layer of Sikagard® 62 epoxy coating covered all exposed concrete surfaces below the high-tide waterline and the underside of slabs.

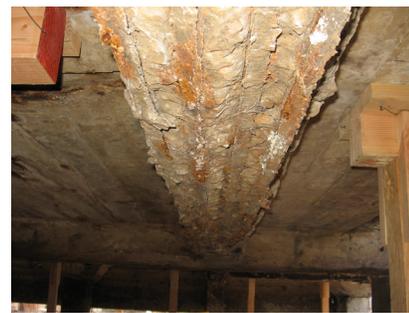
Once exposed, cracking, spalls and signs of corrosion problems were observed throughout the building's substructure. A materials and engineering firm determined that most of the beams, girders, piles and slabs had cracking, spalls and signs of corrosion. The chloride content was very high, ranging from 0.4-0.9% by weight of concrete (theoretical threshold for corrosion is 0.02 - 0.03%). Heavy corrosion was noted in many areas and several areas had complete loss of the stirrups and/or the longitudinal steel. The firm concluded the spalling was caused by corrosion of the reinforcing steel from insufficient cover and chloride ingress.

Extensive spalling of the beams, girders and slabs caused by severe corrosion of the reinforcing steel.

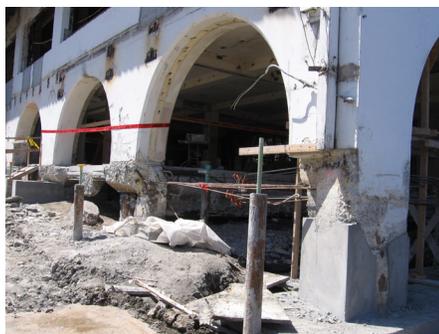
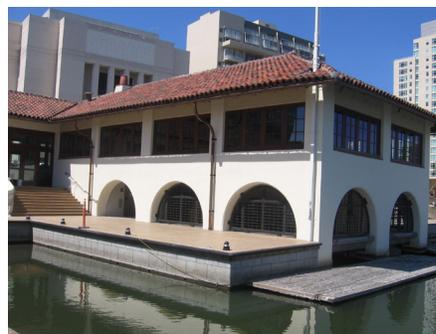
Close up of a completed area (before and after).
