Liquid Plastics Inc.

CASE STUDY

The Jones Lang LaSalle managed property, Urban I & II in Tampa, Florida, has several arrays of Lexan skylights on the roof of the buildings that were a continual source of leakage into the atrium areas of the building. Over the years numerous amounts of different types of materials had been applied and slathered onto the skylights but with the same affect, they still leaked.

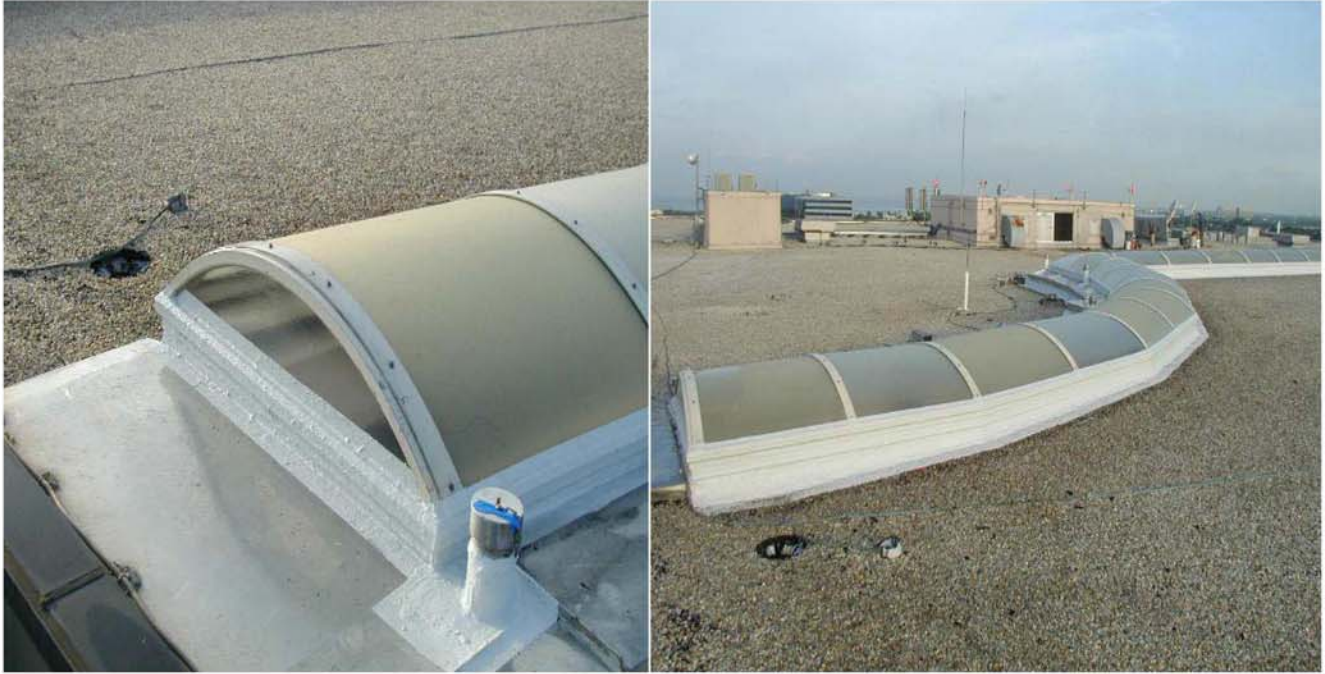
The project has been completed and several Florida rain storms have come and gone without any leakage. Jones Lang LaSalle has indicated that this is the first time that they have seen a repair system work so well on these skylights.
