Risks of Roofing Over Concrete Decks

By Joe Schwetz

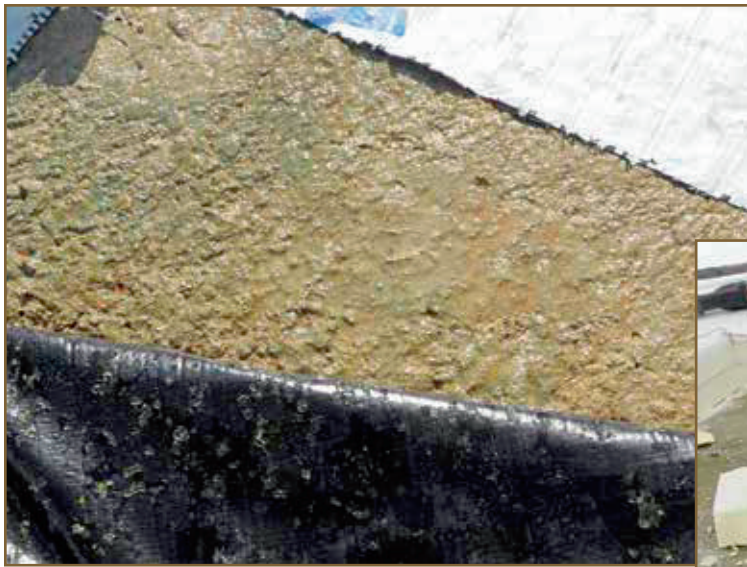
Photo 2 – Moisture between the concrete and self-adhered vapor barrier.

On February 15, blisters were seen under the adhered vapor barrier. Test cuts showed moisture and standing water on the deck (*Photos 2, 3, 4, and 5*). An additional 12 test cuts were done on February 23, with nine test cuts showing moisture and standing water between the vapor barrier and the concrete deck (*Figure 3*). At this point, the project was shut down, and accusations and blame for the presence of the water started, followed by claims that the

It was subsequently determined that high moisture content in the concrete roof deck and the initial cold temperatures inside and out caused a slow cure and slower drying of the concrete. When the GC heated the interior of the structure to 70° to 75°F while the outside temperatures were averaging in the mid-20°F range, a strong moisture drive up into the roofing vapor barrier had been created. The moisture drive was so great that the diffused water that accumulated on the deck lifted the bar-

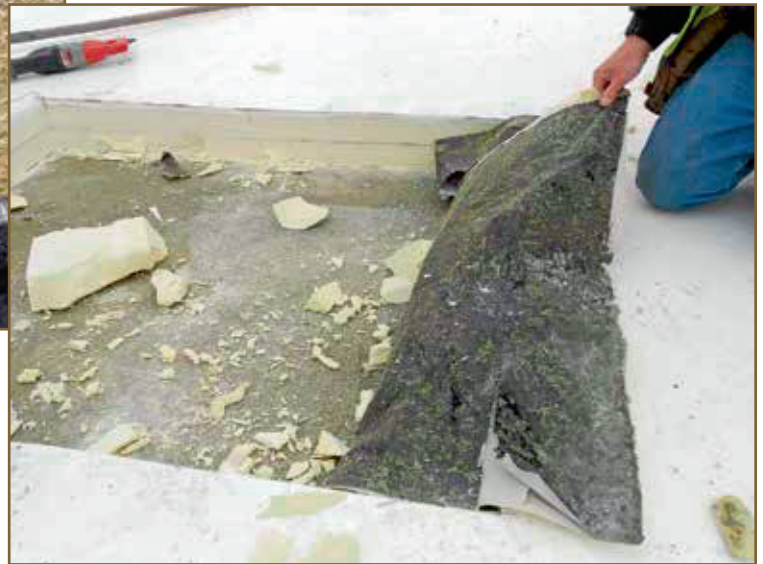
Photo 3 – Removal of adhered vapor barrier from primed concrete deck.

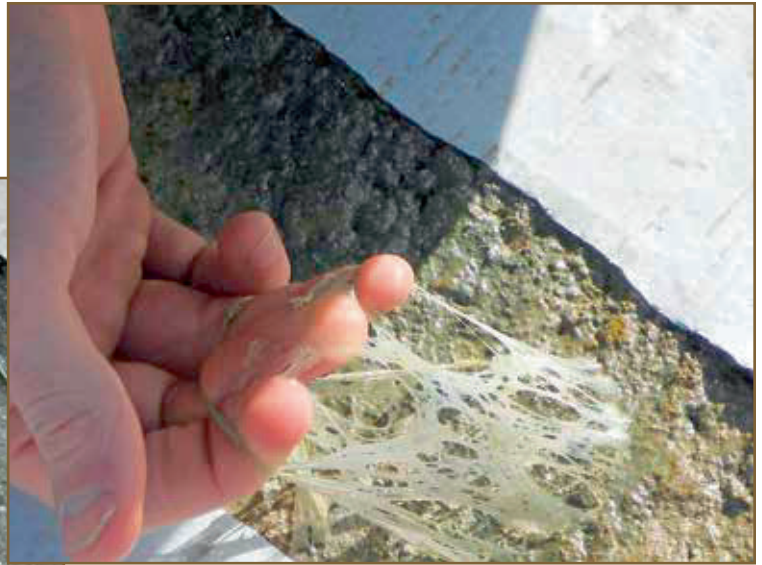
Photo 5 – Primer coming off the concrete deck.

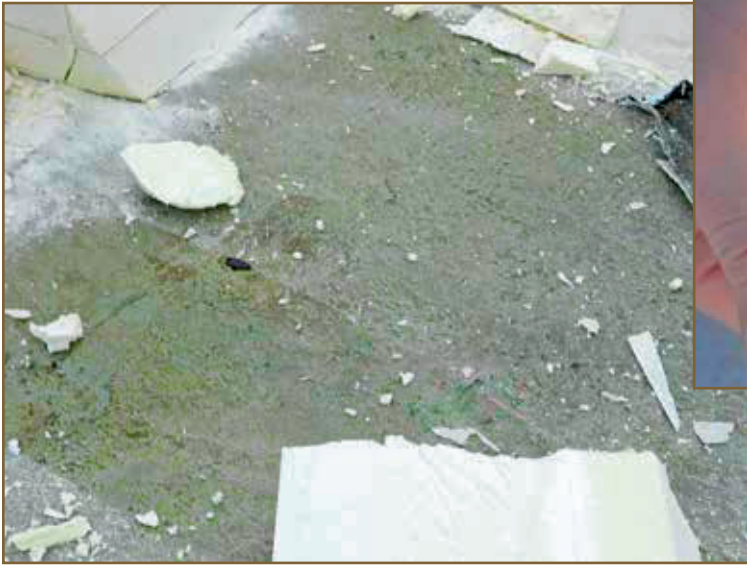
Photo 4 – Moisture on the deck; minimal primer.

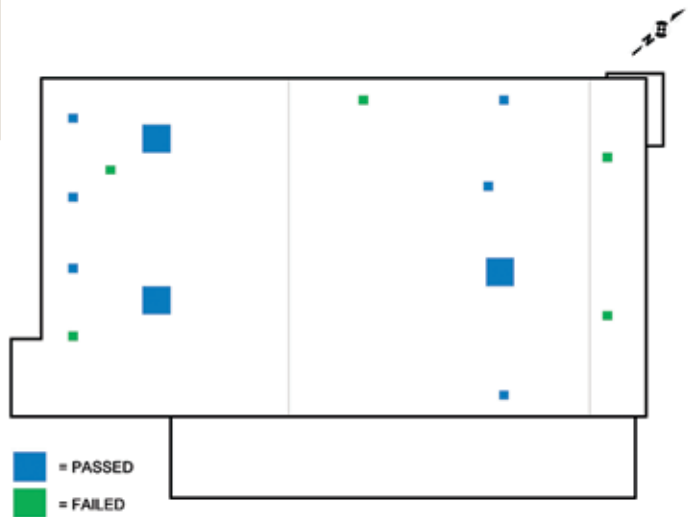
The self-adhered vapor barrier sheeting was removed from the entire 20-ft.-wide perimeter on February 23. The exposed deck was left to surface-dry (*Photo 6*). On March 5, pull testing was done on new self-adhered vapor barrier to the primed deck. The first test failed within the urethane adhesive foam due to inadequate cure time. The other five assemblies all showed very good pulls, with the readings between 645 and 1,185 pound force—well above the calculated design uplift load of 28 psf for the wind uplift pressure. During this site visit, the GC did acknowledge that the interior of the building was heated to a constant 70° to 75°F temperature to allow the intumescent paint to dry.

Figure 3 – Field-testing of the self-adhered vapor barrier, Case Study 1.

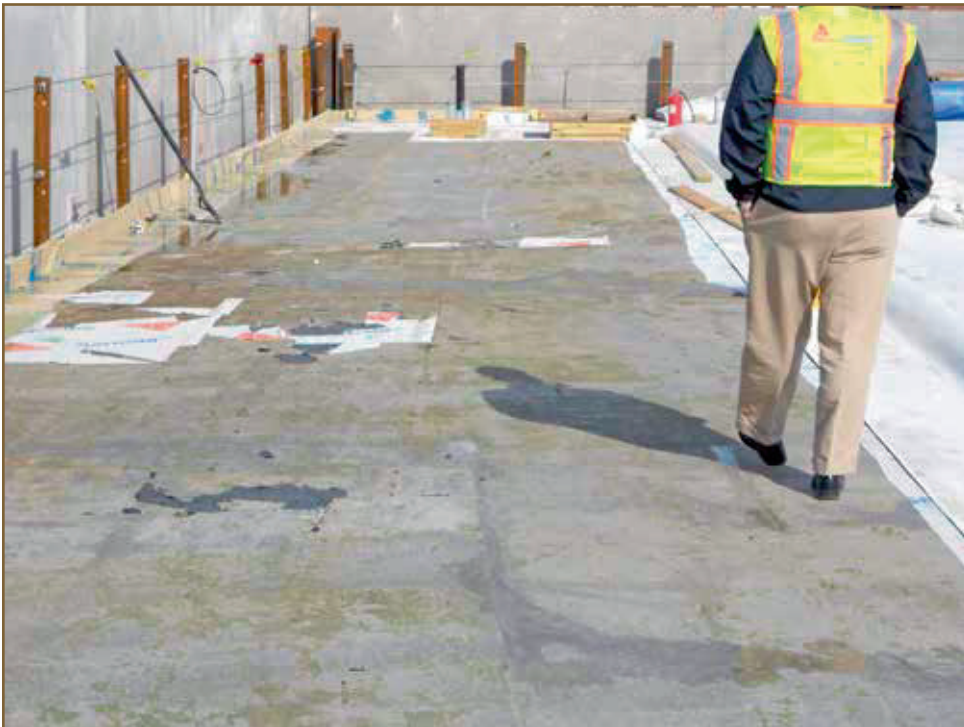
Photo 6 – Roofing removed from the perimeter.

The roof system was completed as specified with the inclusion of sealing all of the through-deck penetrations, as well as along the walls. Two mechanically fastened batten bars, at 4 and 8 ft. from the perimeter, were installed with a cover strip welded over the top. The roofing contractor has monitored this project for the past two years, reporting no issues.

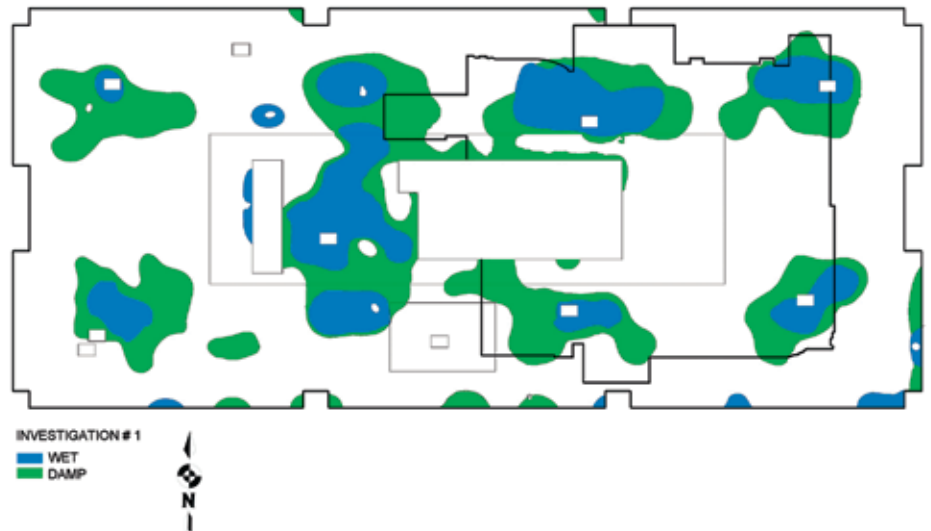
It was determined that approximately 75% of the roof was dry, 15% damp, and 10% wet. This survey noted the water infiltration occurred at the drains and where the flashing details along the penthouse were not completed. Concern was noted that while the majority of the roof appeared to be dry, over time, the trapped water would

Figure 4 – Initial area of moisture in the roof system and replacement (Case Study 2).

The construction team identified areas of the roof to be replaced (approximately one-third of the total area), which was done during the late summer and early fall of 2008 (Figure 4). It appears that most of the areas identified as wet/damp from the nuclear scan were replaced (heavy black lines on Roof Plan 4). Project records indicate not all of the identified damp/wet areas were replaced, primarily at the west end of the building. At the completion of the rework, 11 test cuts were done by a third party to determine the condition of the roof assembly; the cuts are designated by the orange dots on Roof Plan 5. Based

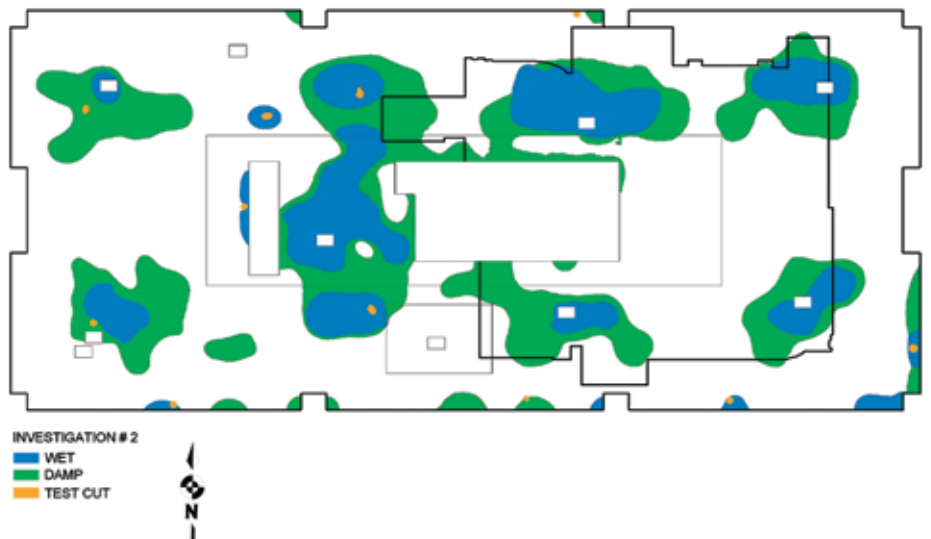
Figure 5 – Test cuts indicating all areas of the roof to appear to be dry (Case Study 2).

on the report, all test cuts indicated the roof system layers and concrete deck to be dry, including the west end of the building where there was no product replacement (Figure 5).

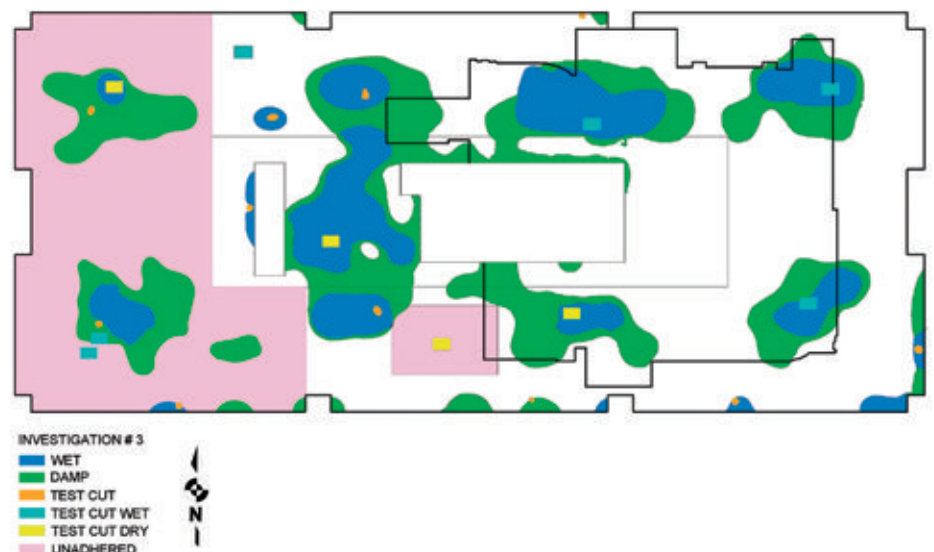
The area where the roof system was replaced with new insulation and membrane had three areas that showed wet

Excess water/moisture caused the issues with this roof installation and performance. A major contributor to the problems was the water from the flood test. The ponding water from the flood test that entered the conditions (Samples 6, 7, and 9). The roof system was thoroughly checked to see if there were any breaches or possible entry points for the water, and none was found the roof system was able to move between the roofing components and along the concrete deck, aided by hydrostatic pressure (Photos 7, 8, 9, and 10). After the water test, the water in the system has to travel around the insulation boards as well as the ribbons of urethane adhesive. The adhesive ribbons that

Figure 6 – Field evaluation with test cuts indicating the movement of the moisture within the system at Case Study 2.

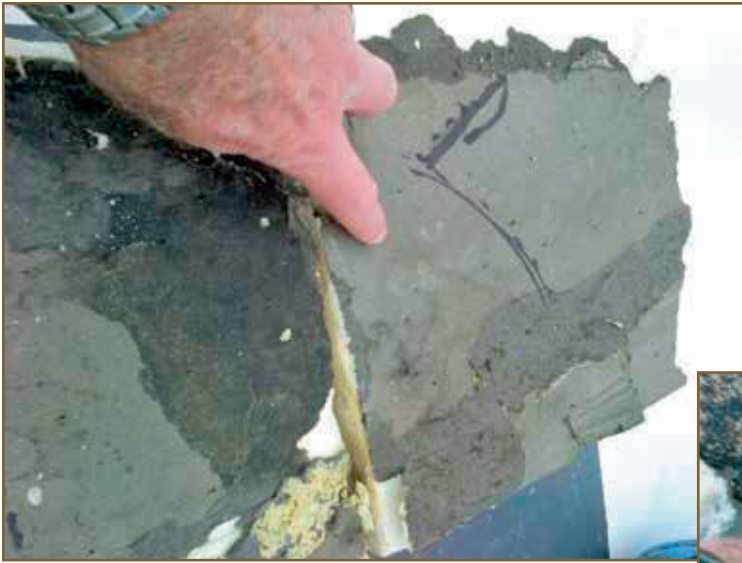
Photo 7 – Moisture underneath the bottom layer of iso.

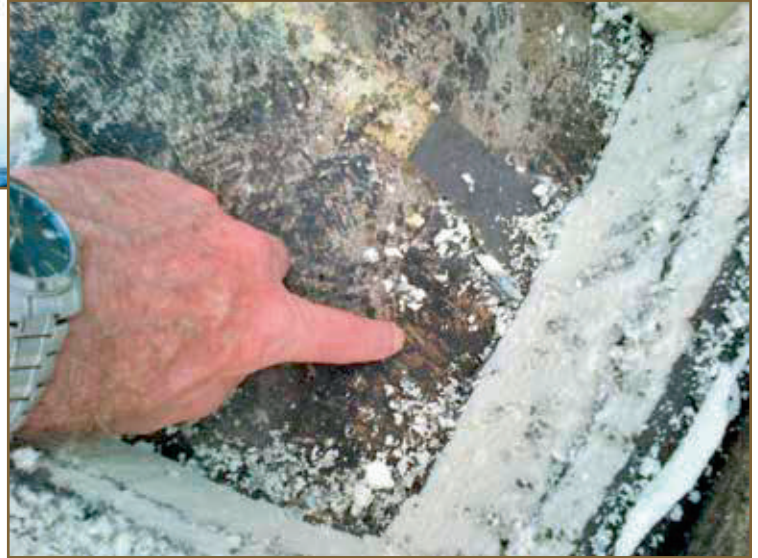
Photo 8 – Moisture on concrete deck.

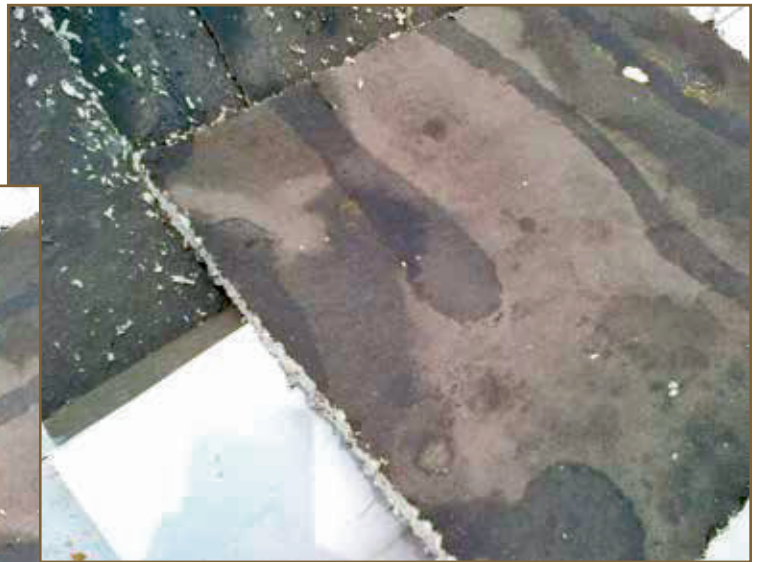
Photo 9 – Moisture between the layers of boards.

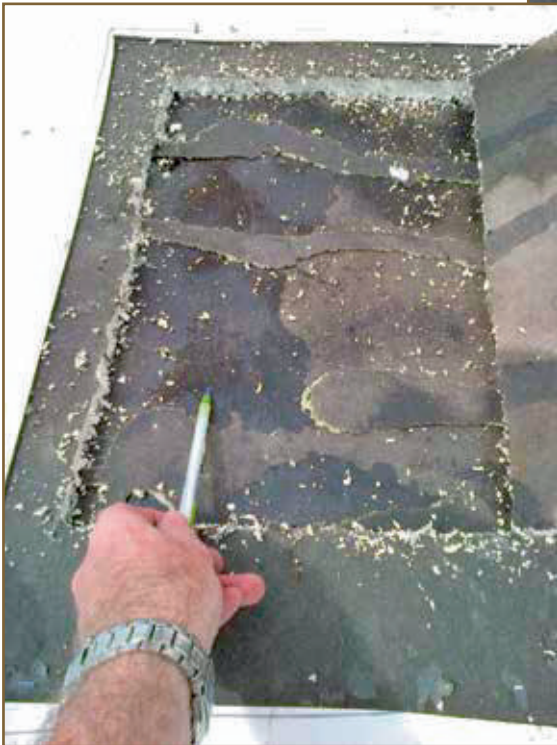
Photo 10 – Moisture between the layers of iso.
