Market Application Focus

Project: Morris Sheppard Dam & Powerhouse
Owner: Brazos River Authority
Engineer: Jaster-Quintanilla
Contractor: Restek Inc.
Year: 2007

Case Study

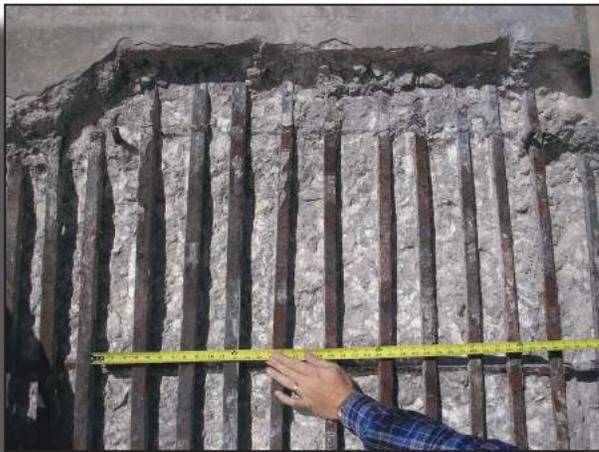
bars spaced 4 inches on center at portions of the outer face of the Powerhouse walls. Further investigation of the existing conditions revealed that extensive corrosion of the embedded reinforcing steel was causing the 4 to 6 inch thick concrete cover to shear off at the exterior face of the reinforcement.

Other areas of concern included delaminated concrete on the sloped top and vertical face of large encasement blocks that anchored the 12-foot diameter Penstocks and spalling concrete was also found beneath several of the large concrete struts located between the massive buttresses that support the dam's concrete slab.
