Market Application Focus

Project: Morris Sheppard Dam & Powerhouse
Owner: Brazos River Authority
Engineer: Jaster-Quintanilla
Contractor: Restek Inc.
Year: 2007

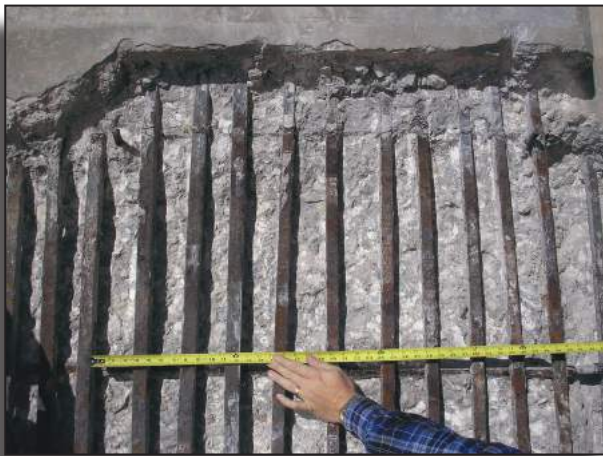
The Morris Sheppard Dam, constructed between 1938 and 1941, impounds the 19,800 surface-acre Possum Kingdom Lake, highly regarded as one of the most beautiful lakes in Texas. The cast-in-place concrete Powerhouse sits at the base of the 190-foot tall, 2,015-foot long dam structure, and houses twin 11,250 kilowatt generating units. Maintenance personnel observed that cracks and spalls had developed in the heavily reinforced exterior walls of the Powerhouse. The original drawings showed a concentrated vertical layer of one-inch square reinforcing

bars spaced 4 inches on center at portions of the outer face of the Powerhouse walls. Further investigation of the existing conditions revealed that extensive corrosion of the embedded reinforcing steel was causing the 4 to 6 inch thick concrete cover to shear off at the exterior face of the reinforcement.

Repair areas with significant concentrations of reinforcing steel were called to have ¼ inch diameter stainless steel pins installed 24 inches on center each way to mechanically anchor the repair material to the substrate. To help ensure effective material placement in small, hard-to-reach areas, wall systems below designated elevation were specified to be repaired using Sika MonoTop 611, a free-flowing, polymer-modified, silica fume enhanced, form and pour repair mortar. Repair areas above the
