# CASE STUDY

## BELLAIRE TOWER

**Owner:** The Bellaire Homeowners Association, San Francisco, California

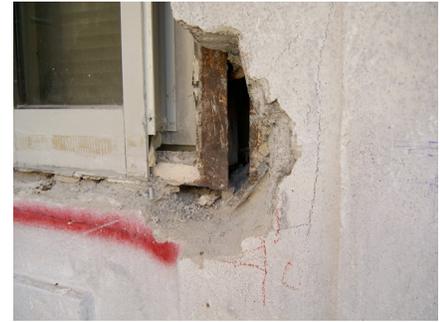
Good example of spalling caused by the window steel flange corrosion.

Sika Armatec® 110. Spall repairs were either hand-applied or formed and poured with polymer-modified repair mortars, SikaTop® 123+ and SikaRepair® 223. Sika® Galvashield® XP+ and CC galvanic anodes were used along with Sikacrete® 211 and SikaGrout® 212 to protect the steel window flanges and select areas of the reinforcing steel near the windows. On the north and east elevations, some windows had to be removed and replaced without refurbishment as they were beyond repair. After the windows were addressed, the exterior walls were power washed and coated with an elastomeric, breathable, waterproof coating, Sikagard® 550W.

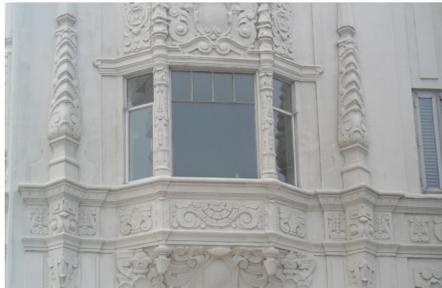
Completed area with intricate detailing and ornamentation. The four vertical elements of the window are made of GFRC.

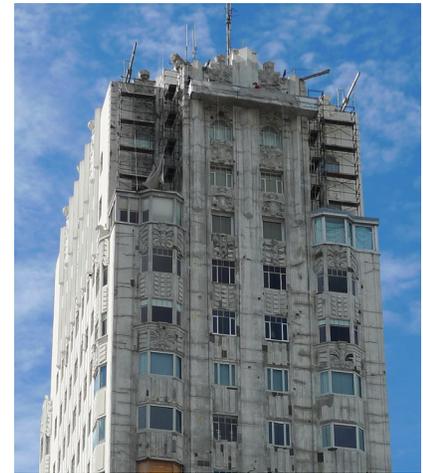
North facade: 1. coating removed, 2. Crack and concrete repair in progress
