WITHSTANDING HURRICANE IVAN

By S.P. GRAVELINE

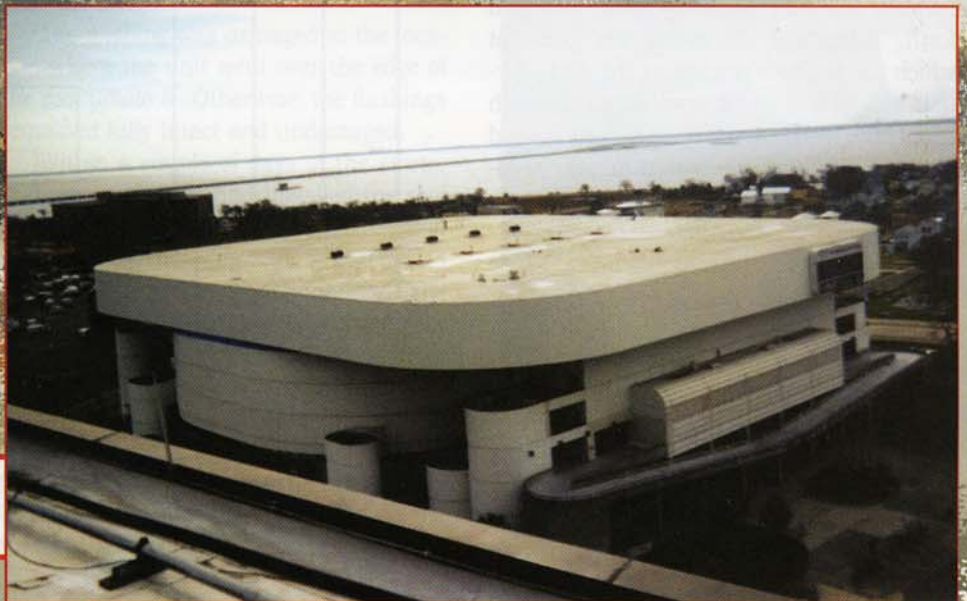
**Photo 1: Pensacola
Civic Center.**

The Pensacola Civic Center (Photo 1) was built in 1985. The 10,000-seat arena is a popular venue for major concerts, sporting events, and trade shows. More importantly, the building is one of the region's emergency hurricane shelters. It is counted on to provide a safe haven through the worse possible storms.

A fully-adhered EPDM assembly was originally installed on its 136,000 square-foot roof. Hurricane Erin struck Pensacola in 1995 and did approximately \$7 million worth of damage to the building. More than 80% of the roof's surface, the facer had delaminated from the core of the insulation boards, which allowed the membrane to peel back.

A decision was made to re-roof the facility with a polyvinyl chloride membrane secured by lineal fixation elements.

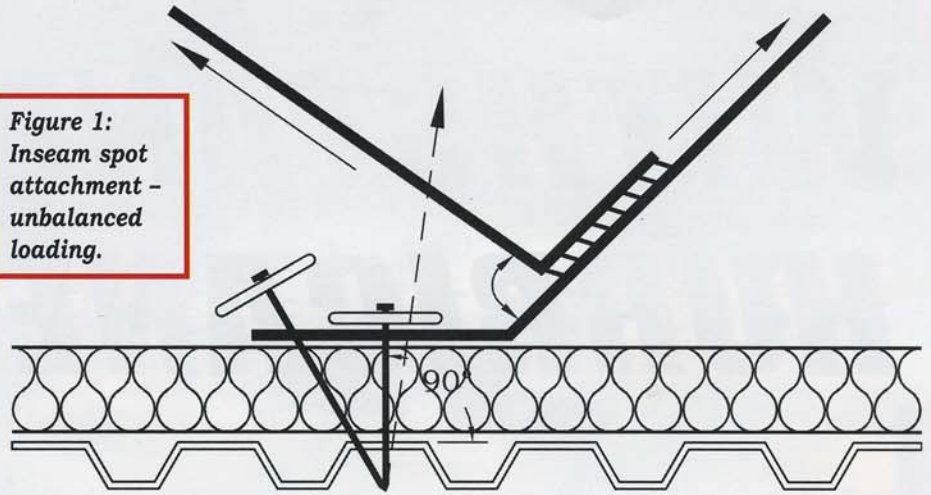
In a traditional mechanically-attached installation, the fasteners and plates are installed in the sheet overlap. Under wind loading, the membrane (and consequently, the fastening components) are subjected to unbalanced or asymmetrical forces (Figure 1). This imposes tremendous stress on the seams, on the membrane where it is penetrated by the fastener, and most importantly causes the fasteners to tilt slightly. Fastener pull-out resistance is reduced as the fastener is acting at an angle to the deck. Additionally, under cyclic wind loads, the fastener and plate assembly "rock" back and forth, potentially elongating the point at which the fastener penetrates the deck, further reducing pull-out resistance. Although these spot-attached assemblies have a good track record on roofs exposed to more modest wind loads, there was concern that such a system would not provide the level of performance required to protect this structure from hurricane-force winds.

Figure 1:
Inseam spot
attachment -
unbalanced
loading.

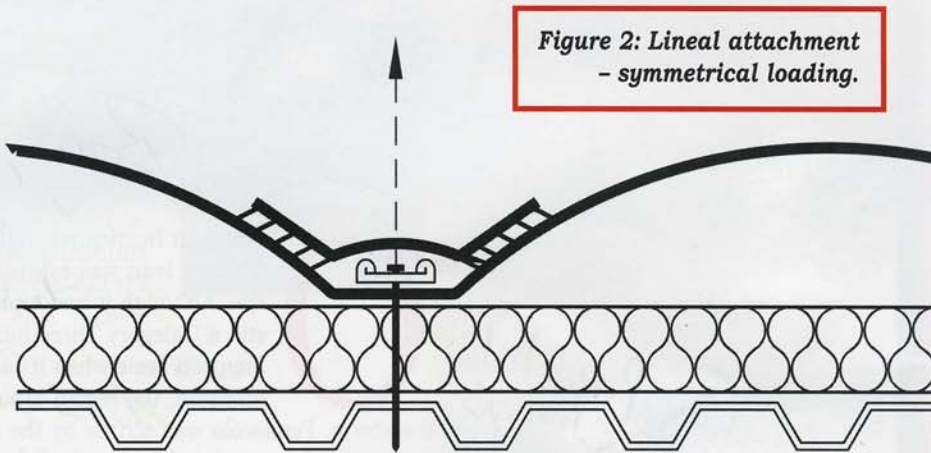
In a lineal attachment system, stiff 14-gauge, U-shaped profiles are used to distribute the wind loads. The bars are secured with fasteners through the membrane to the structural deck. The bars are then made watertight with cover strips hot-air welded to the base membrane. Such systems allow for a uniform load distribution on both sides of the fixation element (Figure 2).

Figure 2: Lineal attachment
- symmetrical loading.

This eliminates peel stress on the seams, rocking of the fixation elements, and ensures that fasteners are loaded perpendicular to the deck, ensuring that maximum pull-out resistance is achieved, also reducing fatigue.

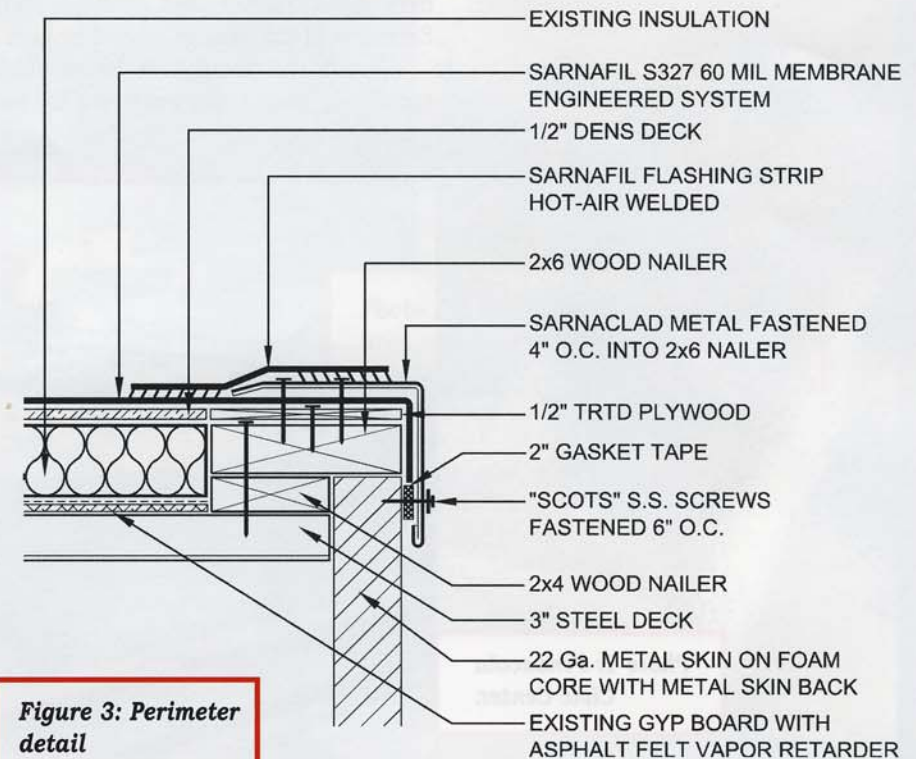
Figure 3: Perimeter
detail

The perimeter detail (Figure 3) was designed to ensure the critical edge of the roof was airtight. The fascia was face fastened through a gasket tape sealed to the wall panel.

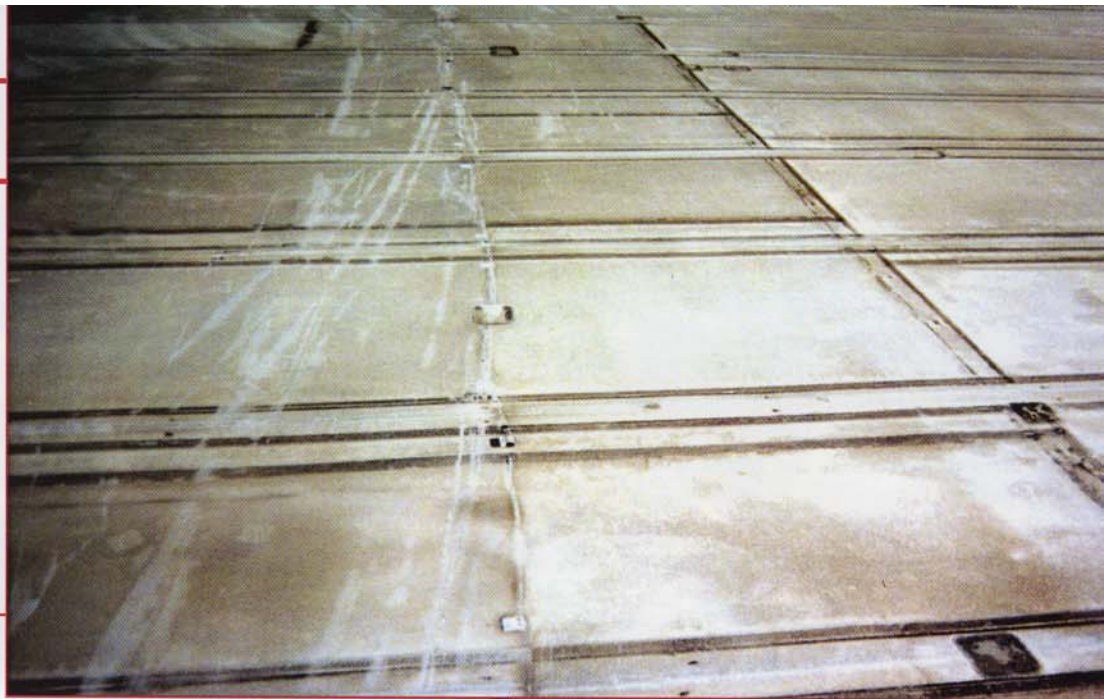
Photo 2: "Track" of one of the wind-blown HVAC units.

The Civic Center is located less than a half of a mile from the waterfront. At 102 feet in height, and with only much smaller, lower buildings in front of it, the building took the full brunt of Ivan coming in along the Gulf of Mexico. The 130-mph winds dislodged five rooftop exhaust units from their curbs. Each of the units was approximately 6 x 6 feet in size and weighed roughly 300 lbs. The units were literally blown

across the roof surface, leaving their paths clearly marked on the membrane's surface (Photo 2). One of the units actually blew off the roof and landed on a car in the adjacent parking lot (Photo 3).

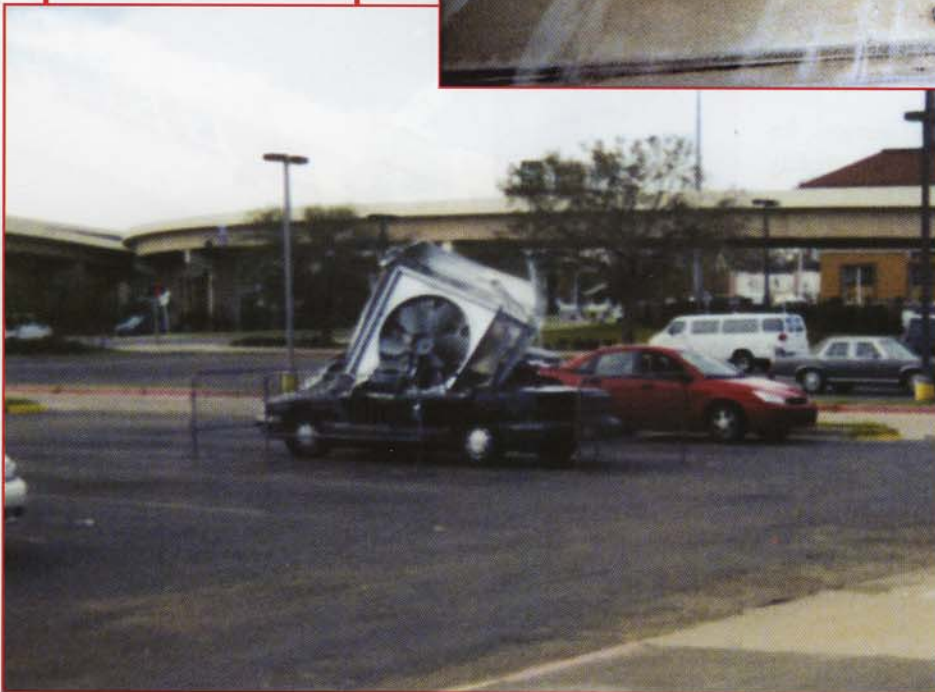
Photo 3: Exhaust unit blown off the roof.

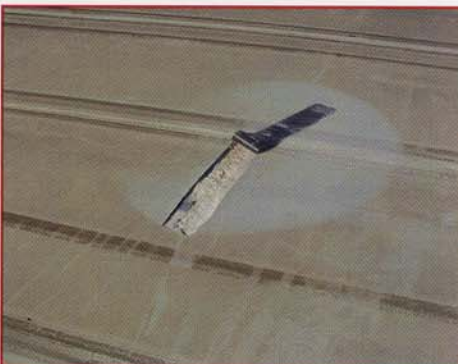
Photo 4: Membrane cut by an exhaust unit.

The membrane was cut or punctured in numerous locations (Photos 4 and 5). At one location, immediately adjacent to where a unit was ripped away from its base, the sheet was slashed along a 25-foot length (Photo 6). The large opening allowed air below the sheet, which in combination with the winds in excess of the design speed, caused slight lifting of some fixation bars (Photo 7) in the field of the roof. Despite the pull-out of a few fasteners, the bars remained in place, albeit slightly deformed. No bars were displaced or fasteners pulled out in perimeter or cor-

Within a couple of days of the storm, the contractor who had installed the roof in 1995 was able to repair all the cuts and punctures by hot air welding patches to the existing membrane. Having made the roof watertight, the roofer will return later to address the deformed bars. Less than 1% of the fixation bars were affected.

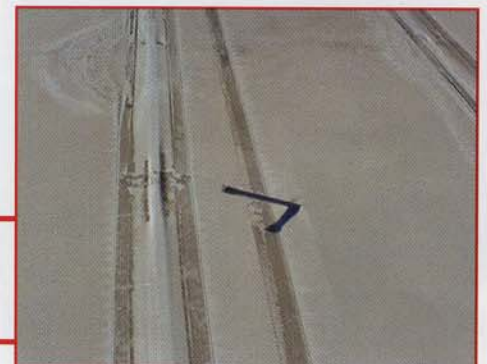
Photo 5: Membrane punctured by an exhaust unit.

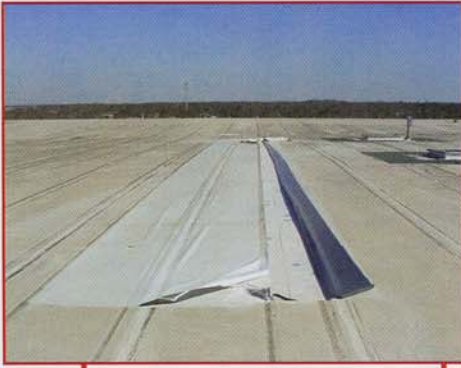
Photo 6: Membrane slit by a tumbling exhaust unit.

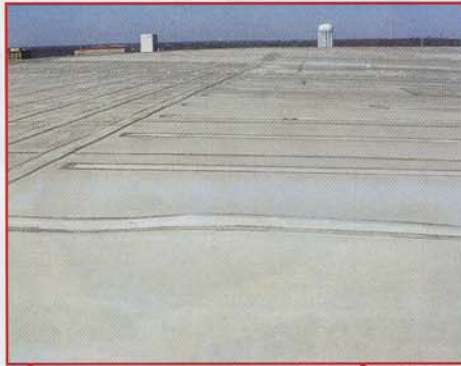
Photo 7: Partially deformed fixation bar.

ner zones, where the highest loads are generated.

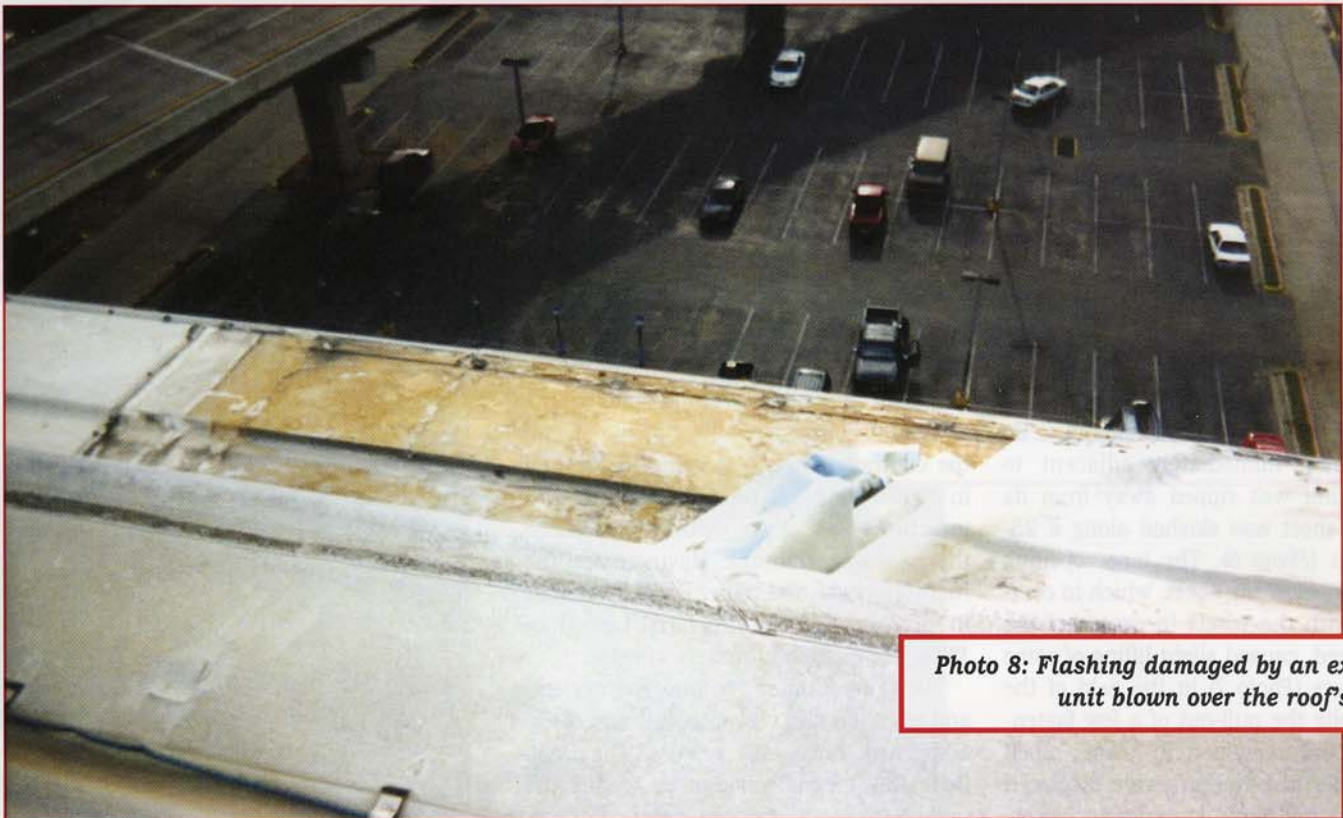
Photo 8: Flashing damaged by an exhaust unit blown over the roof's edge.

The flashing was damaged at the location where the unit went over the edge of the roof (Photo 8). Otherwise, the flashings remained fully intact and undamaged.

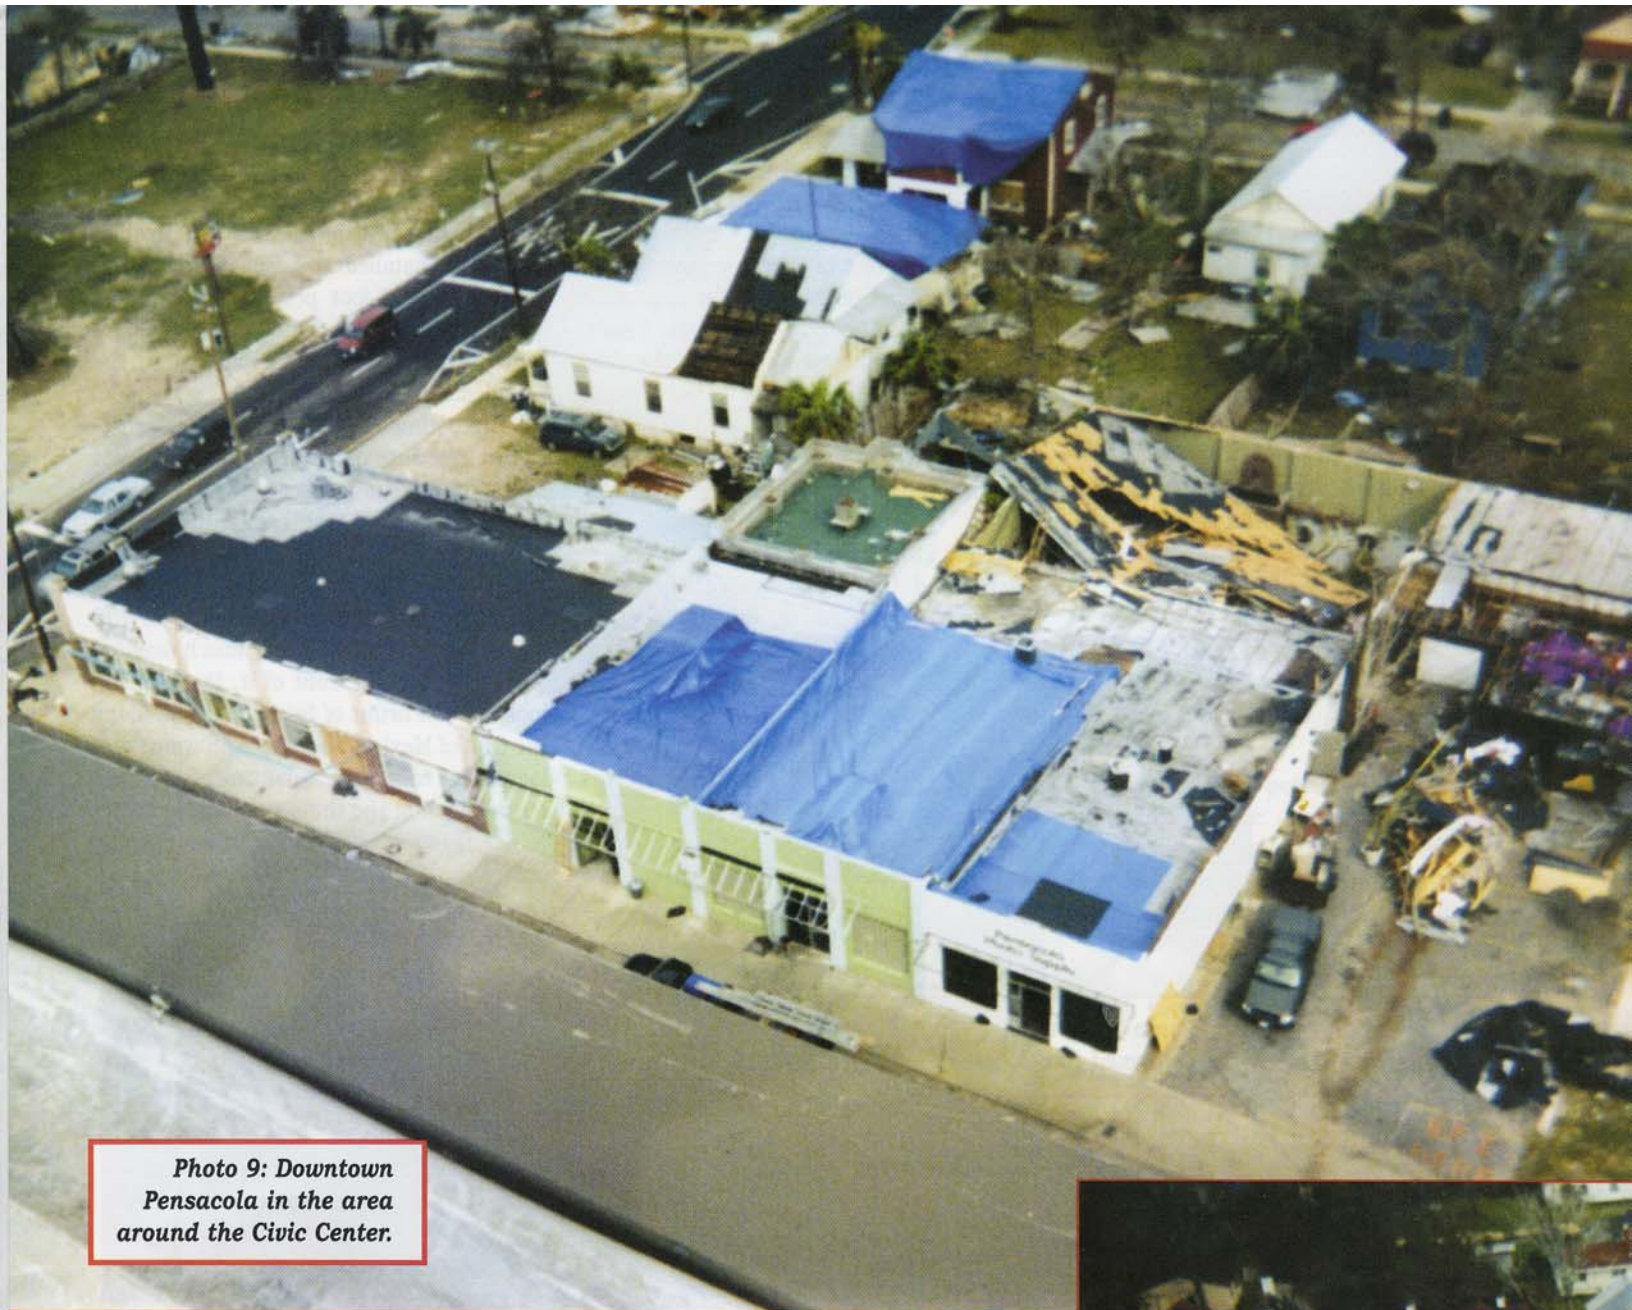
Photo 9: Downtown Pensacola in the area around the Civic Center.

Pensacola's downtown core in the area surrounding the Civic Center was absolutely devastated (Photos 9 and 10). However, although the noise from the displaced mechanical units rolling around the roof was disconcerting, the thousands of people who weathered the storm inside the Civic Center were kept dry and secure. ©

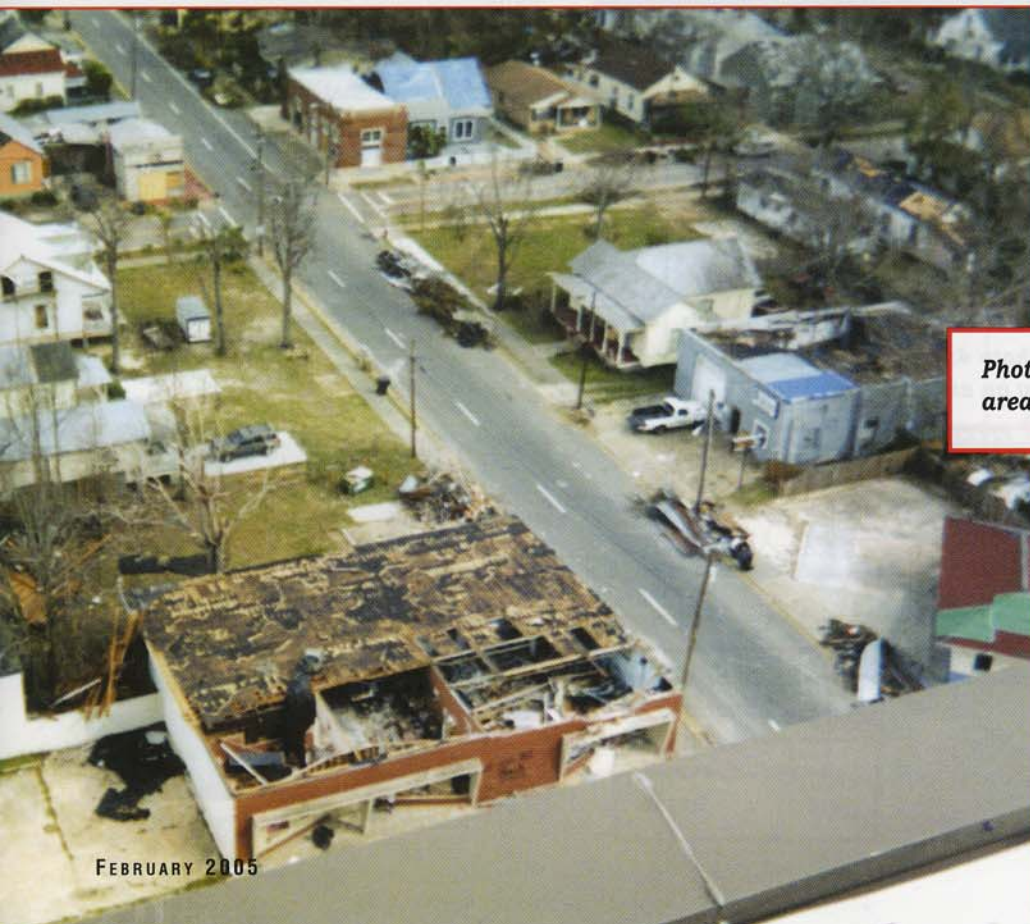
Photo 10: Downtown Pensacola in the area around the Civic Center.
