Concrete Repair & Protection

Corrosion & Surface Erosion

Project: The Cotton Bowl
Owner: The City of Dallas
Engineer: Jaster-Quintanilla Dallas, LLP
Contractor: Charter Builders/L.S. Decker
Year: 2008

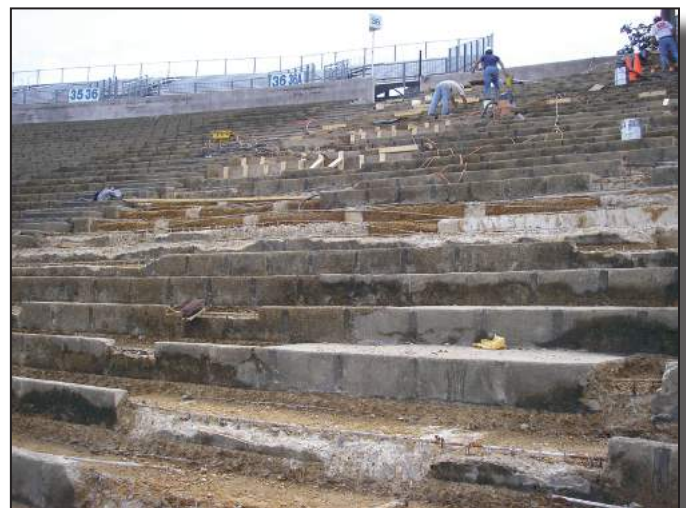
Years of "wear and tear," coupled with a failure to provide adequate funding for maintenance and repair, had taken its toll on the oldest sections of the Cotton Bowl – the original "lower bowl." Cracks, spalls, and inadequate repairs were visible everywhere. Severely eroded steps in aisle ways and unevenness across expansion joints in the seating areas were potential trip hazards for patrons. Unsealed expansion joints allowed water to penetrate into critical service areas such as concession stands, food storage areas, and restrooms.
