# CASE STUDY

## SOUTH CAROLINA DEPARTMENT OF NATURE RESOURCES

**Owner:** South Carolina Department of Natural Resources, Columbia, South Carolina

**Project Engineer/Designer:** Davis & Floyd, Inc., Charleston, South Carolina

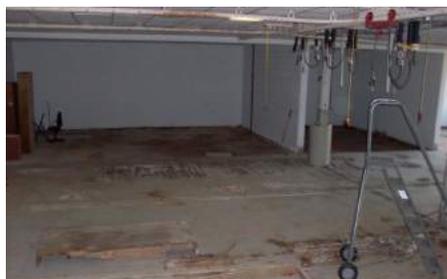
Living next to the ocean, corrosion is a serious concern. The State of South Carolina Department of Natural Resources (SCDNR) determined that the large amounts of corrosion observed throughout their building needed to be addressed. Visual investigations in 2006 found several degraded structural conditions, including deteriorated reinforcement, spalled concrete, cracked concrete, and rust stained concrete. In 2008, a destructive investigation uncovered many areas in which 25-50% section loss of the reinforcing steel had occurred. Some areas had complete section loss of the reinforcing steel. Approximately 20% of the 50,000 sf building required concrete repair. The top surface of the floor slab in the "wet labs" was coated with an epoxy floor coating that had failed, allowing saturation from the saltwater tanks and routine washing of the lab area. The root cause of the steel corrosion and resulting spalling stemmed from high chloride content and insufficient cover.

Top side spalling and steel corrosion.

Multiple measures of concrete repair and protection to restore structural integrity included full slab removal in some areas as well as partial depth removal in both wet lab areas A and B. The previous floor coating was removed and replaced while cracks were gravity fed with Sikadur® epoxy resins. Local and general corrosion mitigation and protection was implemented using Sika® Galvashield® CC 65 and Sika® Armatec® 110. Other improvements included: repair of the floor systems within the wet labs wet labs using SikaTop® Seal 107 waterproofing to protect the slabs, removal and replacement of all support clips for the exterior precast wall panels, removal and replacement of exterior concrete stairs and supports, and installation of new, insulated window and doors throughout.

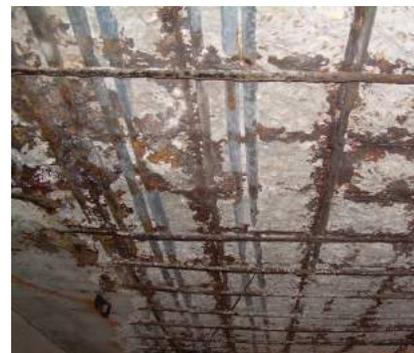
Underside spalling and steel corrosion.

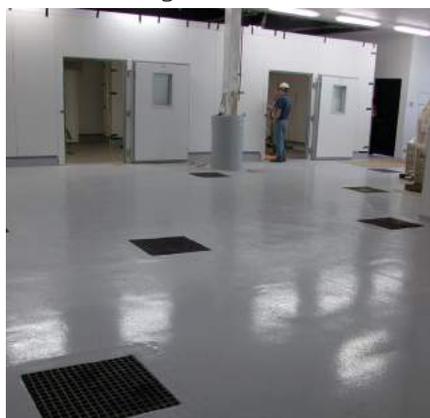
Completing lab finishes.

The new ready-mix concrete design included a corrosion inhibiting admixture to provide additional protection for reducing the same incipient anode effect throughout the entire slab placement areas. Due to the high level of chlorides found in the concrete in Lab B, 634 anodes were installed by laying out the steel reinforcement grid. A surface applied penetrating corrosion inhibitor, Sika® FerroGard® 903, was applied to the beams and underside of the slabs to provide protection of the entire exposed concrete underside. The underside spall repairs included large, deep repair areas that required forming and pumping the repair mortar, Sika® Monotop® 611. The structural strengthening of different beam locations was accomplished using Sikawrap® Hex 103C carbon fiber fabric saturated in Sikadur® 300 epoxy wrapped around the sides and undersides of four beams. Wet lab Area B received SikaQuick® 1000, a cementitious overlay, to provide better pitch to drains and improve the floor finish. Finally, all wet lab floor slabs were coated with a high-build epoxy floor coating system, Sikagard® 62.

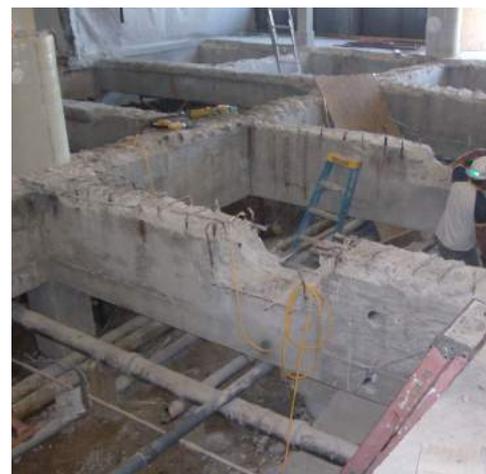
Demolition at Lab A
