CASE STUDY

LSU TIGER STADIUM

Owner: Louisiana State University, Baton Rouge, LA

Project Engineer/Designer: Engensus, LLC, Baton Rouge, LA

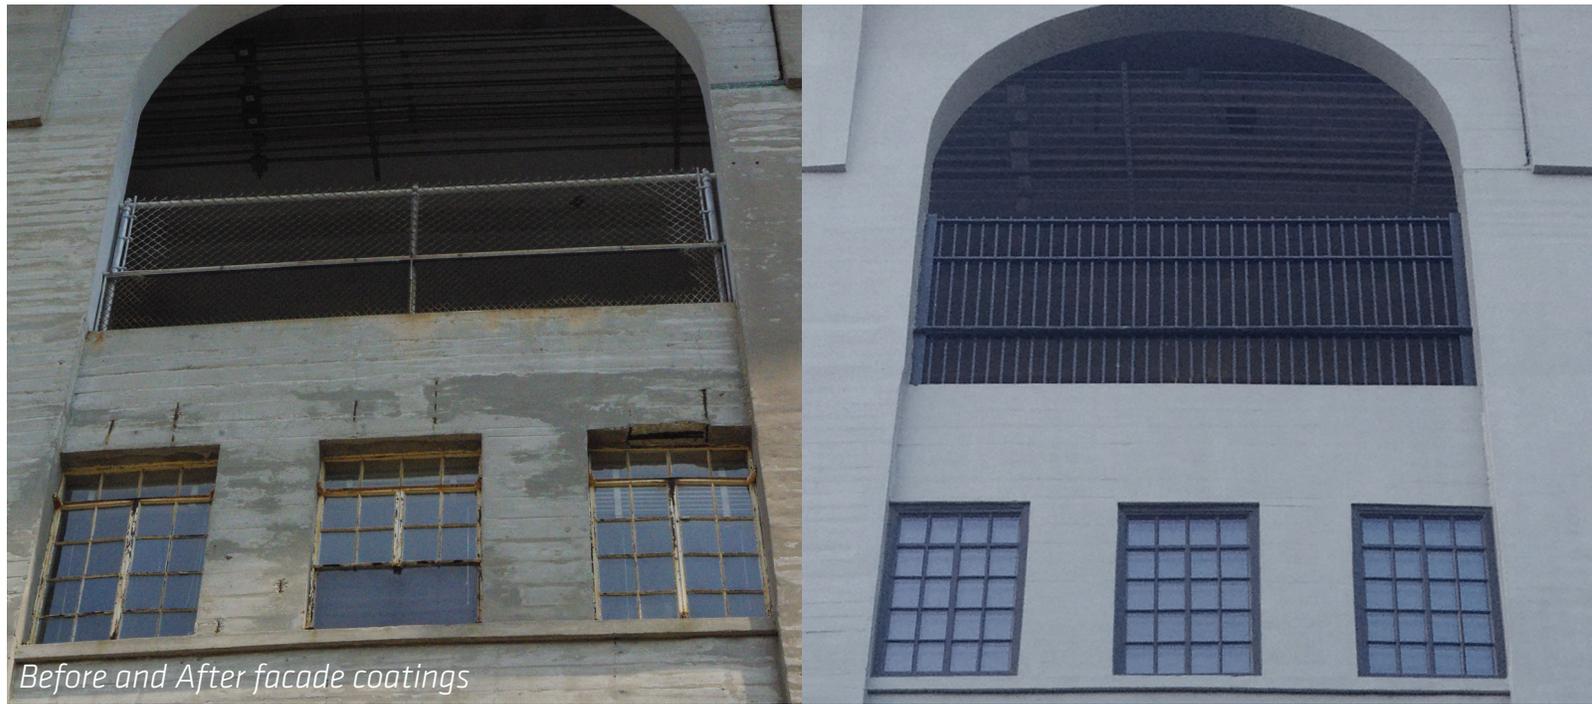
The Louisiana State University “Bengal Tigers” are one of the most successful college football programs today boasting 3 NCAA national championships and 14 conference championships. Located on LSU campus in Baton Rouge along the Mississippi River, Tiger Stadium is an iconic structure. It is known as “Death Valley” for being one of the loudest and most difficult stadiums for opposing teams to play. Construction of this historic stadium began in the early 1920’s and opened with a capacity of 24,000. Now Tiger Stadium has increased its capacity to hosting 92,000 die-hard fans. On game day Tiger Stadium becomes the 6th largest city in the State of Louisiana. The north end zone, constructed in 1936, was experiencing concrete deterioration on the outer surface due to insufficient concrete cover on the reinforcing bars and cracks that had developed around the new windows installed prior to the façade restoration adding some complications. The façade had minor spot repairs of spalls and surface cracks and was littered with abandoned anchor bolt holes. LSU wanted to restore this façade while maintaining the historic look.

The original stadium was formed with 2” x 6” horizontal planks, which are visible between the planks in the concrete. It was critical to restore the finish and maintain the formed planks look. When spall repairs intersected one of the form lines, it was required that the repair contractor employ a technique of honoring this form line in ten repair areas. The workability of the repair mortar Sikatop® 123 allowed the contractor to mock the form lines by tooling them into the repair. The engineer required that any repairs to the cracks around the newly installed windows could not reflect through the coatings applied later and that the existing surface finish must be maintained. Therefore, an epoxy gel Sikadur® 31 as the surface seal and a low viscosity resin Sikadur® 35 were used for filling these narrow cracks. The spalled areas were square cut, the concrete was chipped to the required profile and the area pressure washed to remove dust of fracture. The Armatec® 110 bonding agent and Sikatop® 123 non-sag repair mortar were used for patch repairs and the Sika® FerroGard® -903 corrosion inhibitor was applied to protect the reinforcing steel from further corrosion. Finally, two coats of a cement based coating Sikatop® 144 with a fine texture provided a uniform look to the concrete while hiding repairs. This also produced the original concrete appearance and instead looking like a newly painted wall. A clear anti-carbonation coating Sikagard® 670W was then roller applied to the surface to provide another layer of protection and reducing dirt pick up.
