# TECHNICAL BULLETIN

**Subject: Root Resistance Testing of Sarnafil® Membranes**

**19-01**

Green Roof Water Proofing Root Resistance  
Evaluation for Sika Corporation  
Sarnafil G 476 and G 410 Membranes

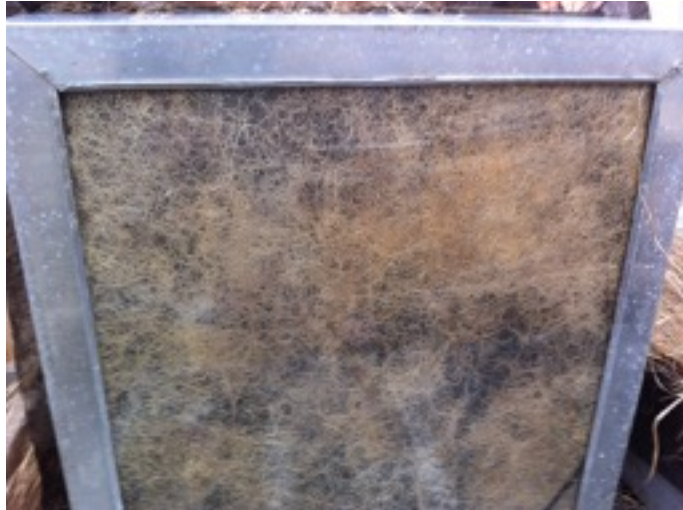
Test and control boxes were tipped on their sides and the bottom of the test system was closely evaluated for evidence of roots. There were many root traces visible with the control boxes (Figure 1). There were no roots or rhizomes visible through the plexiglass of the test boxes. Plants and media were removed from the test boxes by flipping them over and lifting off the test boxes and the membrane assemblies. In all cases the media and root masses were easily removed from the membrane assemblies. There were large numbers of roots observed on the bottoms of control test boxes (Figure 2). There were no roots or rhizomes evident on the outside of the bottom or sides of any of the test membranes (Figure 3,4). The corners and sidewalls were examined closely and no roots or rhizomes were observed to have penetrated the corners or vertical sides or the membrane assemblies. The membrane assemblies were easily pulled away from the media and root mass suggesting that there was no serious root attachment to the membranes. There were large masses of roots and many rhizomes at the bottom of the media and

**FIGURE 1. CONTROL BOX AT HARVEST SHOWING ROOTS VISIBLE THROUGH THE PLEXIGLASS**

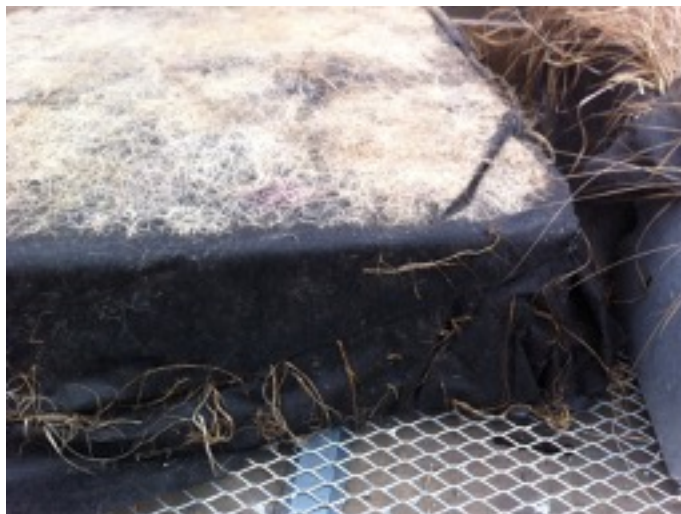
**FIGURE 2. TYPICAL CONTROL ROOT MAT AFTER THE TEST BOX WAS REMOVED WITH THE FABRIC LAYER STILL ATTACHED**

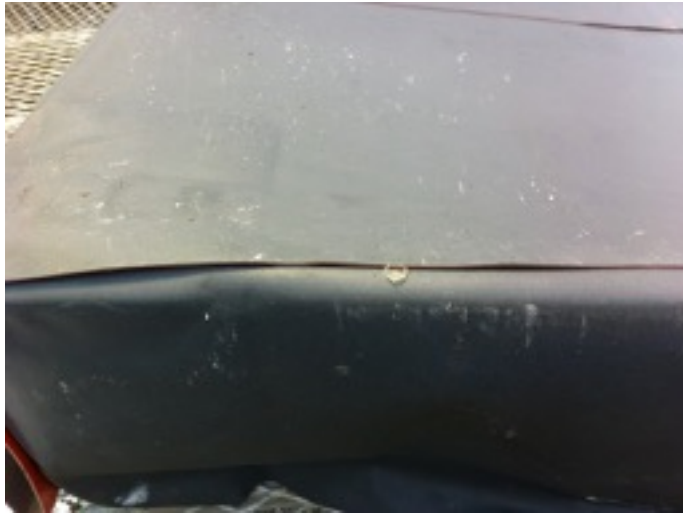
**FIGURE 3. OUTER MEMBRANE SURFACE OF TYPICAL SARNAFIL G 476 MEMBRANE AT HARVEST.**

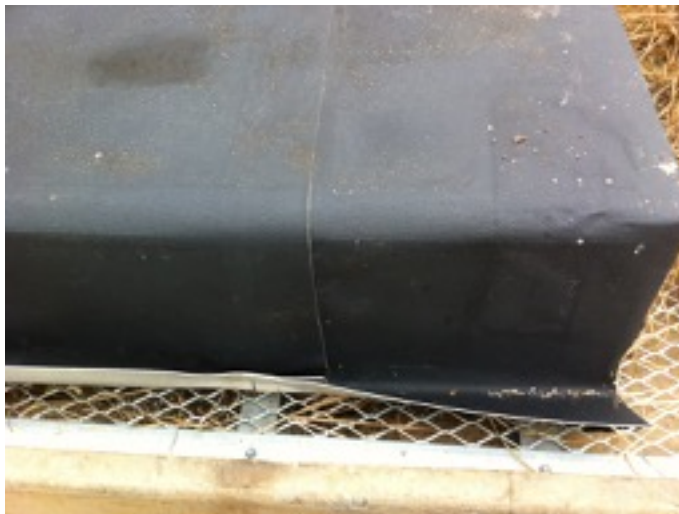
**FIGURE 4. OUTER MEMBRANE SURFACE OF TYPICAL SARNAFIL G 410 MEMBRANE AT HARVEST.**

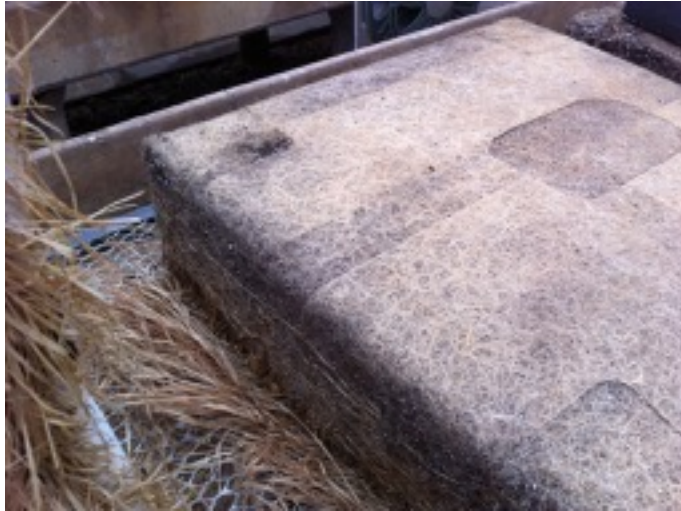
**FIGURE 5. TYPICAL ROOT MAT OBSERVED ON THE BOTTOM OF THE SARNAFIL MEMBRANE TEST BOXES**

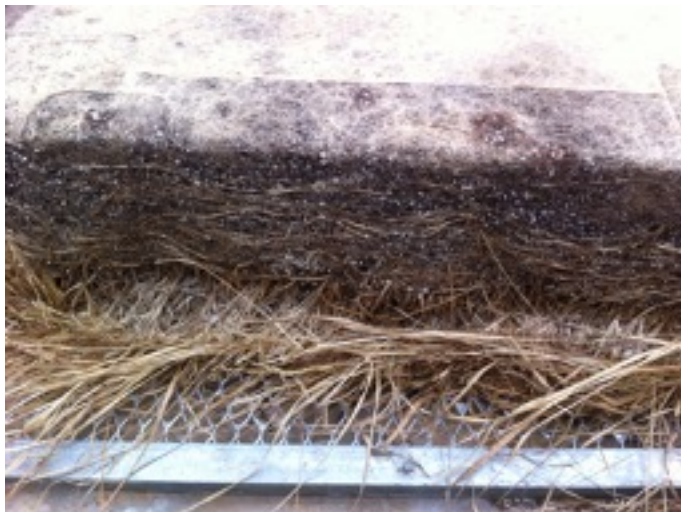
**FIGURE 6. TYPICAL RHIZOME GROWTH ALONG THE SIDES OF SARNAFIL MEMBRANE TEST BOXES**

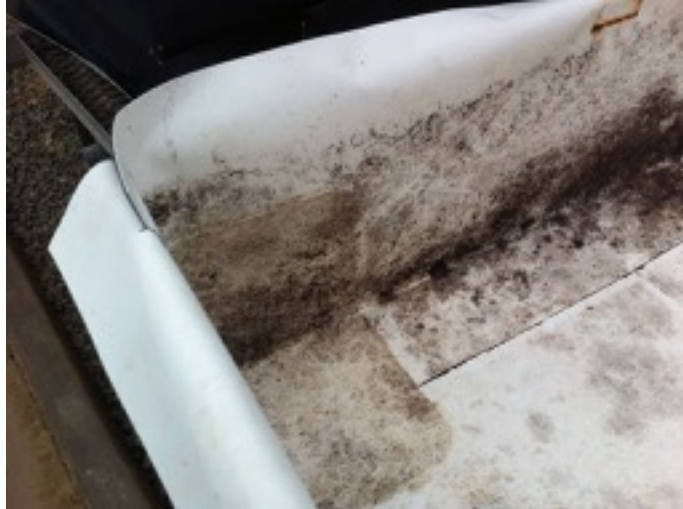
**FIGURE 7. SARNAFIL G 410 MEMBRANE SURFACE AFTER THE MEDIA AND PLANTS WERE REMOVED. SOME MEDIA AND SOME FINE ROOTS STUCK TO THE SURFACE HOWEVER THEY WERE EASILY WASHED OR RUBBED OFF. SOME STAINING WAS OBSERVED.**

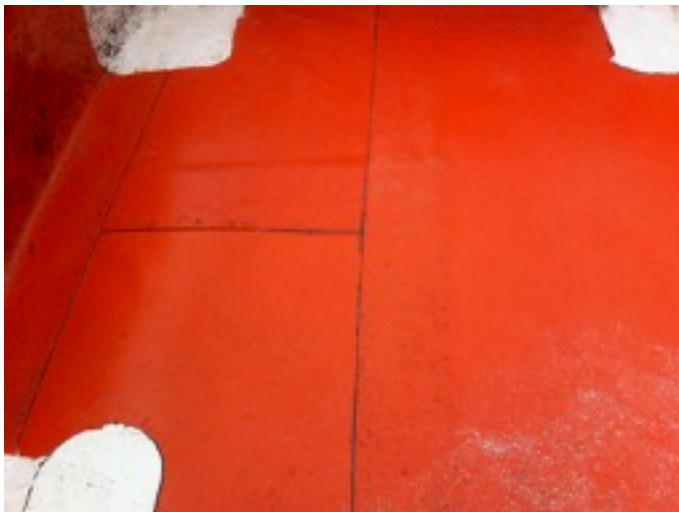
**FIGURE 8. SARNAFIL G 476 MEMBRANE SURFACE AFTER PLANTS AND MEDIA WERE REMOVED. ALTHOUGH THERE WAS SOME STAINING OBSERVED MOST WAS EASILY WASHED OFF.**

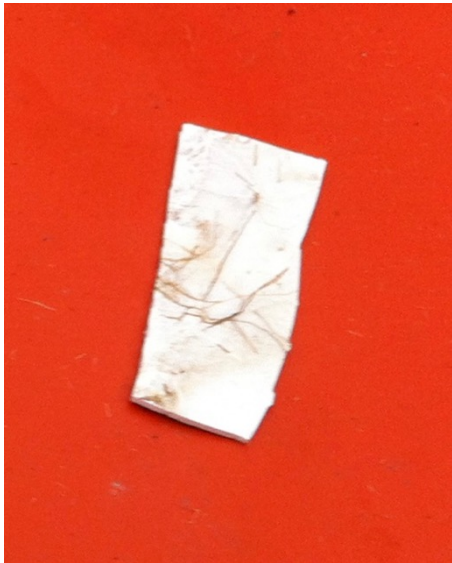
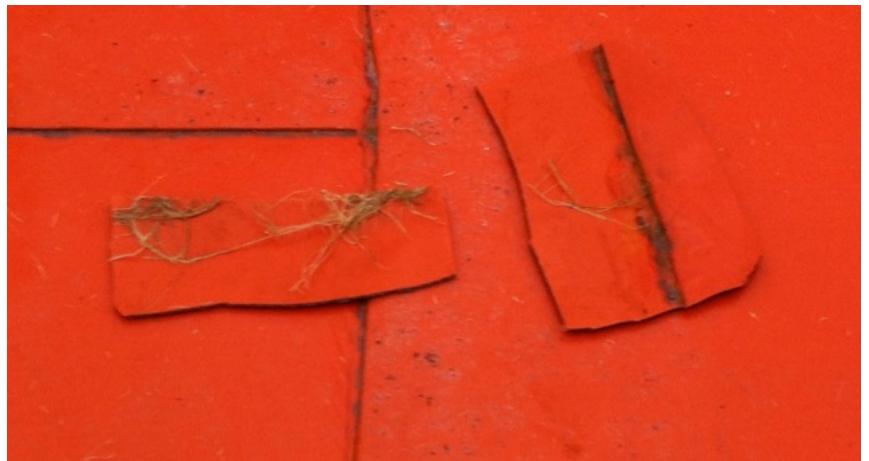
along the sides where they had been in contact with the membrane (Figure 5,6). Some media was stuck on the membranes after the primary root mass was removed. Close examination of the surface of the membrane revealed some fine roots stuck to the surface. These fine roots and media were easily removed by washing or rubbing. Close examination of the surface revealed that there was no penetration or obvious damage to the membrane surface. The white surface of the membrane (Sarnafil G 410) was stained brown or grey by roots and media (Figure 7). Some of the brown stains were not easily washed off. There was much less staining of the orange surface of the Sarnafil G 476 membrane and what staining there was, was more easily washed off (Figure 8). Some roots were found to be tightly attached to some of the seams of the membranes. Close examination reviewed that these roots did not penetrate the sealed seams but were attached to the surface of the weld (Figure 9). There was excellent root growth and large root mats on the bottoms of all test containers.

**FIGURE 9. ROOTS ADHERING TO THE SURFACE OF THE MEMBRANES OR THE EDGES OF THE SEAMS. MICROSCOPIC OBSERVATION INDICATED THAT NONE OF THESE PENETRATED THE SURFACE OF SEAMS.**
