Traffic Membrane Troubleshooting Manual

Technical Manual
May 2019 Edition

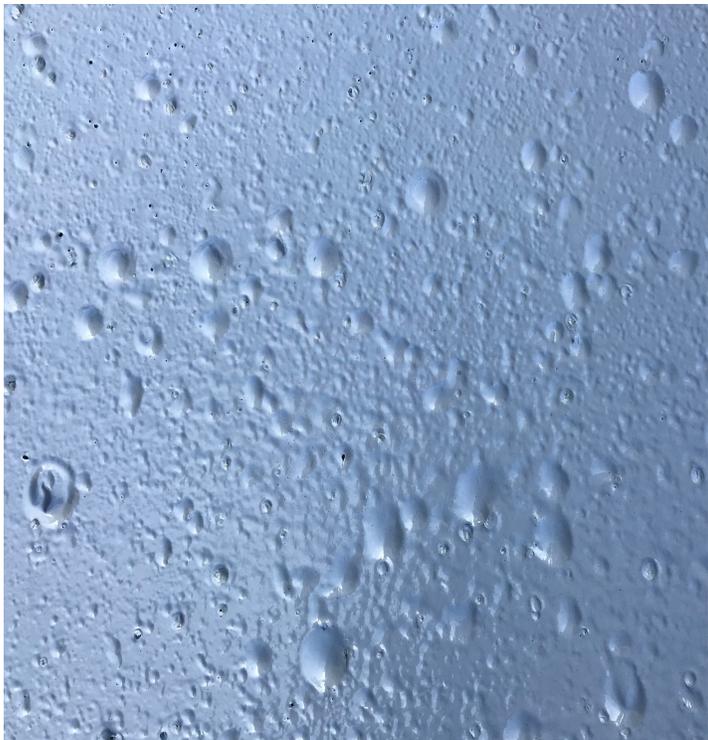
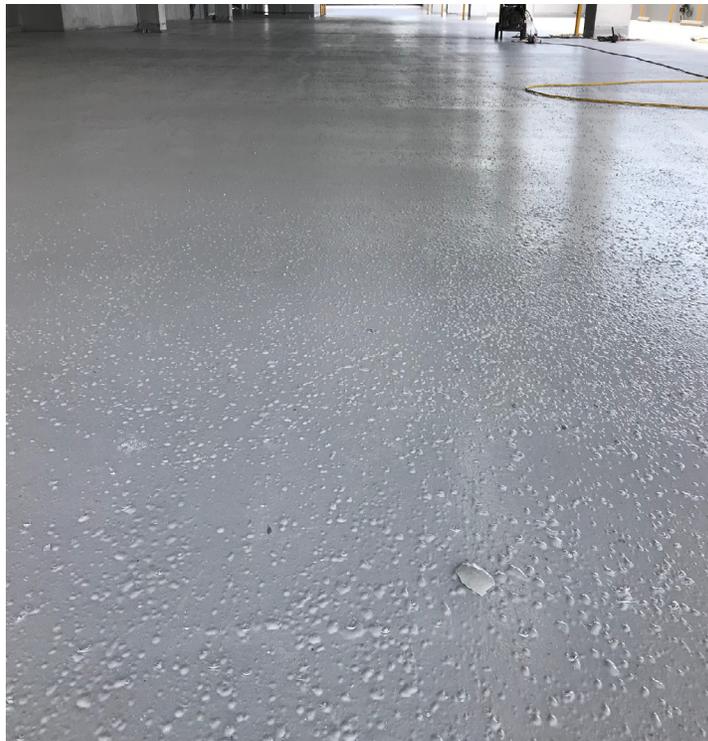
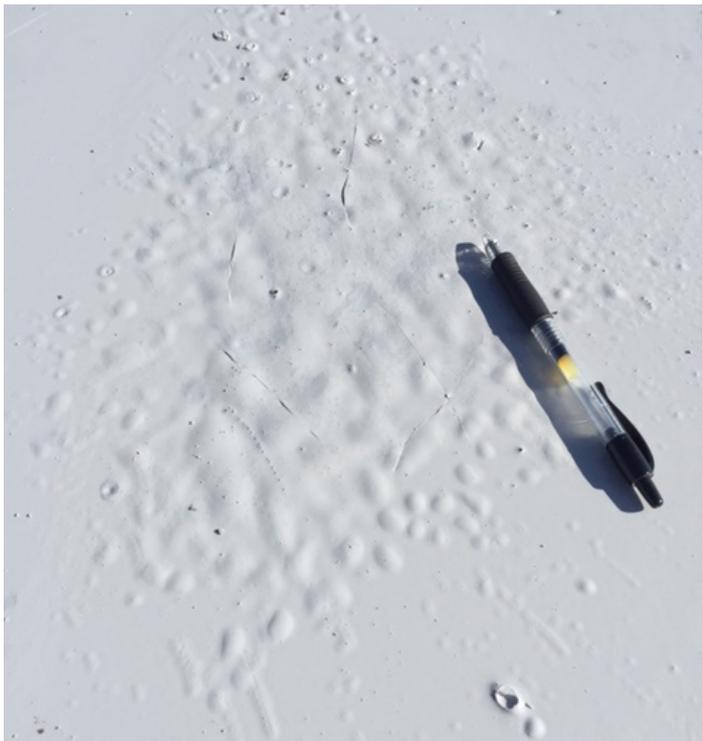
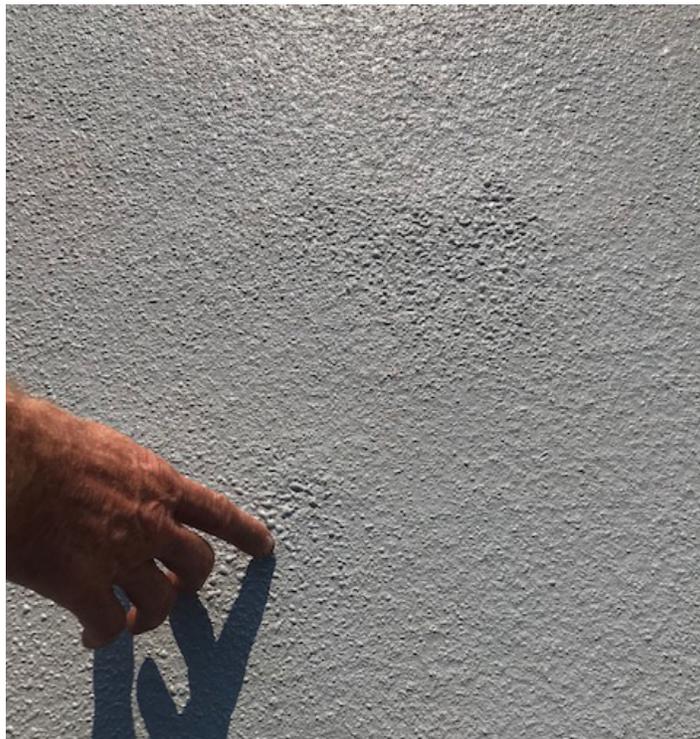
BUBBLING DUE TO ENCAPSULATED MOISTURE IN THE SUBSTRATE

Bubbles in the coating surface which have not popped. When the bubble is cut water comes out or the surface underneath the bubble is wet.

- High surface moisture content prior to application of membrane
- Trapped moisture in insulated split slab construction
- Trapped moisture in metal pan deck construction
- Application during winter months – problem may not appear until the following summer when temperatures rise drawing moisture in the slab to the surface
- Water contamination prior to application of the coating (rain)
- Application above 4% moisture content without using a special moisture barrier

- Completely remove affected area down to the concrete substrate
- Let the surface dry
- Re-apply the system paying special attention to avoid the causes listed above

- Check the substrate moisture content and follow the guidelines if the moisture is higher than 4% by Tramex. One more testing method to check vapor moisture drive strongly is recommended (plastic sheet test)
- Determine if the structure is a split slab or metal pen deck
- Check the dew point and ensure you are a minimum of 5F above the dew point
- Avoid outside application during late fall or winter (what about our winter grade?)
- Minimum temperature and humidity should be within the range specified in PDS
- If ambient conditions are critical apply the product during falling temperatures

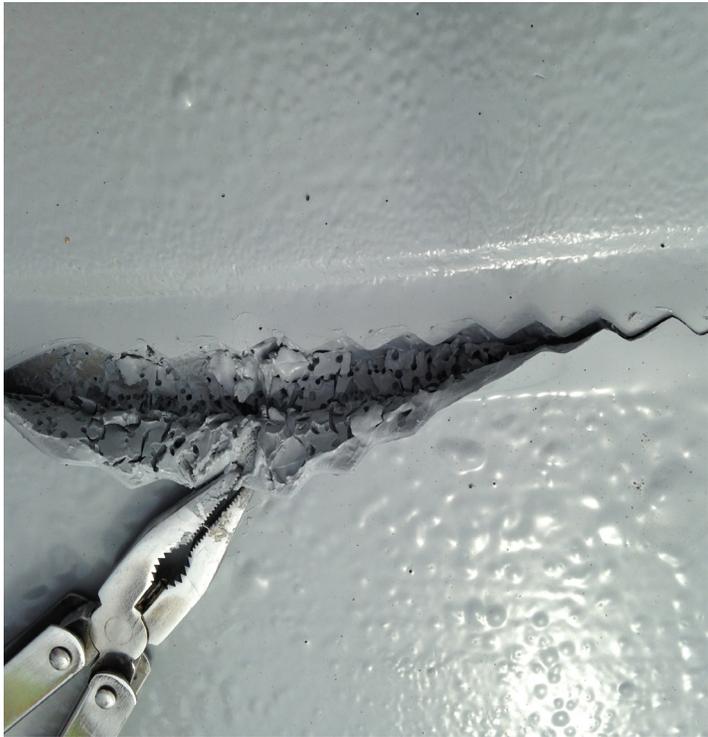
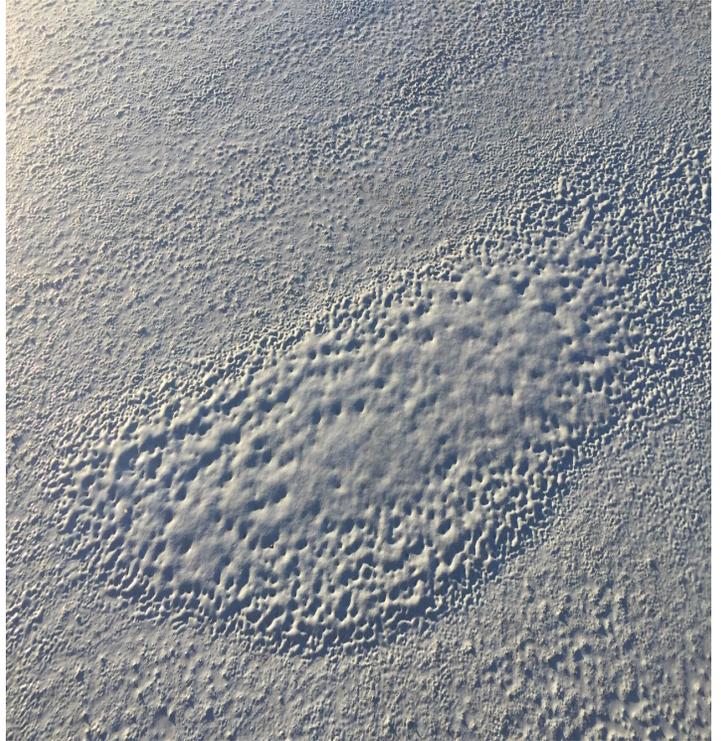
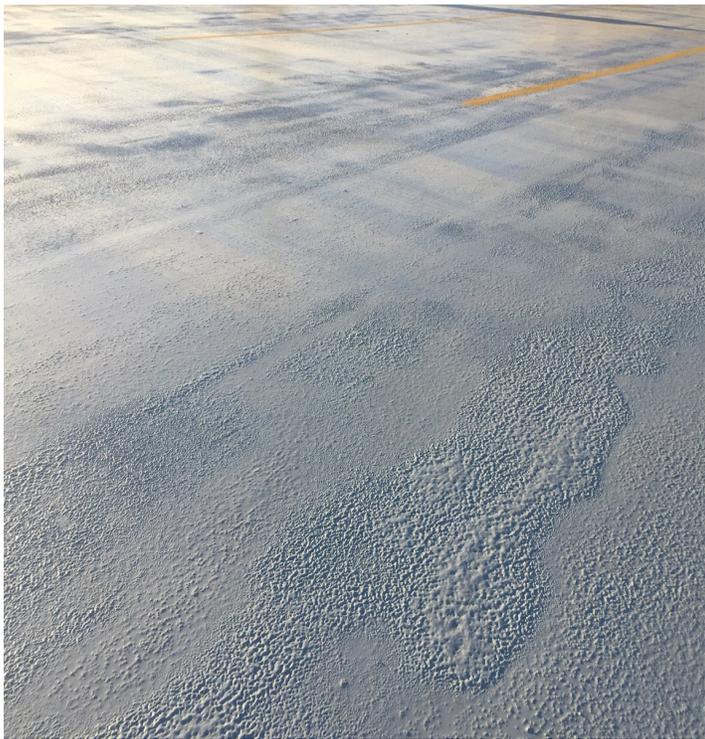
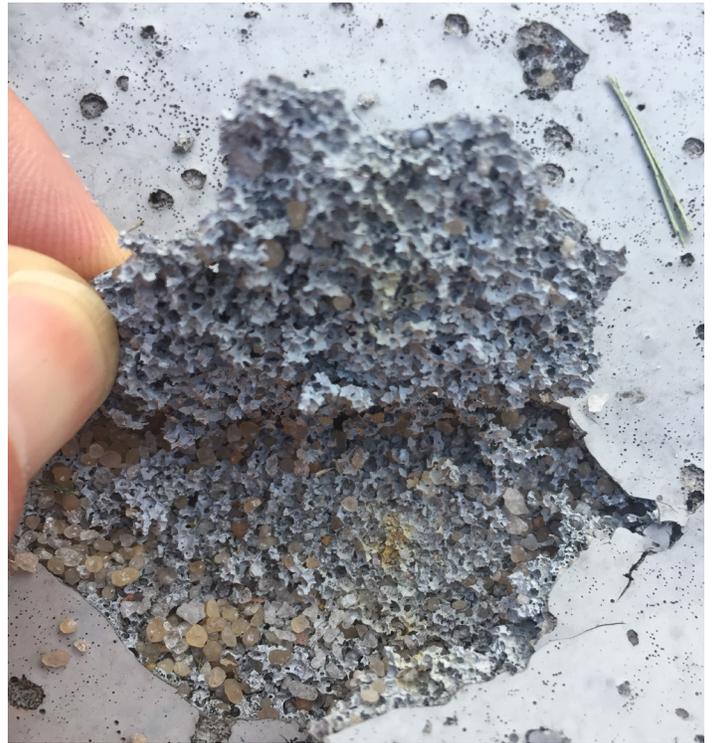
BLISTERING DUE TO THICK COATING

These blisters feel spongy and the coating is usually very thick and soft. When the blister is cut the coating is excessively thick and may be as much as 60-120 mils (DFT) thick and looks like a sponge with unbroken or circular blistering. It happens mostly to top coats especially single component top coats. The affected coating wears very quickly and aggregate usually settles completely into the coating leaving a smooth surface.

- Wet film application is too thick
- Wrong tools (squeegee size)
- Wrong detail work
- Uneven surface – low spots
- Very rough concrete surface profile (more than CSP 4)
- Insufficient mixing of single component product

- Remove affected area down to sound substrate
- Re-apply the coating

- Check the wet film thickness during application
- Detailing - Fill up low spot areas of the substrate prior to application
- Detailing - Check CSP (CSP 3-4 required)
- During application backroll to move the material from low spot areas
- Check your tools – use the recommended size squeegee
- Use a booster or accelerator with single component products

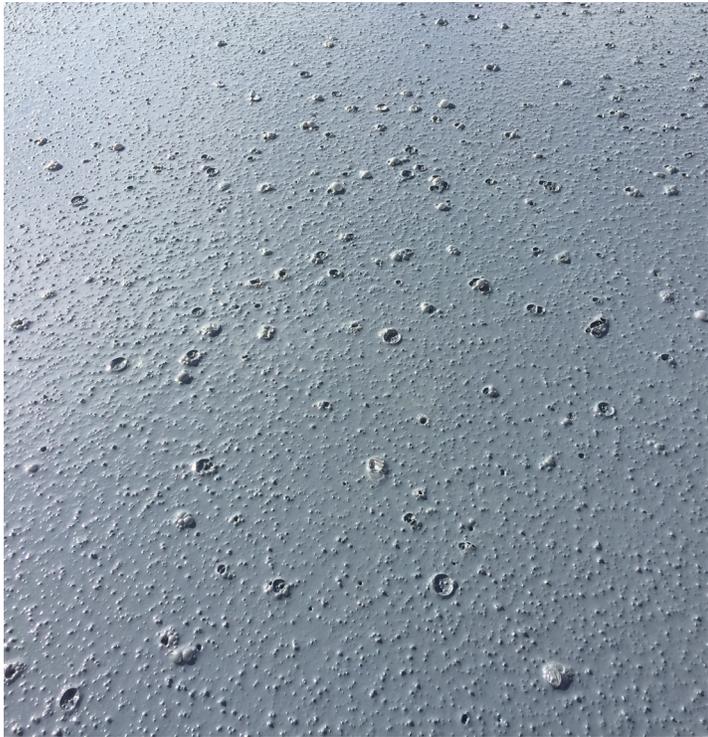
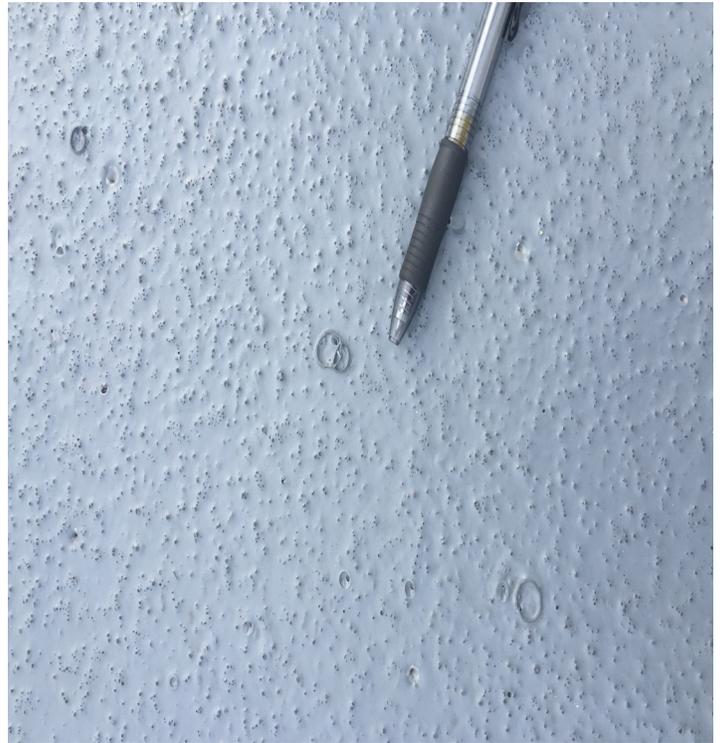
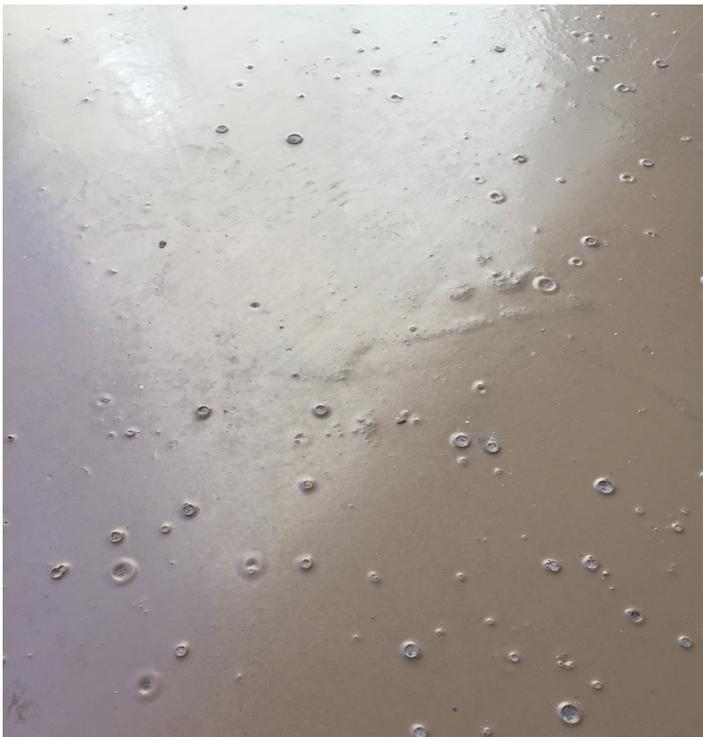
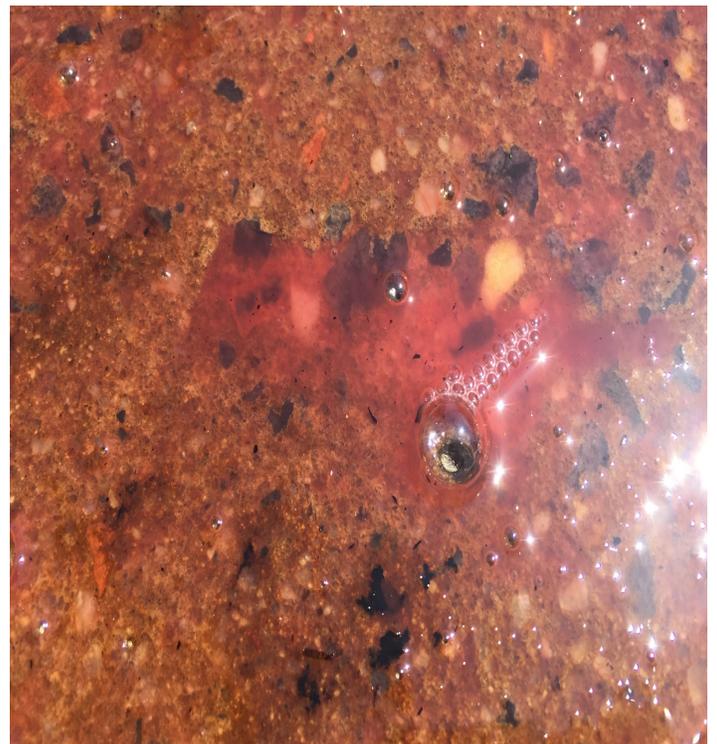
PINHOLING / BUBBLING

Pinholing is a result of outgassing when air escapes from porous concrete and becomes trapped in the coating. As the air escapes through the coating, the first sign is generally small bubbles that appear shortly after the application of the coating. When the bubbles pop they leave behind small craters in the coating. The pinhole can usually be seen at the bottom of these craters.

- Porous concrete surface
- Insufficient primer application
- Aggressive surface preparation
- Moisture (damp substrate)
- High ambient temperature (rapid curing)
- Freshly applied coating exposed to direct sunlight
- High substrate temperature at 90°F and above

- Lightly grind or sand affected areas to a flat finish
- Apply 100% solid epoxy primer and seed it lightly (10lbs/100sf) with 20/40 dry silica sand
- Clean to remove excess sand
- Re-apply base coat or the whole system

- Prime substrate precisely following required coverage rate
- If substrate is very porous or rough, 2 coats of primer are strongly recommended
- Avoid aggressive surface preparation
- Consider application in afternoons or evenings as temperatures are falling in order to avoid rapid temperature increase during application
- Prevent direct sunlight exposure during initial cure
- Temperature and humidity should be within the range specified in PDS
- At the first appearance of bubbles a spike roller can be used to pop the bubbles
- Check substrate moisture and follow the guidelines if the moisture is higher than 4% by Tramex.

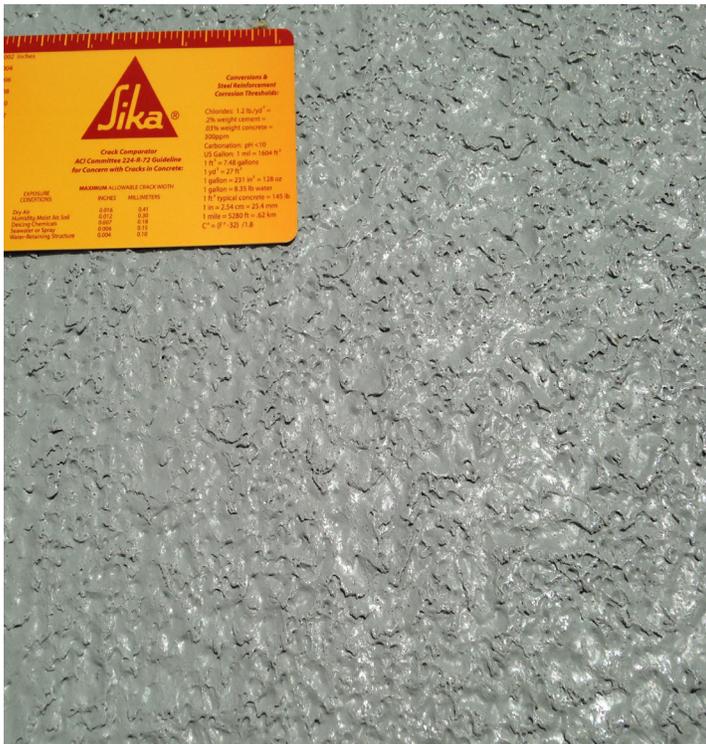
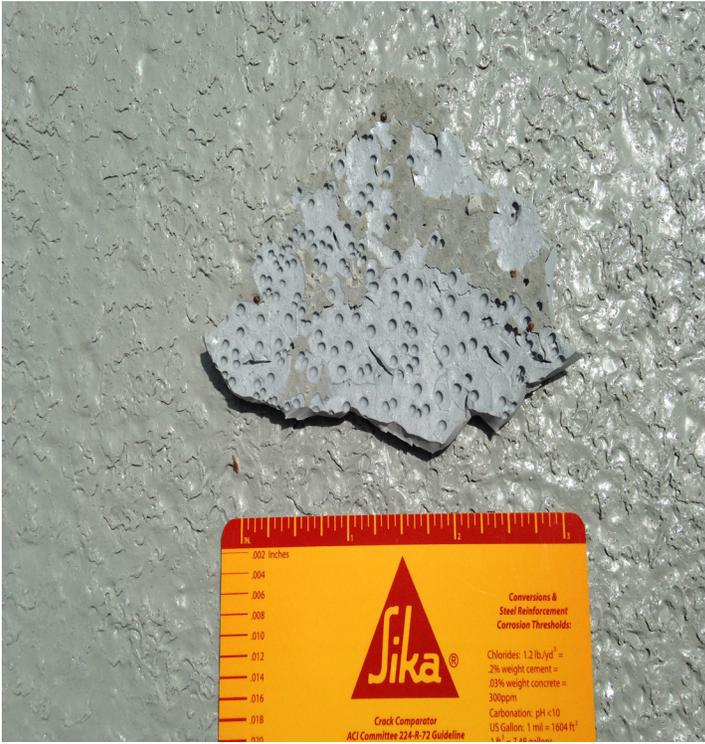
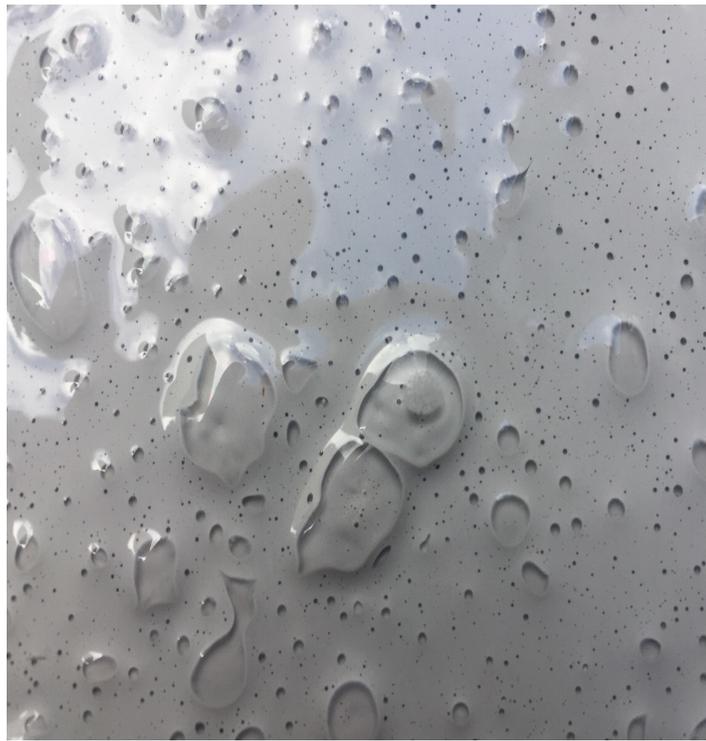
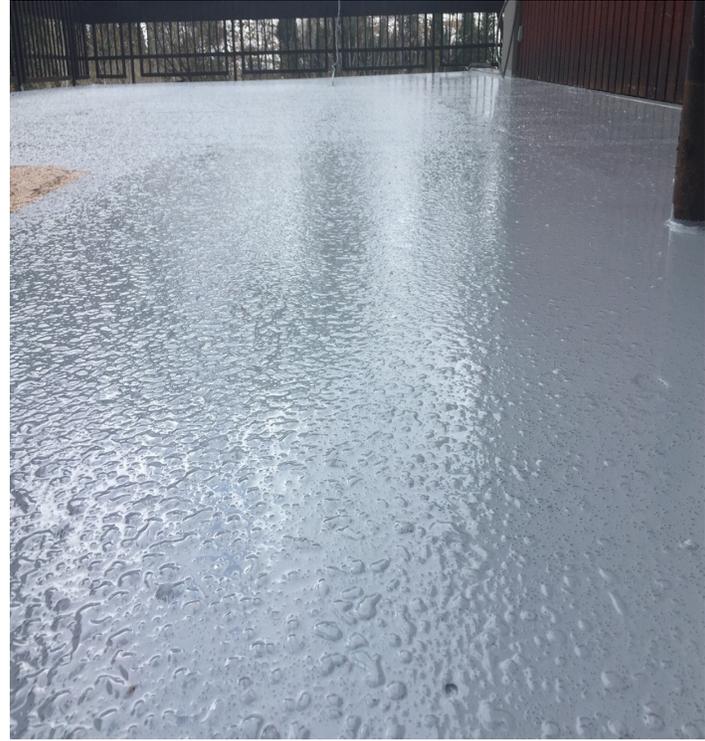
WATER DAMAGE

Water damage occurs as a result of deterioration of the membrane before the material has fully cured. This occurs when there is poor membrane adhesion due to the presence of water or dampness during the application.

- Inclement weather during application (Rain , Snow)
- Accidental water leak (floors above, sprinklers)
- Human sweat
- Contamination by machinery liquids

- Completely remove affected area down to concrete substrate
- Re-apply the system

- Avoid application during or shortly before anticipated inclement weather
- Protect the area from any potential accidental water leak from the floors above
- If possible, sequence the project from top levels to lower ones
- Workers should wear hats or head bands
- Deactivate sprinkler system prior to application

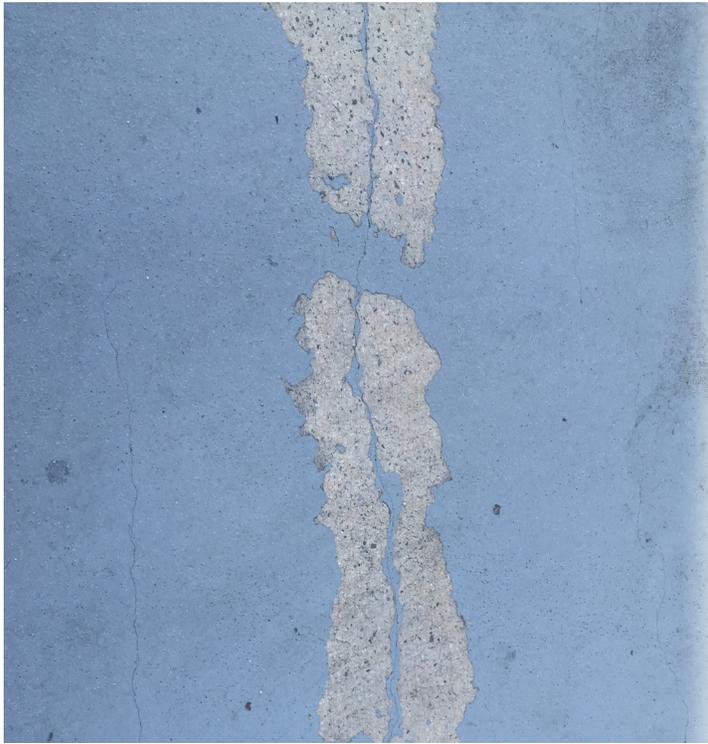
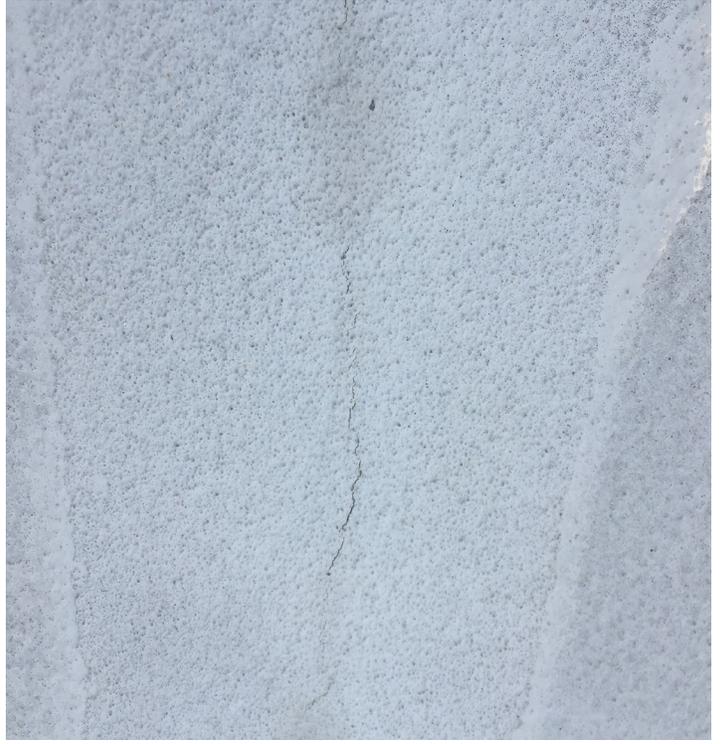
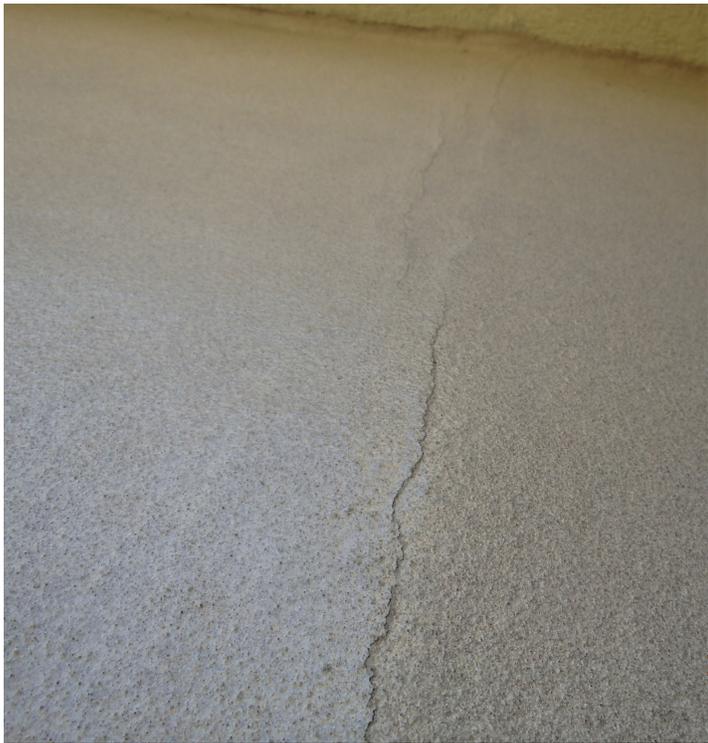
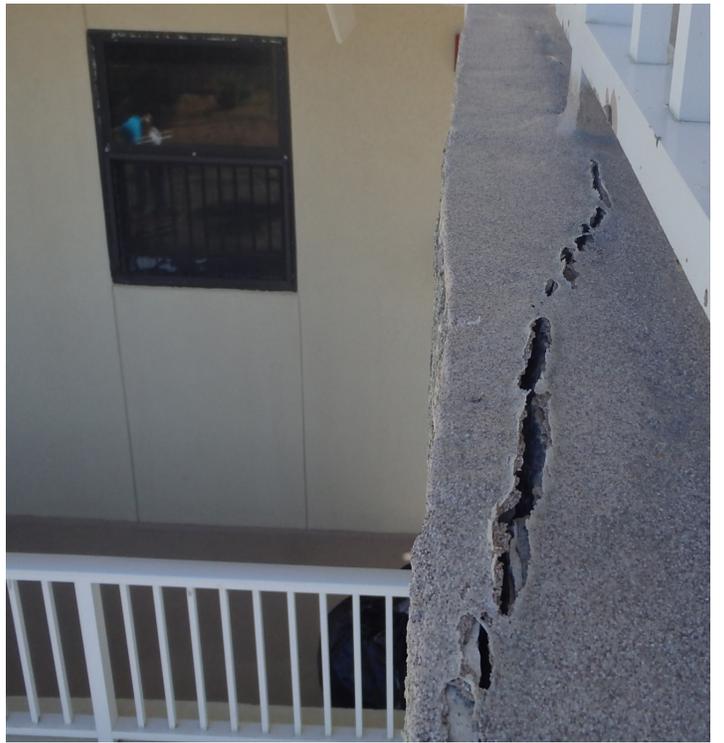
CRACKS / JOINTS

Substrate fractures which telegraph thorough the membrane caused by excessive movement. Cracks may compromise the waterproofing system causing leaks affecting water tightness of the system if not properly treated.

- Structural problem - movement in the joint exceeds elongation of membrane
- Failure to route , caulk and detail every crack greater than 1/16”
- Failure to detail every crack which is less 1/16”
- Uncured sealant in routed and caulked crack
- Coating over joints greater than 1”
- Cracks in the concrete occur; especially in new construction, after the basecoat was applied

- Route existing cracks and seal with a polyurethane sealant
- Apply detail coat
- If excessive movement is expected reinforce detail coat with Sika Flexitape heavy or run the sealed joint through the traffic membrane

- Properly detail cracks
- The correct crack treatment will depend on crack width and expected movement
- Honor joints greater than 1” thorough the system
- The strip of detail coat 23 DFT should be always applied
- Use only PU sealant under PU waterproofing membrane
- Use reinforcement if movement creates crack up to 1/16 inch
- Rout and seal if movement creates crack between 1/16 inch to 1 inch

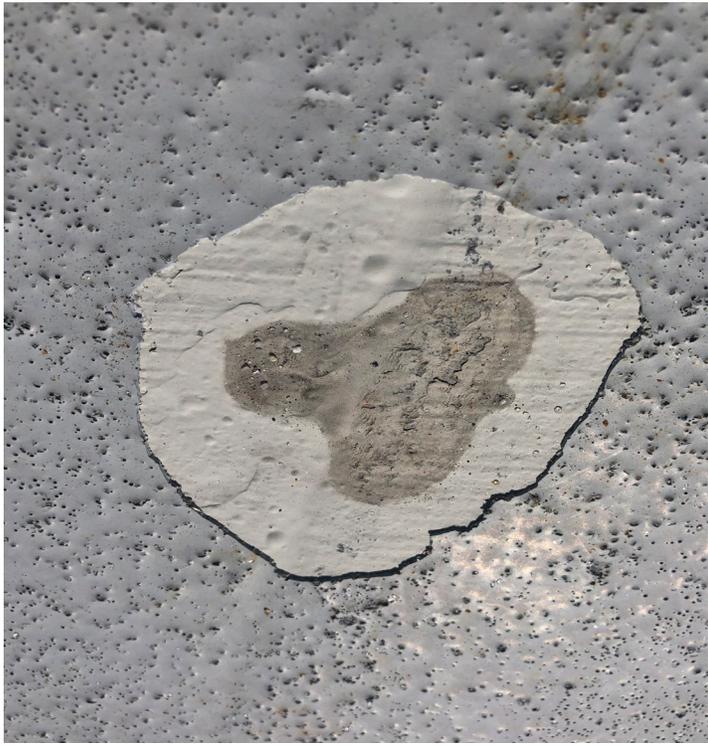
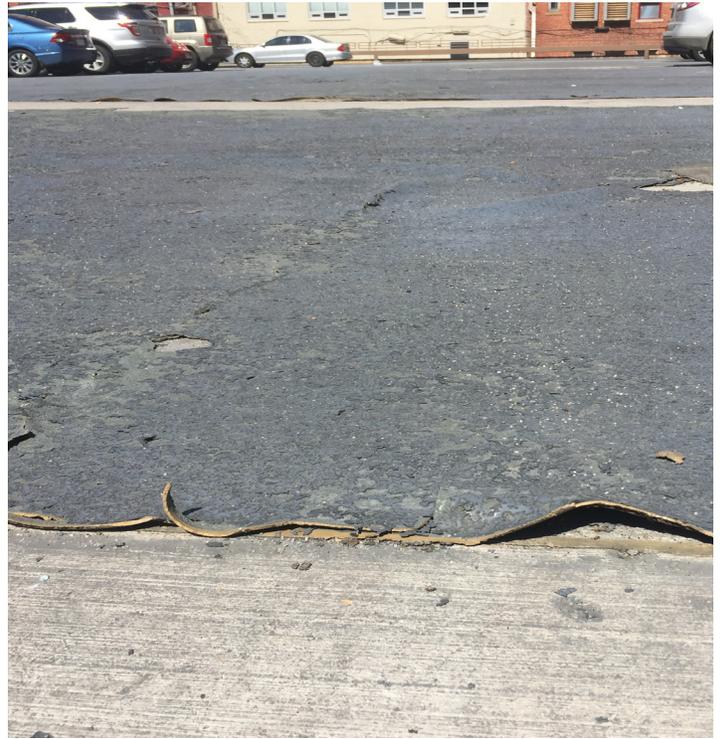
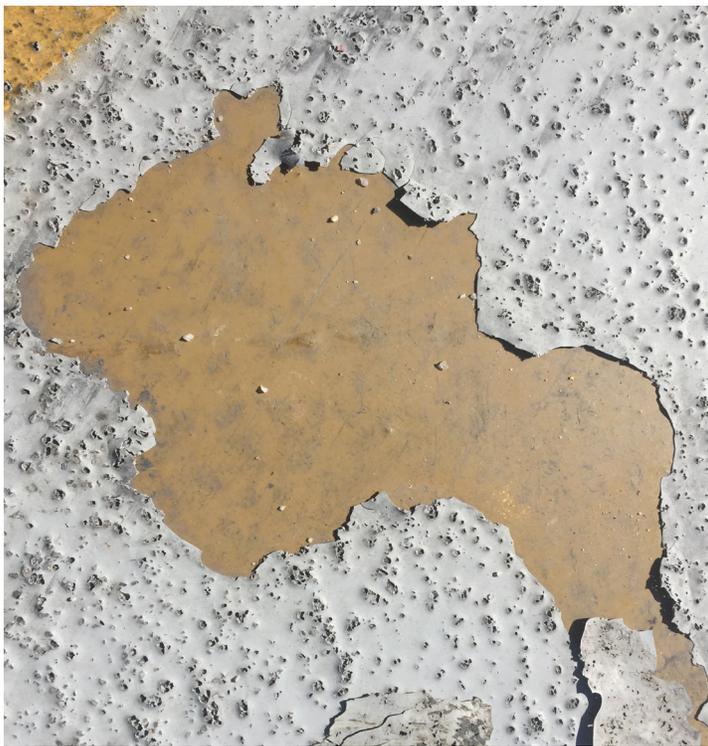
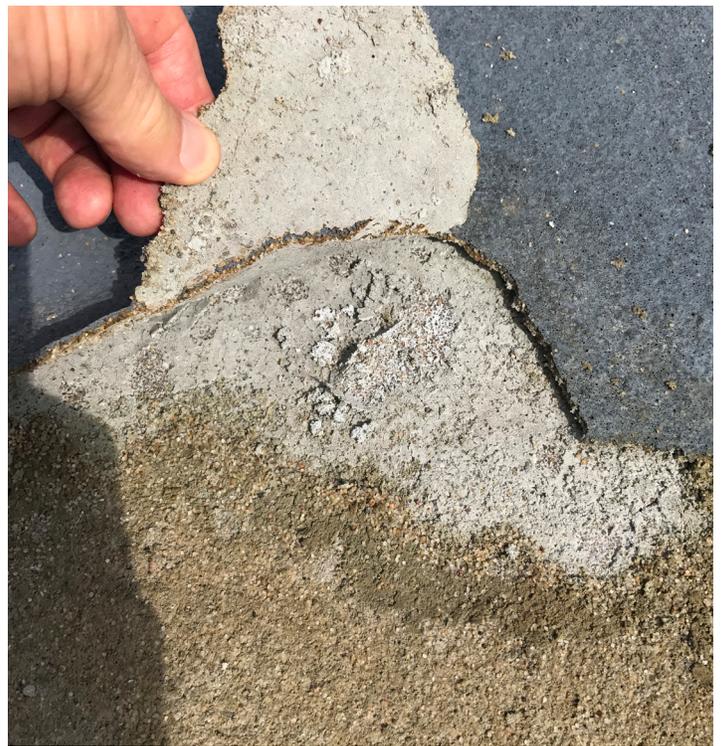
DELAMINATION / PEELING

The coating peels off the substrate (concrete) or previous coat (inter coat adhesion).

- Insufficient concrete surface preparation (suitable CSP)
- Existing coating preparation (grinding, roughening, recoat window, cleaning, primer)
- Surface contamination (dirt, dust, oil)
- Moisture (damp substrate, dew point , sweat)
- Insufficient thickness (min. DFT)
- Not properly maintained (snow plows, aggressive cleaning agents, chemical impact – car liquid leaks)

- Remove loose delaminated coating
- Abrade and clean surface
- Remove all residual contamination (chemically or mechanically)
- Reapply the whole system or top coat using appropriate primers

- Follow PDS recommendations
- Surface preparation : Abrade or shot blast the substrate to achieve a CSP 3-4 per ICRI guidelines
- Surface contamination : Entirely clean substrate prior to application of primer or primerless base coat
- Remove all residual contamination on existing coating (chemically or mechanically)
- Remove all loose areas of existing coating
- Follow required maximum recoat window of new coating
- Follow required minimum coverage rates of each coat
- Check substrate moisture and follow the guidelines if the moisture is higher than 4% by Tramex
- Verify the substrate temperatures are minimally 5F above the dew point

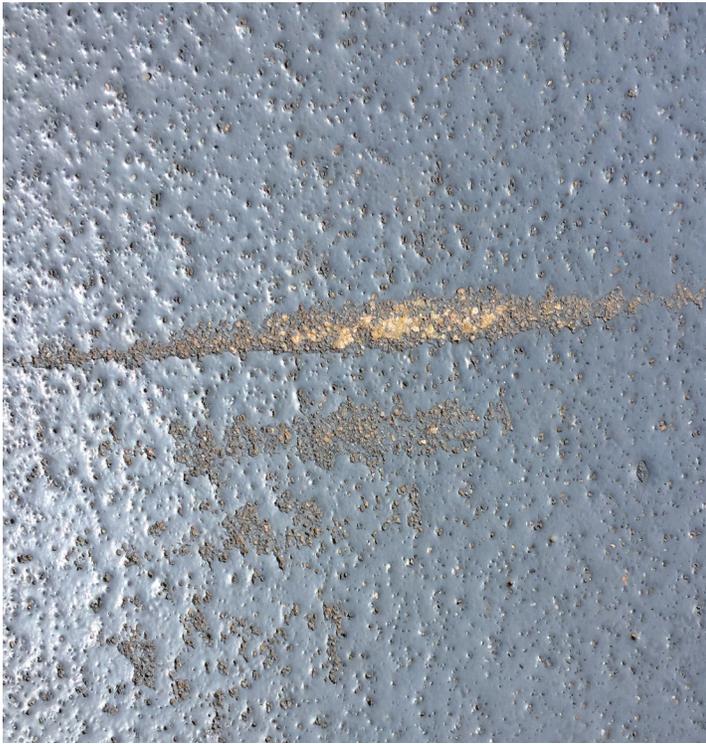
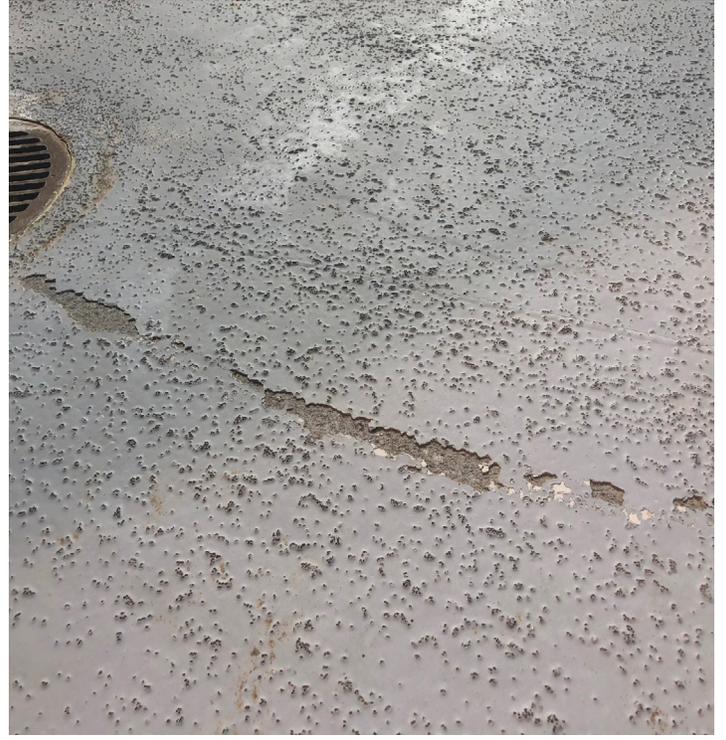
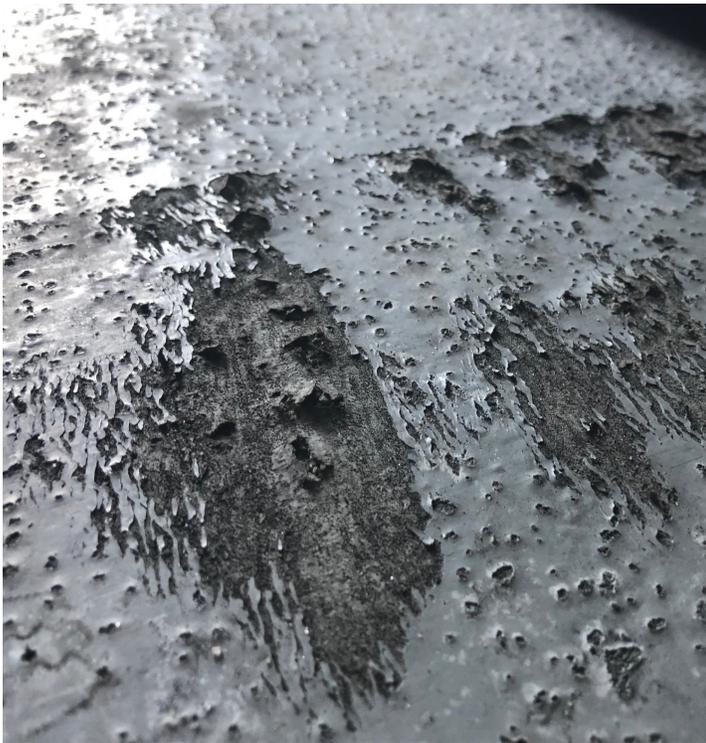
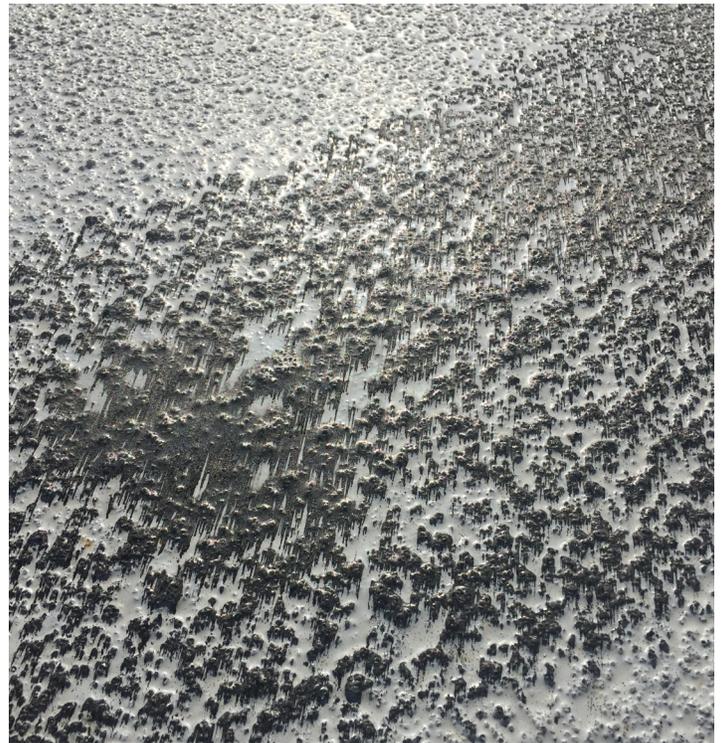
MECHANICAL DAMAGE

Finished waterproofing system damaged by reckless use and insufficient maintenance .

- Reckless behavior
- Vandalism
- Snow plows
- Studded tires
- Skid marks – burned tires

- Completely remove the affected area down to the concrete substrate
- Re-apply the system

- The system should be periodically maintained
- Installation of speed bumps
- Snow removal equipment should be equipped with adjustable , rubber, snow-plow blades
- Heavy duty systems should be installed on the top deck levels where snow plowing is expected
- Do not use wire brush to clean the membrane
- Use solvent free and acid free cleaners

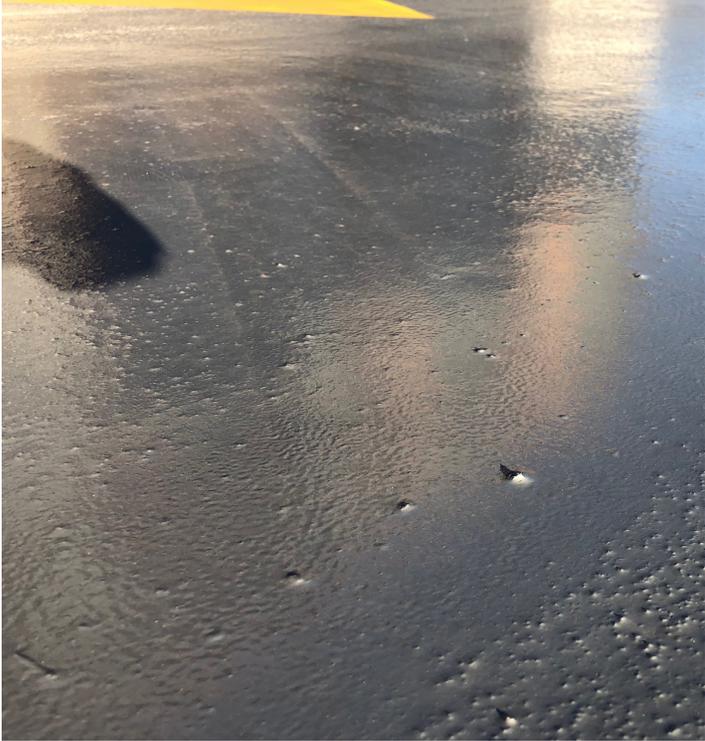
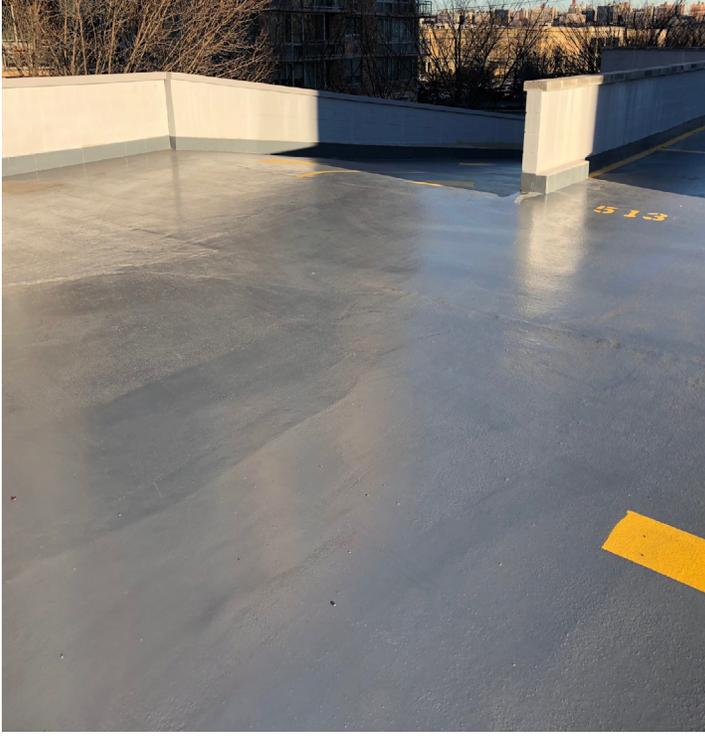
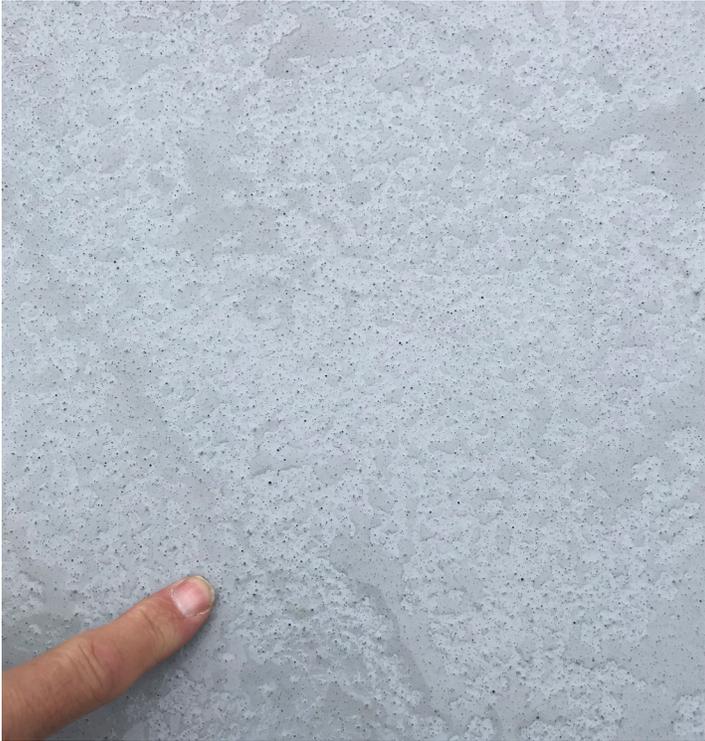
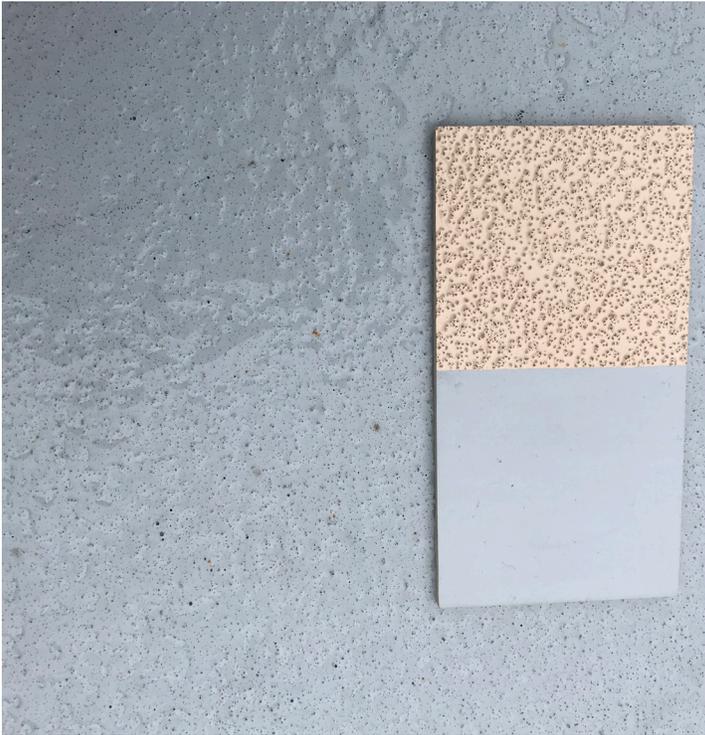
SKID RESISTANCE / INCONSISTANT TEXTURE

The surface of the finished membrane is slippery and/or there are 'bald' spots. Inconsistently seeded aggregate create bold and shiny spots on the membrane . Wear resistance and aesthetics features are also compromised.

- Inconsistent aggregate distribution
- Insufficient amount of aggregate applied per sf
- Wrong tools (roller) used
- Wrong aggregate size
- Difficult seeding of the areas with bad access
- Seed and back roll may be more prone to inconsistent appearance vs seed and lock

- Abrade the surface
- Clean and apply recoat primer
- Apply 2 coats of wear/top coat and broadcast depending on the type of seeding

- Broadcast sufficient amount of aggregate
- Use the right method based on the traffic and specific project need (seed & lock or seed & backroll)
- Use more coarse aggregate and adequate amount of resin to enhance slip resistance
- Use the right size aggregate according to manufacturer's PDS
- Use a pretextured topcoat
- Apply two top coats if using pretextured top coat

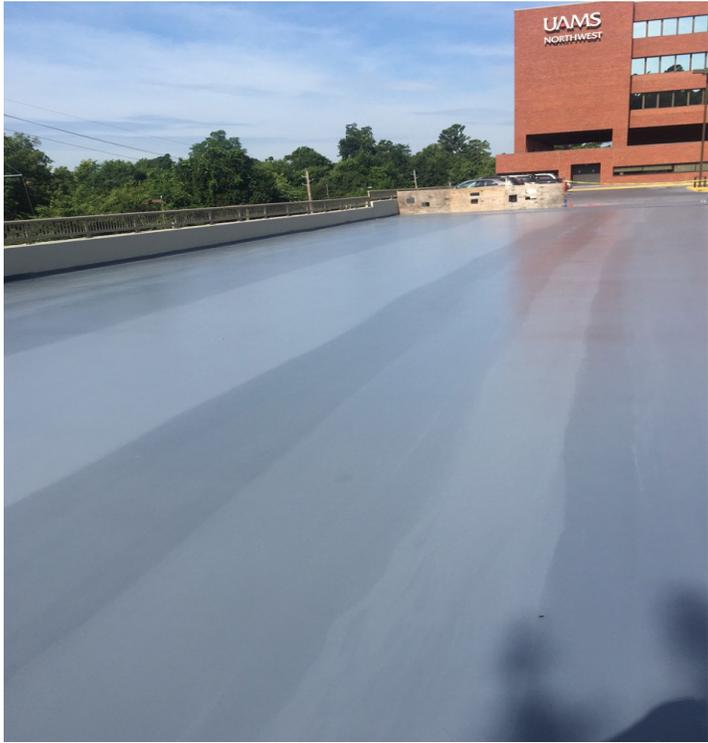
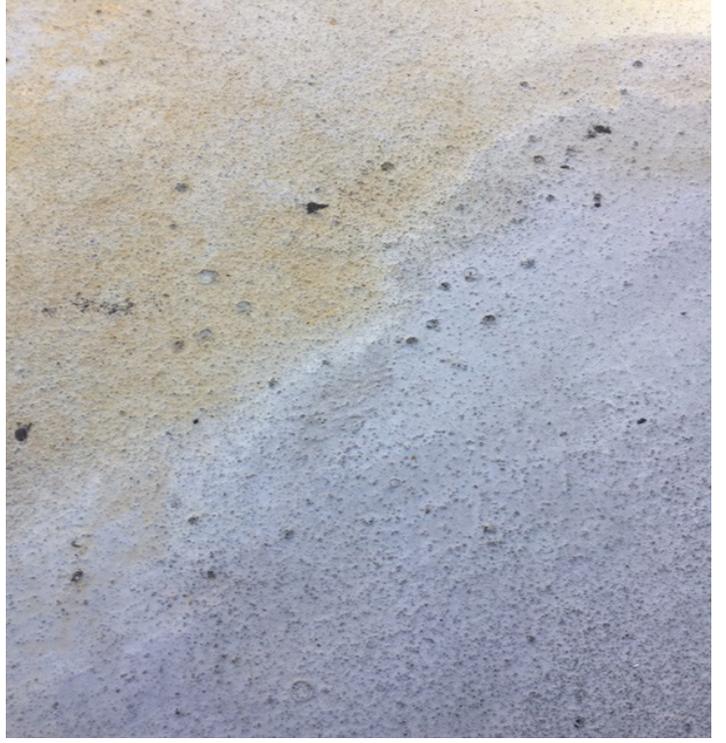
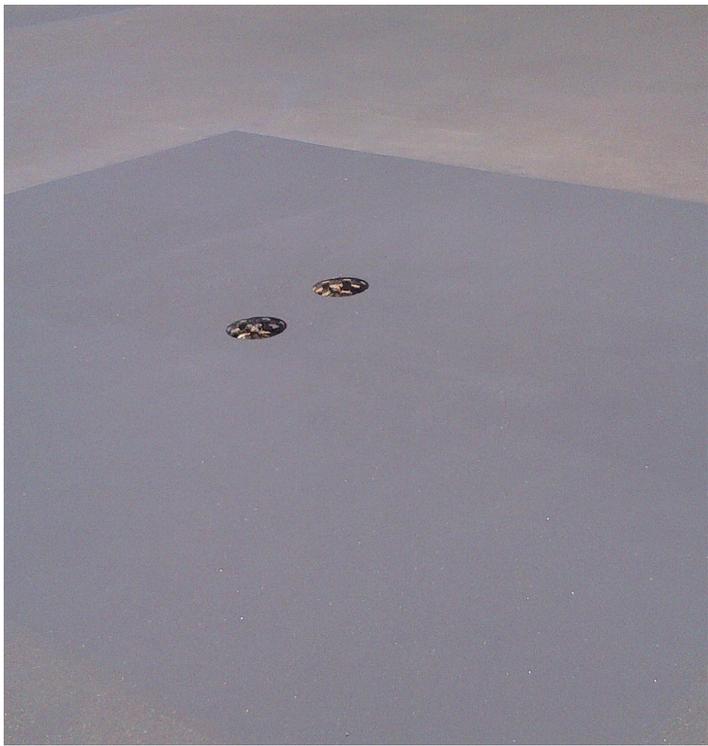
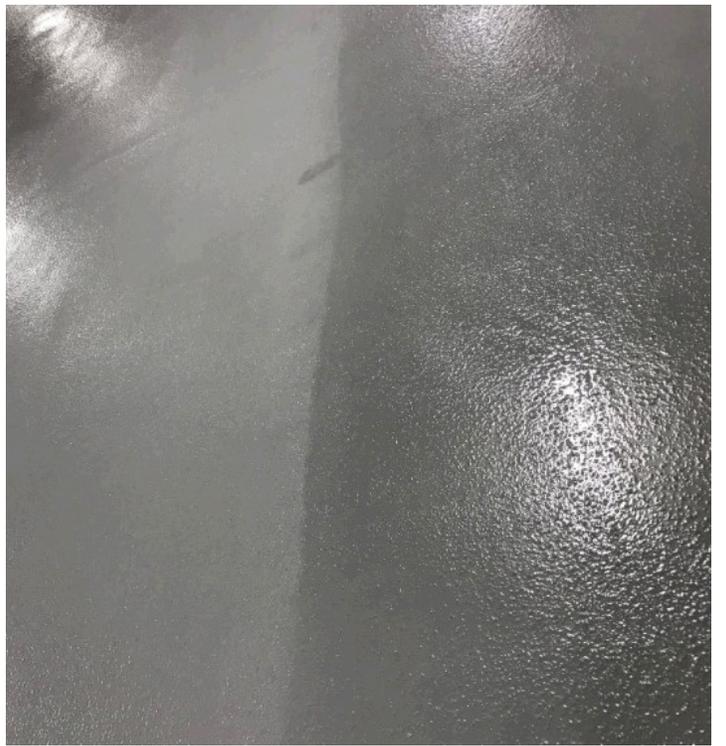
COLOR VARIATIONS

The coating appears to be different shades.

- Product from different batches can have slight variations in color
- The older coating of the same color has had more UV exposure and has weathered
- No sufficient mixing
- Shaded areas of deck can get less UV exposure and can appear darker

- Clean the whole affected area apply recoat primer Use only one batch of the product for this additional coat.
- Apply additional top coat
- Use only one batch of the product for this additional coat

- Check the batches
- Prior to application ensure that you have enough product from the same batch
- Apply the whole top coat in single application
- Mix product thoroughly 3 minutes
- Scrap the sides of the pail during mixing
- Use aliphatic top coat only for UV exposed areas
