Traffic Membrane Troubleshooting Manual

Technical Manual
May 2019 Edition

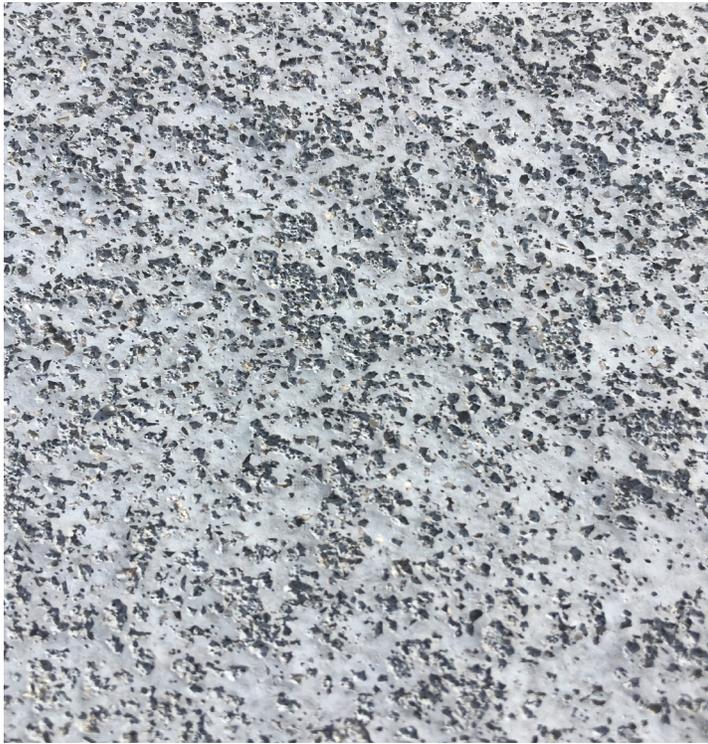
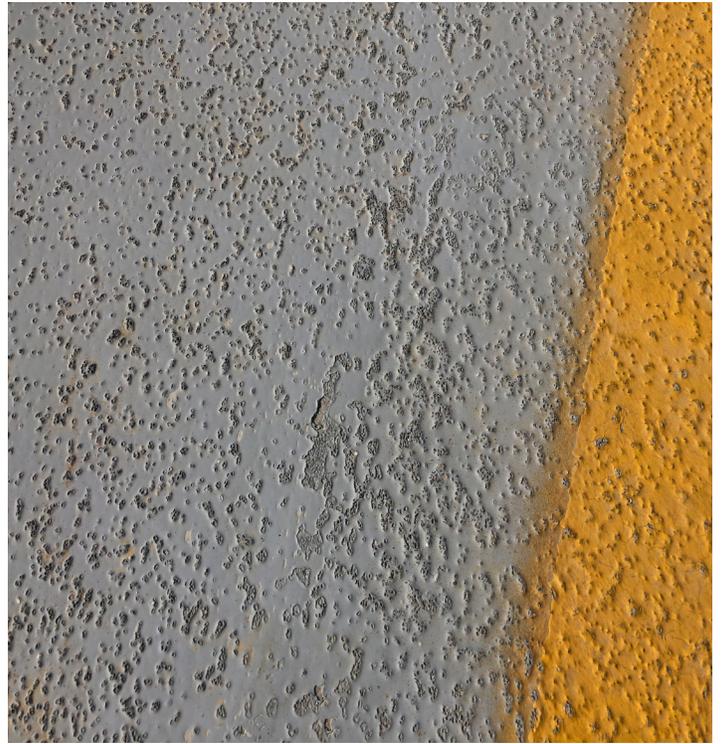
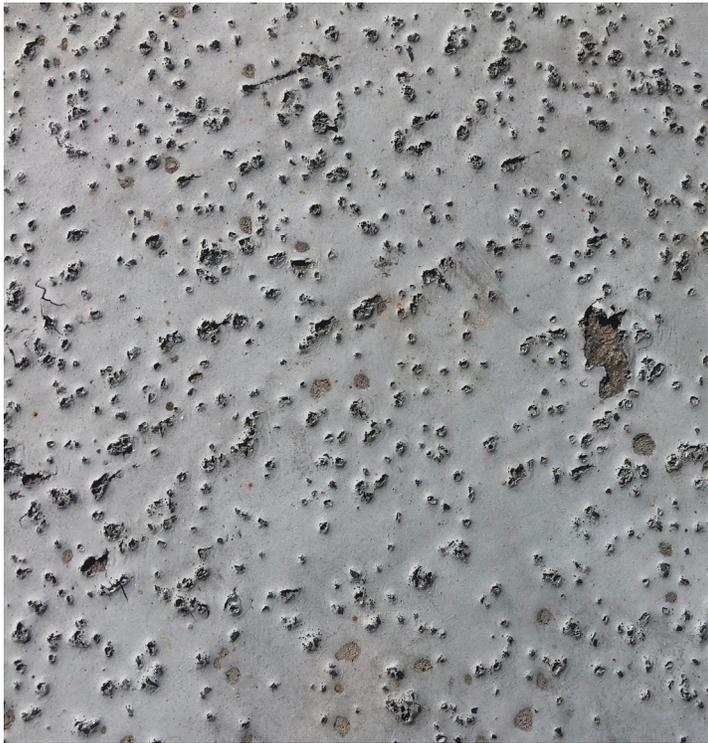
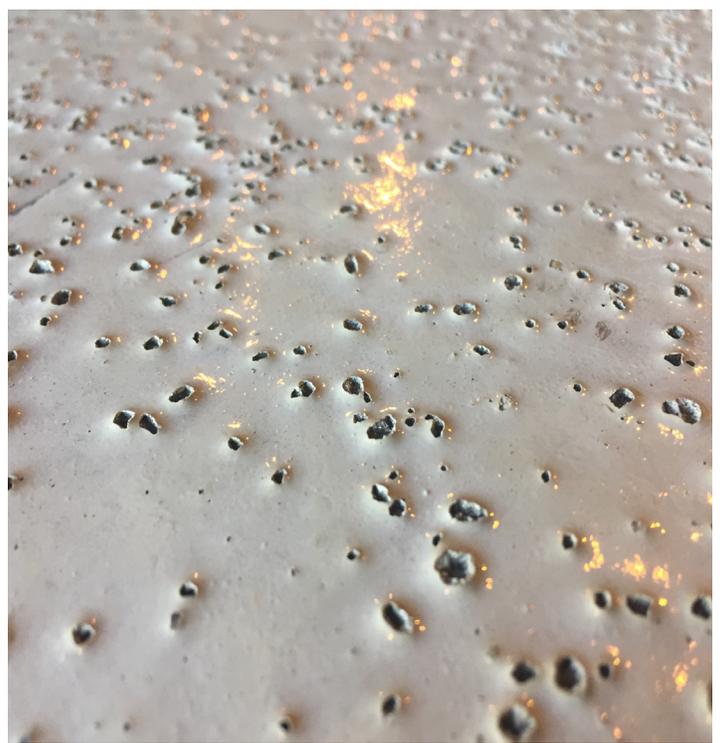
AGGREGATE ROLLING OUT

The top coat loses significant aggregate after a short period of service.

- Wrong aggregate selection
- Wrong thickness of the top coat - insufficient encapsulation
- Wet or contaminated aggregate

- Clean the whole affected area from all loose aggregate and solvent wipe
- Apply recoat primer
- Apply 2 additional top coats seeded with right aggregate

- Check the source of aggregate and make sure that the aggregate is totally dry
- Aggregate can get wet if packed in plastic bags
- The aggregate should be washed silica sand
- Gradation of aggregate should be between 16 - 40 mesh
- Stock aggregate before application indoors or covered to protect from rain
- Follow the minimum and maximum thickness of the top coat
- Use textured products to avoid an issue with aggregate selection and aggregate condition

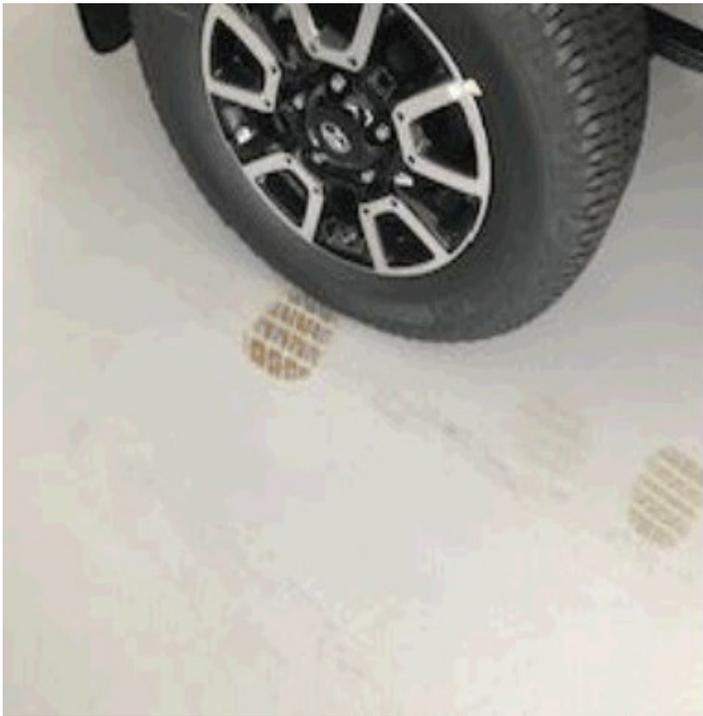
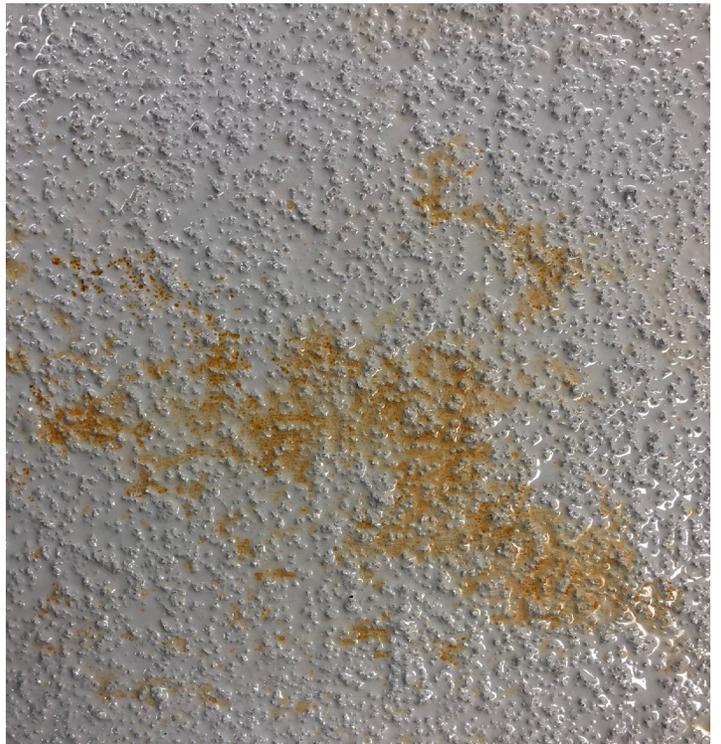
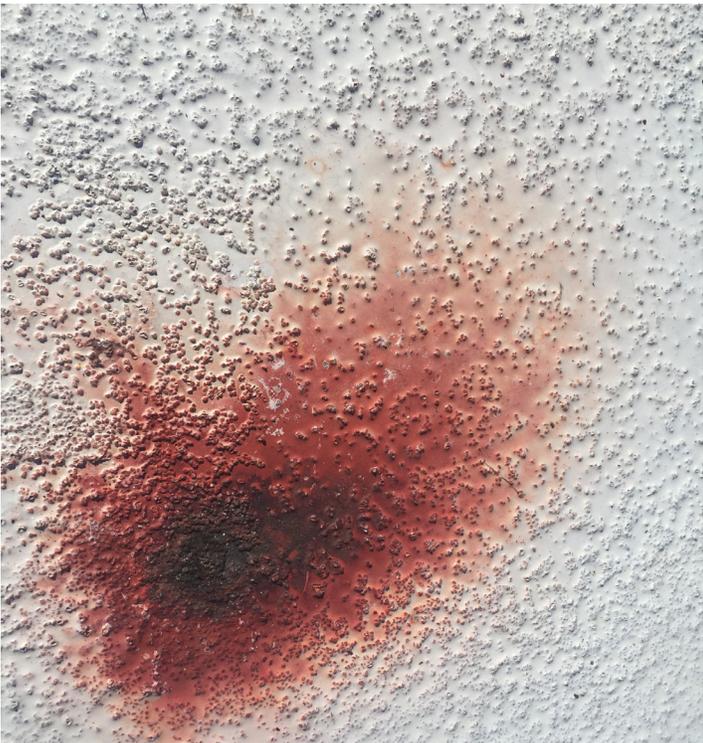
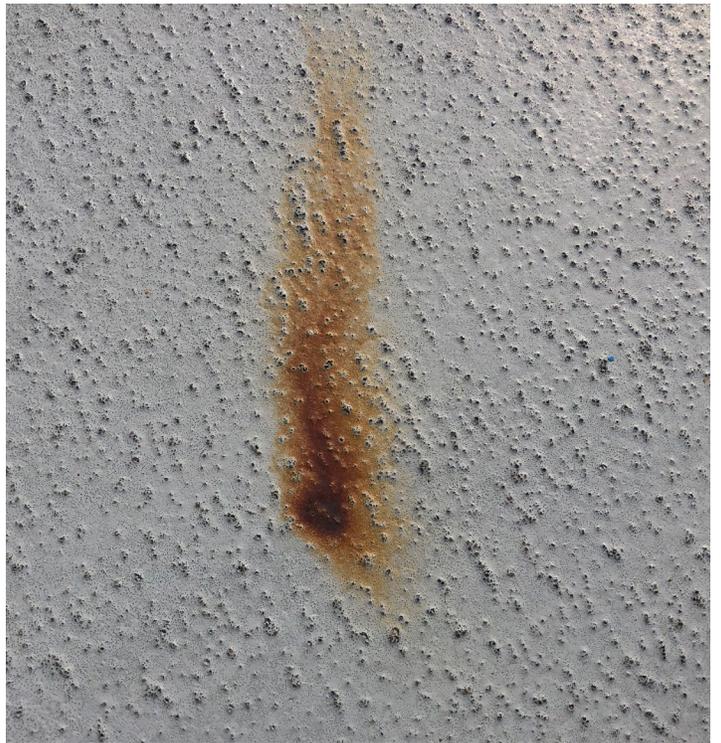
STAINS

The coating has different discoloration stains.

- UV stability of top coat
- Staining due to auto liquids leak
- Metallic content in the aggregate – rusting
- Skid tire marks
- Tire marks due to longer contact with a new high performance tires (car dealerships)
- Insufficient maintenance and cleaning
- Insufficient mixing of component products

- Abrade affected area to remove the whole stain mechanically
- Clean and solvent wipe the whole affected area
- Apply recoat primer
- Apply additional top coat

- Check aggregate for metallic impurities (less than 0.05%)
- Clean the area after shotblasting
- Maintain and clean the deck periodically
- Clean car liquid spill within 24 hours period after first exposure
- Use protection pads under new performance tires when the car stays on one place for more than one week (car dealerships)
- Use aliphatic top coat only for UV exposed areas
- Use Sikalastic 748 Polypl

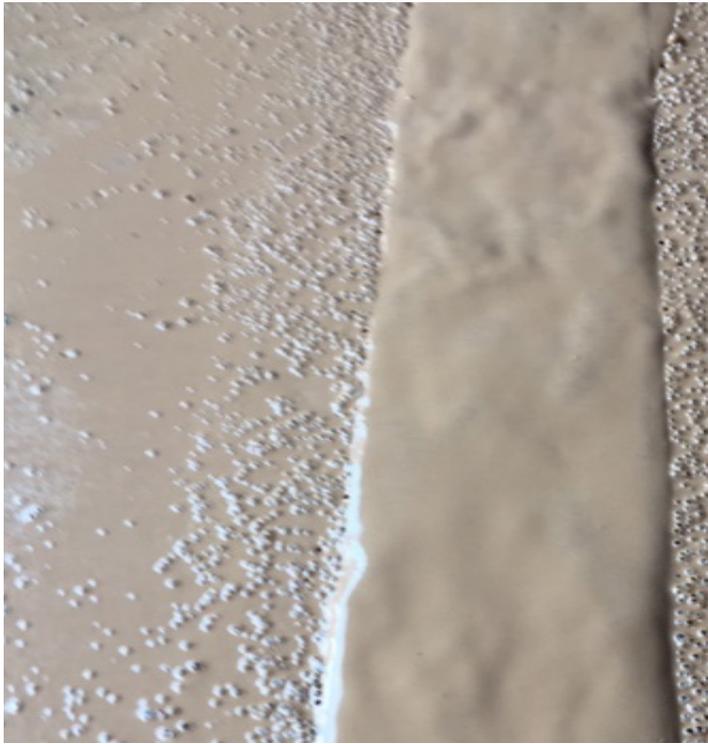
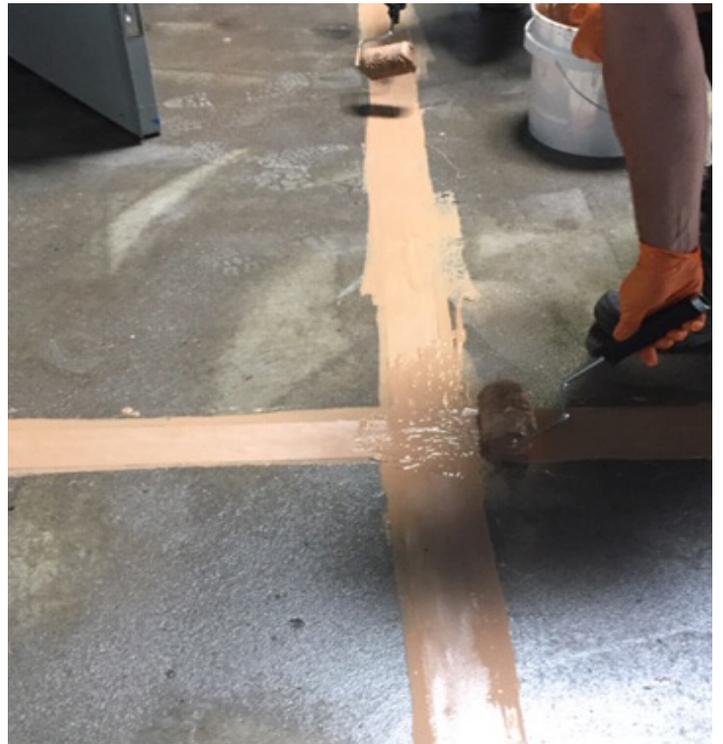
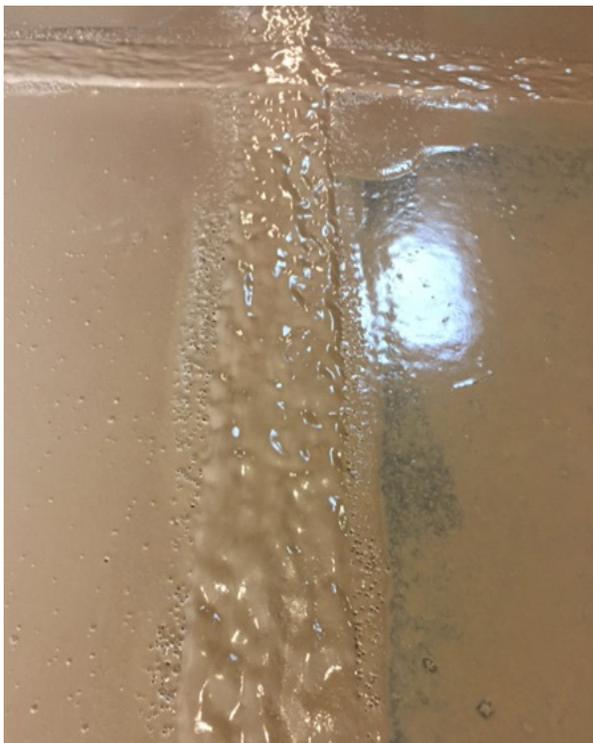
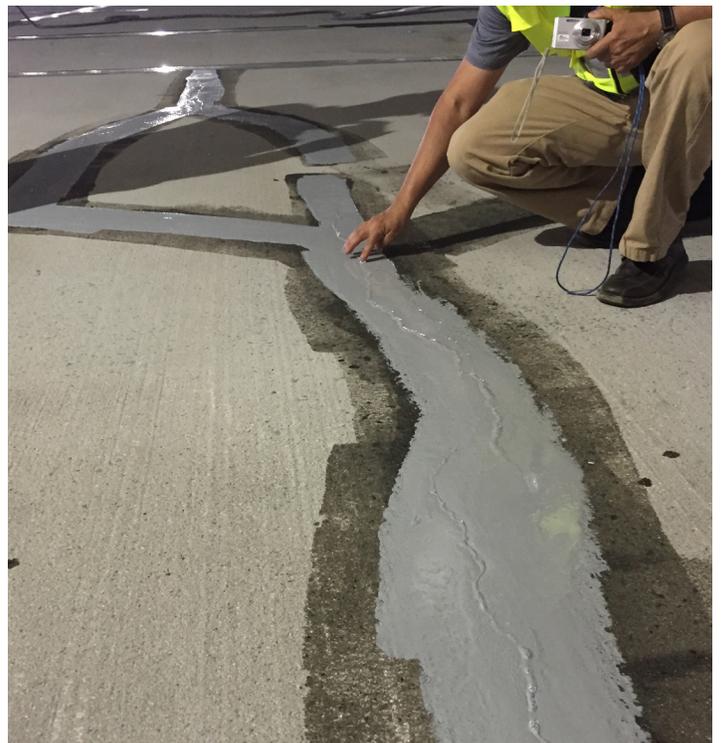
GASSING UNDER REINFORCEMENT FABRIC

Big bubbles occur under fabric after the resin has been cured. When the fabric is cut the big air bubbles occur below. It happens mostly to reinforced detail coat especially when the coating was applied too thick prior to saturation of the fabric. The bubbles occur after 2-8 hours after the fabric was saturated in the resin.

- Wet film application is too thick
- Wrong tools
- Wrong detail work
- Uneven surface – low spots
- Very rough concrete surface profile (more than CSP 4)

- Completely remove affected area down to concrete substrate
- Re-apply the system with new reinforcement

- Check the wet film thickness during application
- Fill up and let cure low spot areas of the substrate before placing the fabric
- Check CSP (CSP 2-4 required)
- The first coat to saturate the fabric should be thinner (10WFT max.) and then the fabric should be saturated with an extra resin from the top
- Check your tools
- Use a booster or accelerator with single component products
