# TRAFFIC DECK MEMBRANE TROUBLESHOOTING GUIDE

TRAFFIC DECK MEMBRANE  
Troubleshooting Guide

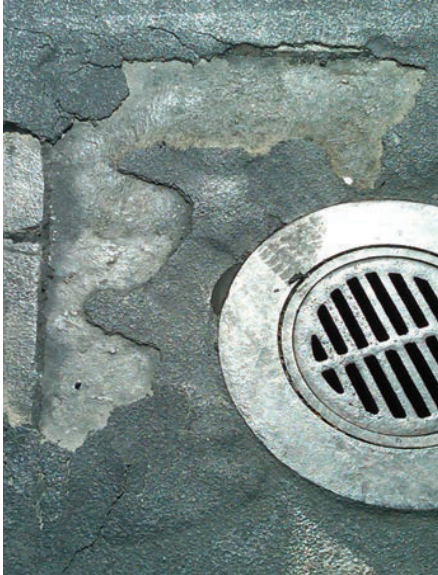
A. Improper concrete surface preparation

- A. Improper concrete surface preparation
  - Failure to abrade substrate to appropriate CSP (Concrete Surface Profile)
- B. Contaminants
  - Failure to remove dust, debris and oil
- C. Moisture
  - Failure to allow surface to dry after water event
  - Environmental moisture resulting from a drop in dew point after application
- D. Incorrect System Selection
  - Exposure to conditions that exceed system design limitations
- E. Improper surface preparation of existing coating
  - Failure to abrade substrate (existing coating) to required surface profile
- F. Missed recoat window

- Remove loose / delaminated / debonded coating
- Abrade surface as recommended in Sika's Sikalastic Traffic data guides
- Reapply coating

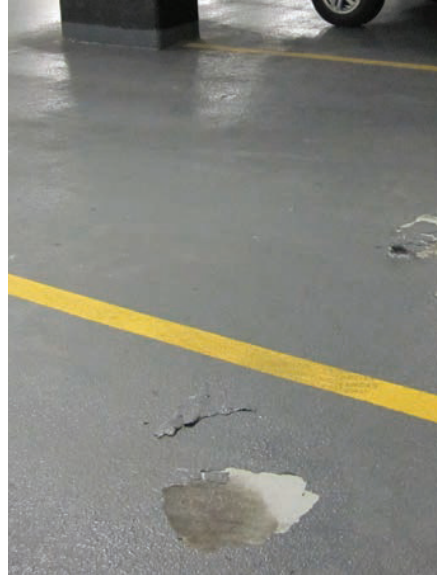
B. Contaminants

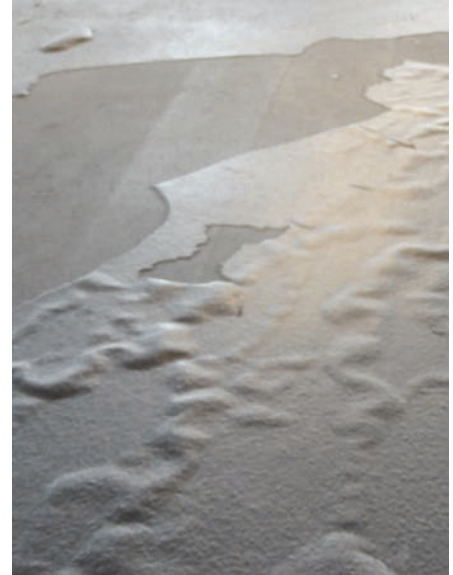
C. Moisture

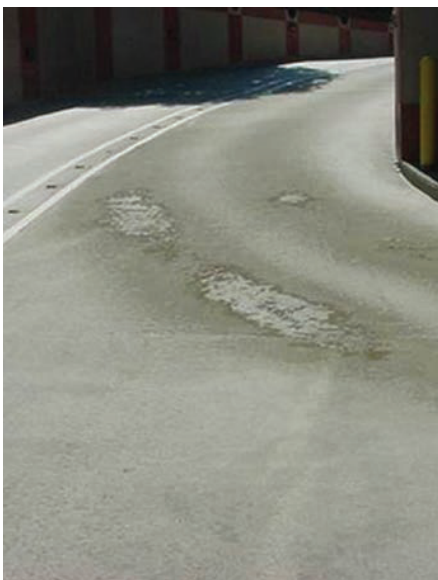
D. Incorrect System Selection

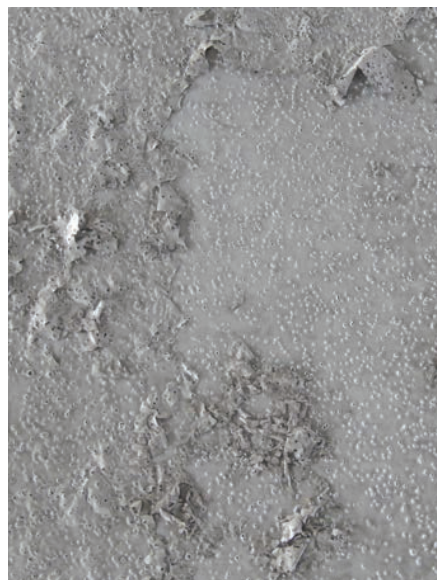
E. Improper surface preparation of existing coating

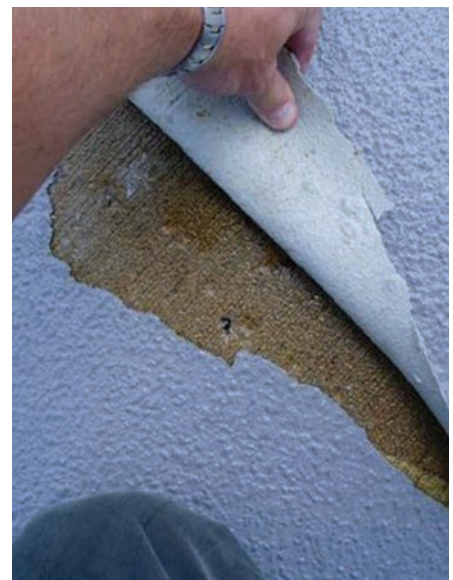
F. Missed recoat window

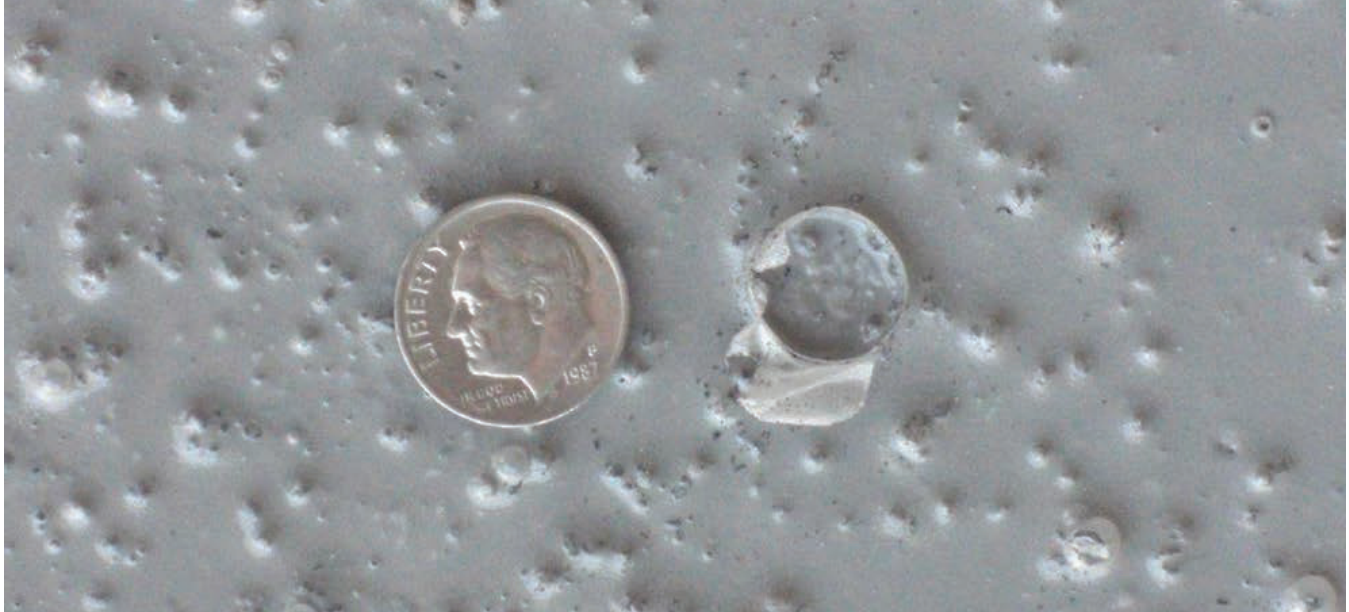
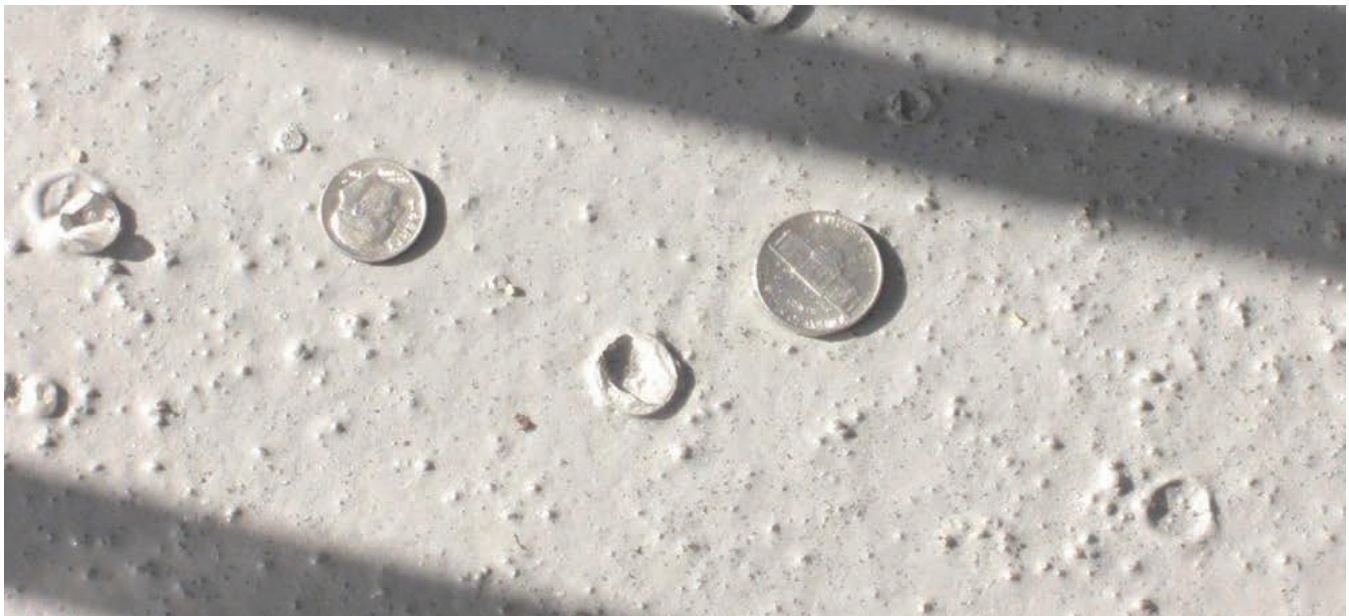
A translucent, thin film forming a bubble on the surface which will form a crater when the bubble pops.

- Moisture in the concrete that permeates through the top surface as the surface heats up from the sun / heat (vapor drive)
- Dew Point / Relative Humidity – atmospheric conditions causing excessive moisture in the air
- Curing at high heat can cause skinning on the surface, trapping CO<sub>2</sub>
- Moisture in the aggregate from improper storage or exposure to weather elements

- Bubbles / pinholes / craters typically do not impair the function of the overall system. They can be aesthetically displeasing and should be addressed on a case-by-case basis.

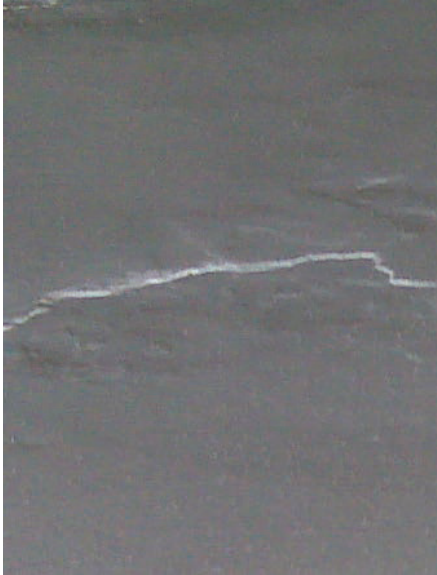
A. Over application

A. Over application that exceeds recommended coverage rates. This primarily occurs in one-component systems and can be exacerbated by high heat, which leads to rapid skinning.

- Overly aggressive surface profile
- Pitted or uneven surfaces
- Improper sized squeegees
- Damp aggregate

- Remove existing blisters
- Abrade and/or clean existing surface
- Apply waterproof basecoat where relevant
- Patch blisters with urethane and / or epoxy mortar
- Apply topcoat

- Remove existing blisters
- Apply primer when required
- Apply urethane intermediate coat
- Apply topcoat

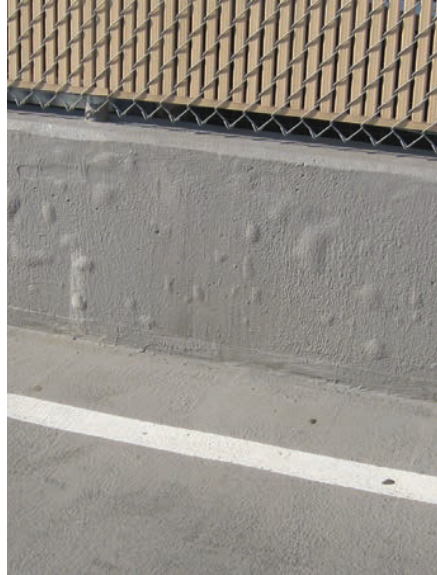
B. Excessive vapor drive

B. Excessive vapor drive and high moisture levels in the concrete slab. This occurs most often in unvented pan decks, slab on grade and split slab applications.

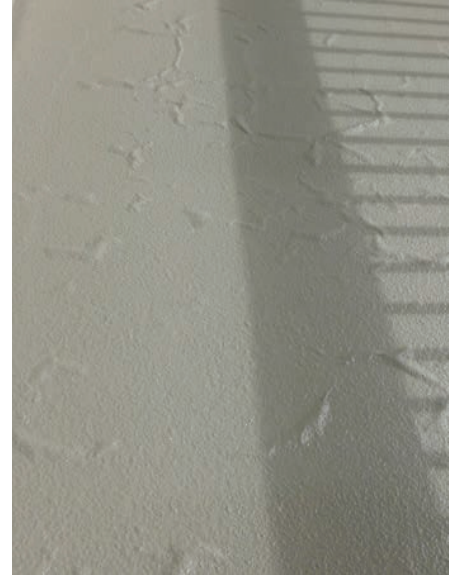
C. Incompatibility with existing coatings

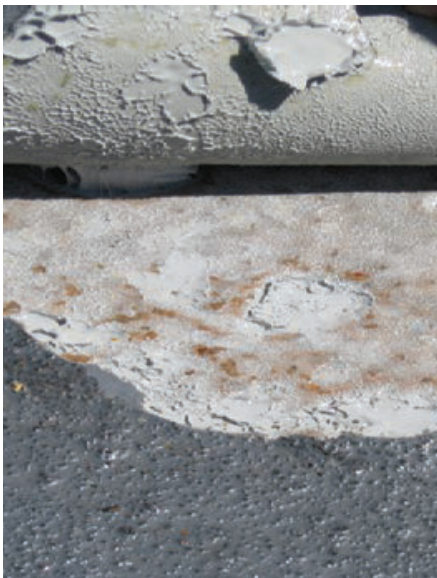
D. Improper mixing

- Failure to premix individual components in one-component systems
- Incorrect ratios when splitting two-component units

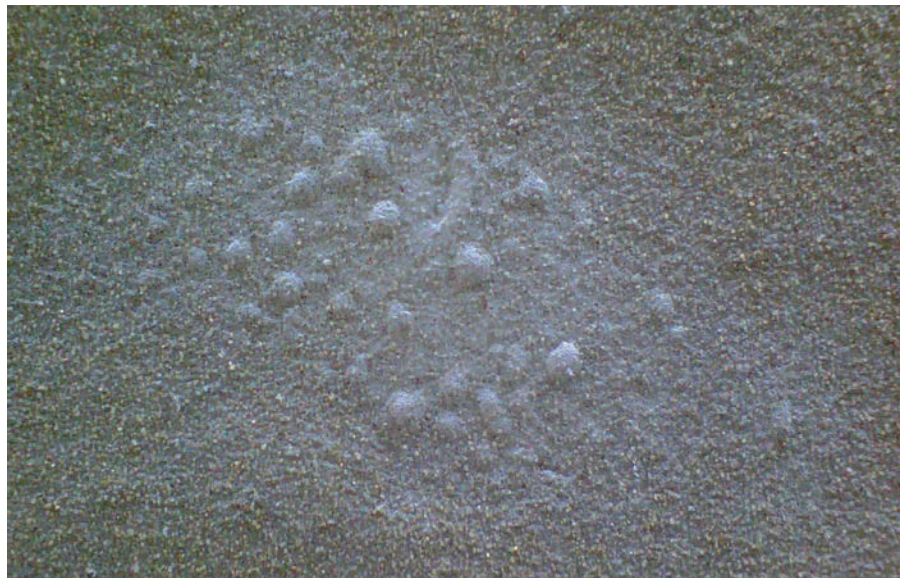
E. Curing at high heat

E. Curing at high heat can cause skinning on the surface, trapping carbon dioxide

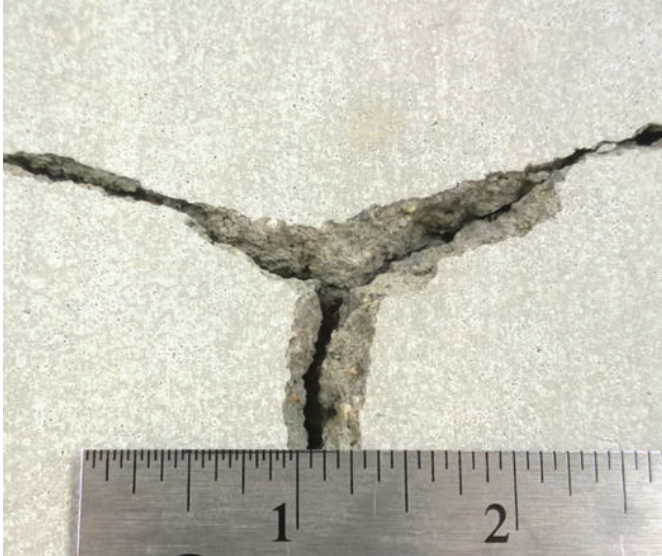
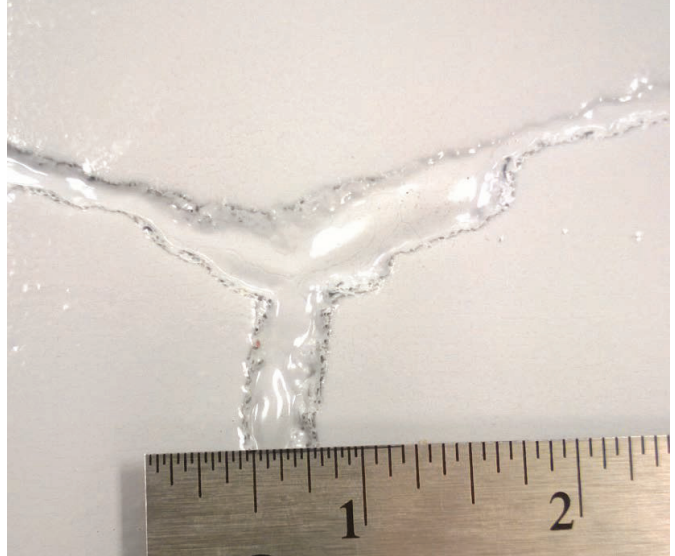
A. Improper detailing

- Failure to follow necessary preparation guidelines by routing and caulking cracks greater than 1/16" (1.5 mm) followed by prestripping
- Failure to follow necessary preparation guidelines by prestripping cracks less than 1/16" (1.5 mm) as indicated in manufacturer technical data guides
- Coating applied over moving joint exceeding elongation of membrane

- Route existing crack
- Apply a Sika polyurethane sealant and strike flush.
- Apply the system basecoat to provide waterproofing properties
- Apply intermediate / topcoats

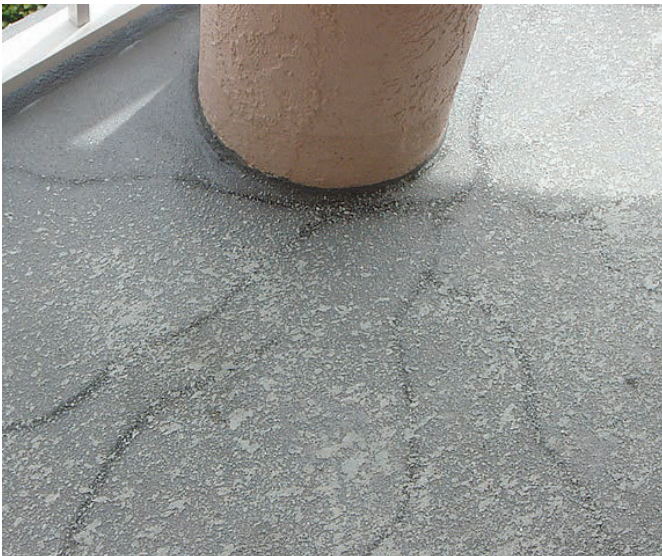
B. Improper sealant chemistry

- Urethane coating applied over silicone sealant

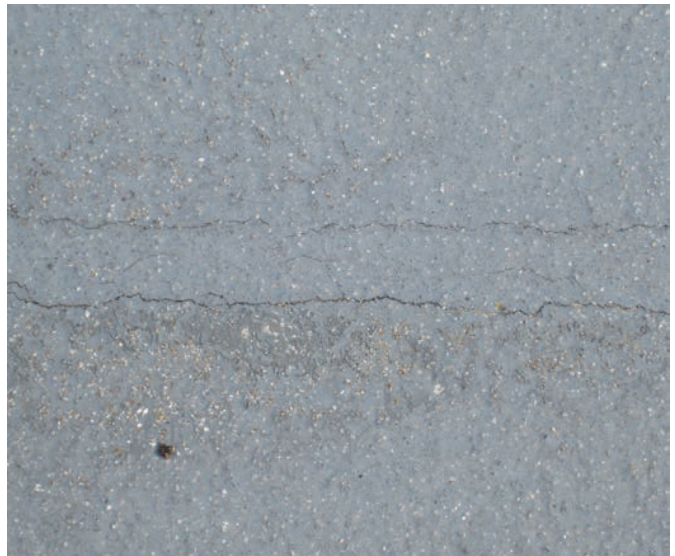
C. System component flexibility

- Movement of substrate exceeds system capability. Note: Membrane may maintain waterproofing properties despite cracking and is therefore not necessarily deemed a system failure.

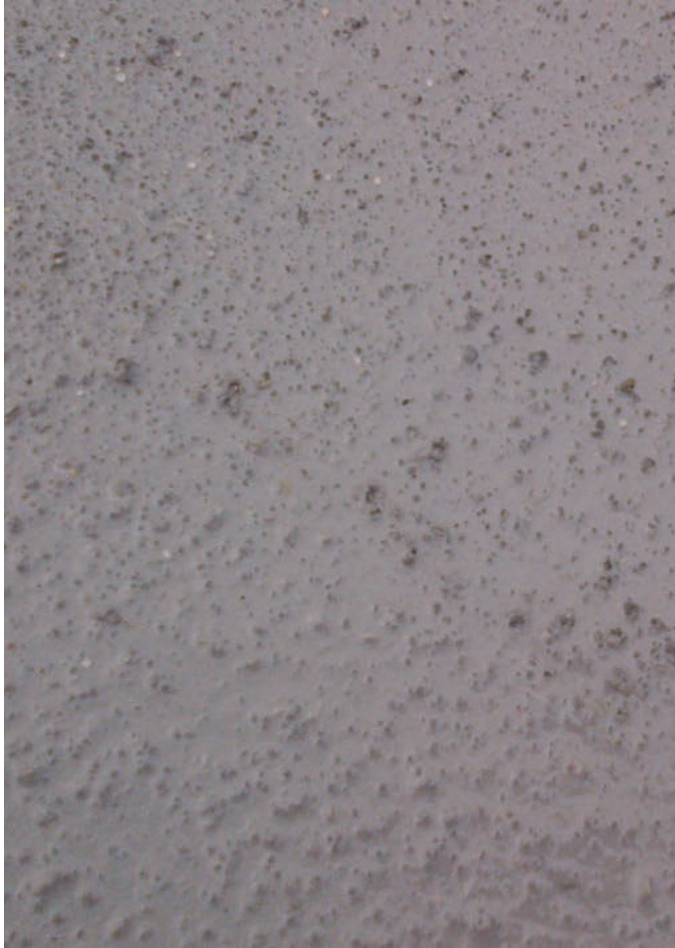
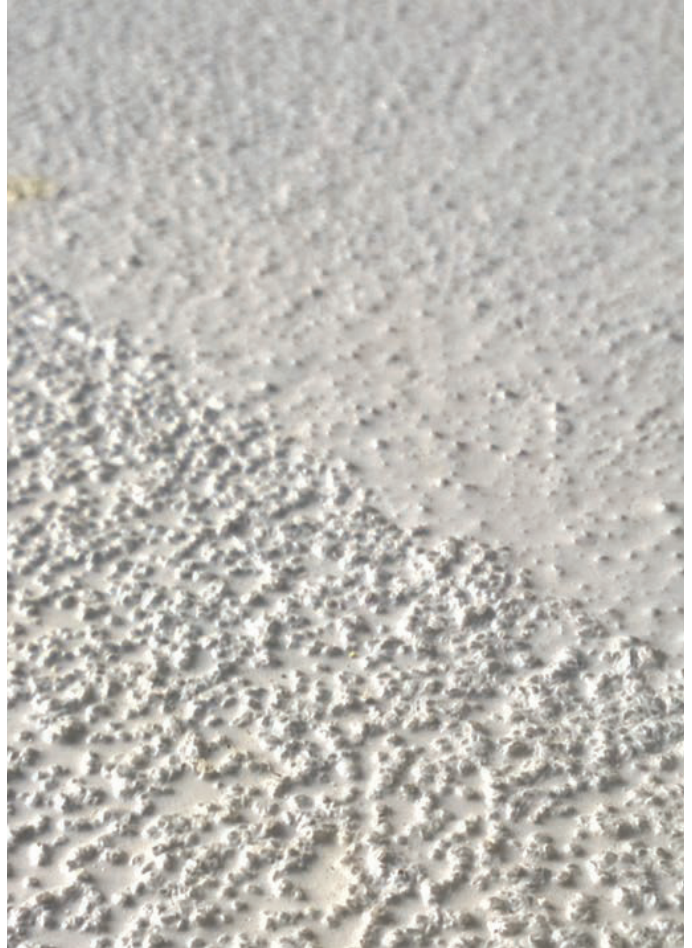
The finished coating is insufficient to impart adequate skid, slip and wear resistance as well as provide protection and aesthetic features to the system.

- Insufficient aggregate amount
- Inconsistent aggregate distribution
- Incorrect size of aggregate
- Improper back rolling
- Aggregate roll out resulting from a mil thickness of topcoat and/or intermediate coat that is insufficient to properly encapsulate aggregate.

- Abrade affected areas
- Solvent wipe immediately before applying coating
- Apply one or two coats of intermediate / topcoat and recommended aggregate broadcasts depending upon traffic volume and location

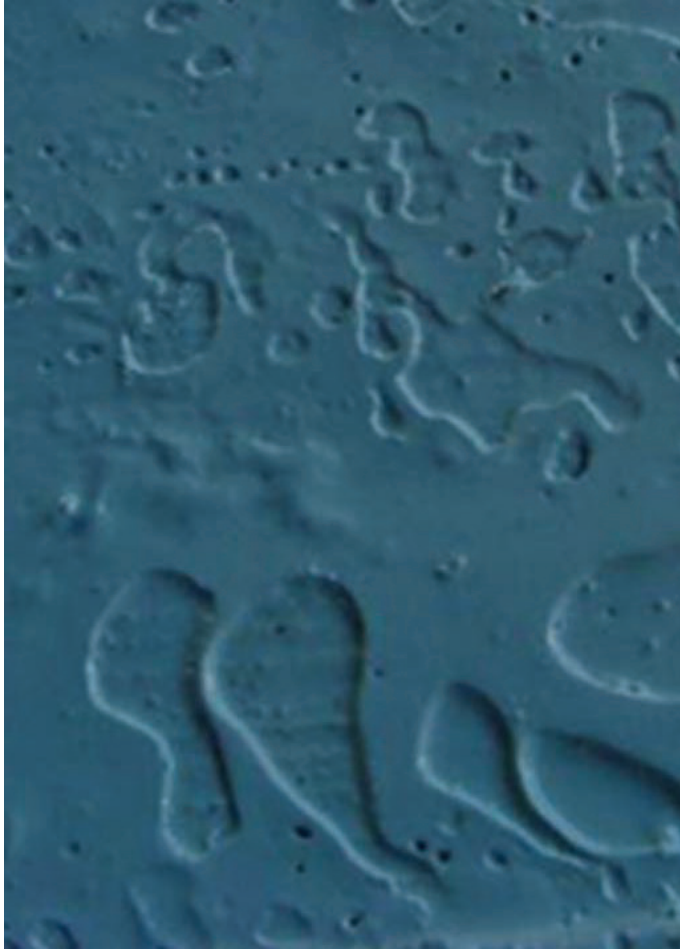
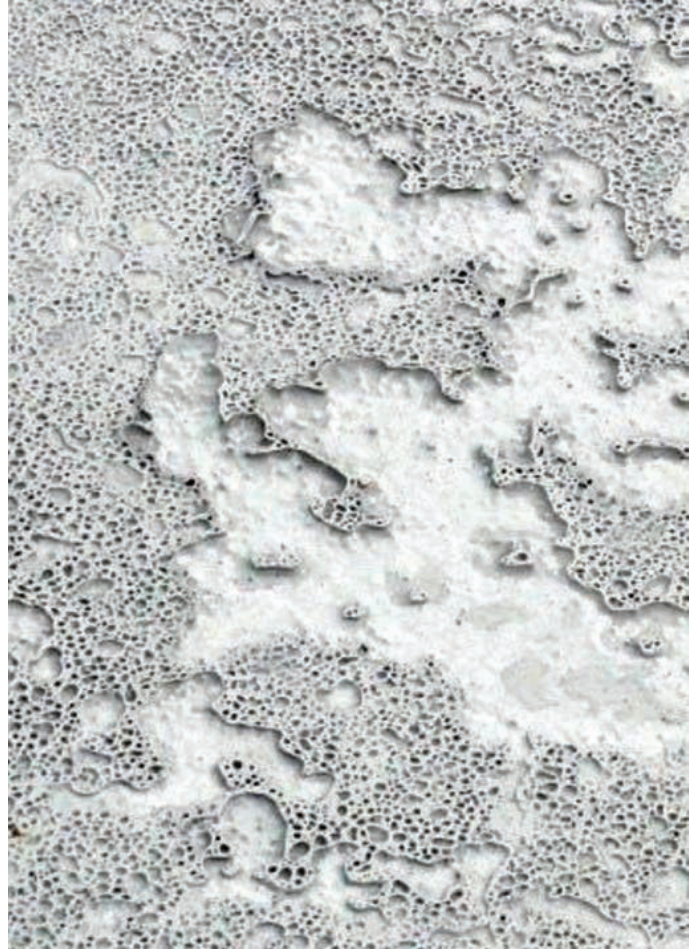
Displacement of material due to a water event before the system has cured. Severity of damage is typically proportional to the length of time the coating has been allowed to cure.

Introduction of water before cure

- Application during or immediately preceding inclement weather
- Sprinkler system activation prior to full cure of coating

- Minor damage may require a simple re-prime and reapplication
- Moderate damage may require grinding followed by solvent wipe, priming and reapplication
- Severe damage may require complete

removal and reapplication of system

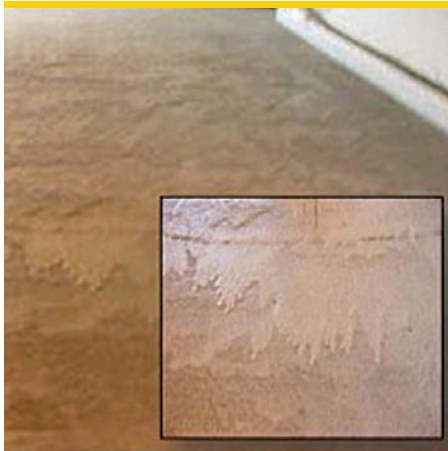
## SAGGING

- CAUSE: Excessive pitch and lack of back rolling
- REPAIR: Grind high spots and recoat
- PREVENT: Use slope grade material and employ proper back rolling technique

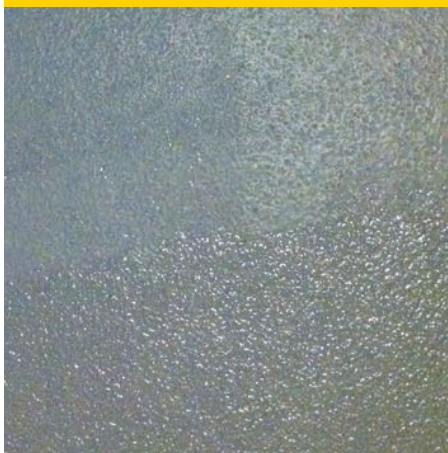
## DISCOLORATION

- CAUSE: Non-UV-stable topcoat used in areas exposed to sunlight, contaminants such as salt residue on the surface, moisture on surface during cure, plasticizer migration from tires
- REPAIR: Contact your Sika representative to determine proper course of action
- PREVENT: Use proper UV-stable topcoat, provide proper drainage to prevent water ponding, do not apply coating if inclement weather is expected during cure, and ensure the system is cleaned and maintained. Also, ensure that owner expectations regarding color are managed. Be sure to install mockups.

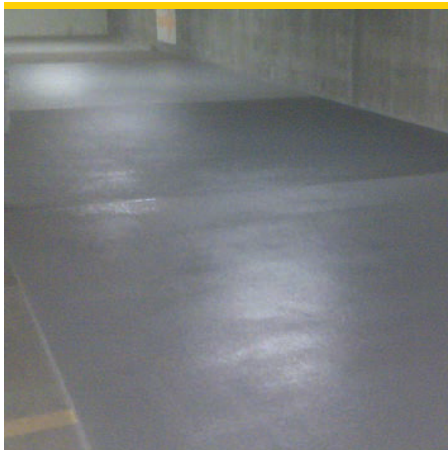
## COLOR VARIANCES

- CAUSE: Color variations from applying two different systems, inconsistent roller marks, or variances from installation stop and start points. Also see section on texture variations as inconsistent textures can cause inconsistencies in appearance of coatings.
- REPAIR: Contact your Master Builders Solutions representative to determine proper course of action
- PREVENT: Ensure customer expectations regarding color are managed when applying different systems. Be sure to install mockups.

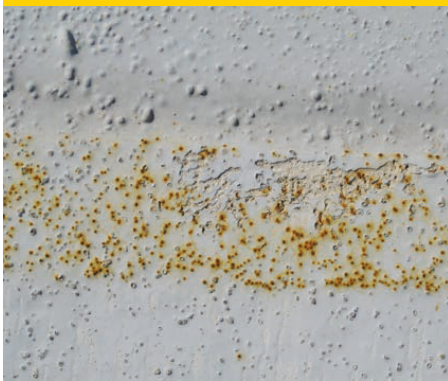
## RUSTING

- CAUSE:** Loose steel shot not removed after shot blasting or iron in aggregate
- REPAIR:** Remove the coating in the affected area and reapply in accordance with Sika technical data guides. Contact your representative for more information.
- PREVENT:** Use magnet to remove all loose shot and blow off surface prior to applying coatings. Verify aggregate purity with aggregate supplier.

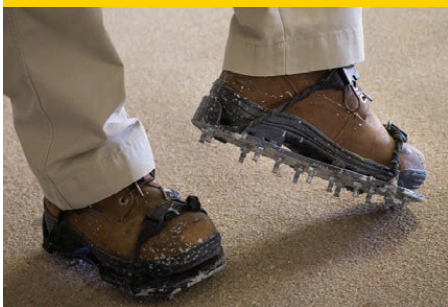
## SPIKED SHOE DAMAGE

- CAUSE:** Walking on insufficiently cured coating with spiked shoes
- REPAIR:** Reapply coating to damaged areas in accordance with Sika technical data guides.
- PREVENT:** Coating must be able to support your weight in spikes before next application

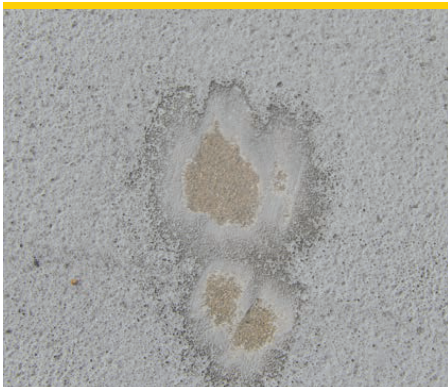
## SNOWPLOW DAMAGE

- CAUSE:** Scraping of the membrane from metal blade used to remove snow
- REPAIR:** Reapply coating to damaged areas in accordance with Sika technical data guides.
- PREVENT:** Ensure owner uses plastic or rubber blades on snow removal equipment
