CASE STUDY

BAYSHORE BOULEVARD BALUSTRADE REHABILITATION

Owner: City of Tampa - Contracts Admin. Dept. Tampa, FL

Project Engineer/Designer: Weber and Tinnen, PA - Structural Engineers Tampa, FL

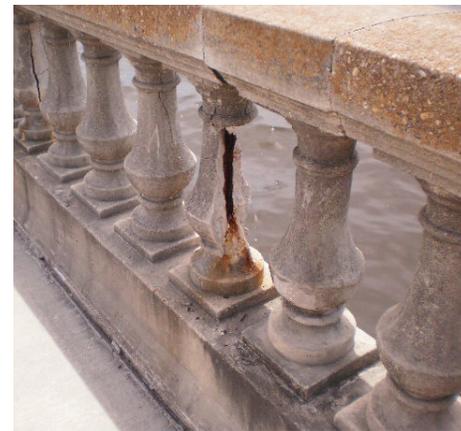
Damaged baluster revealing reinforced steel.

The objective of the repair was to extend the life of the structure and lessen future maintenance costs and the need for significant repairs. The rehabilitation process consisted of many major items of work. The balustrades that were beyond repair were removed and replaced. Cracks between 1/16" and 1/4" wide were sealed with Sikadur® 31 and Sikadur® 35 epoxy, cracks less than 1/16" wide were sealed with SikaTop® Seal 107 - a flexible polymer modified cement based coating. 5 miles of the existing joint sealant between the base of the balustrade and the concrete sidewalk were removed and new silicone joint sealant installed. Vertical and horizontal spalls were patched with polymer-modified repair material SikaTop® 123 Plus. Newly Installed expansion joints relieved stress at selected locations and existing expansion joints that were closed were either re-cut or removed and re-formed. The deteriorated exposed rebar was replaced with stainless steel rebar to resist corrosion. Sika® Ferrogard® 903 migrating corrosion inhibitor was applied to all the concrete elements along the 5 mile long balustrade. The final step in the rehabilitation process was to coat the concrete railing with SikaTop® 144 - a breathable, polymer modified, cementitious protective coating. The purpose of this coating was to protect the reinforced concrete railing from the salt water spray from the bay and to provide a like-new appearance. Mineral color pigments were added to the 3,360 gallons of SikaTop® 144 on site to create an off-white color.

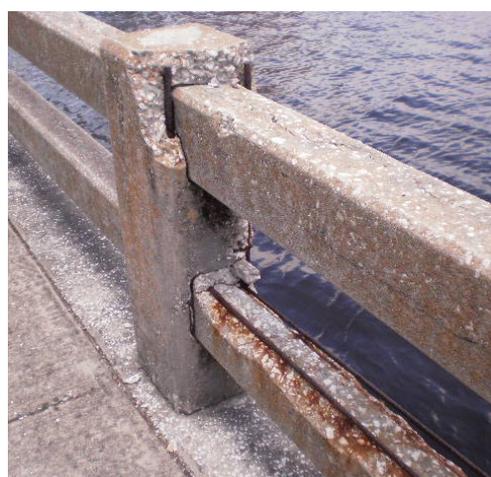
Damage to a post and rail section.

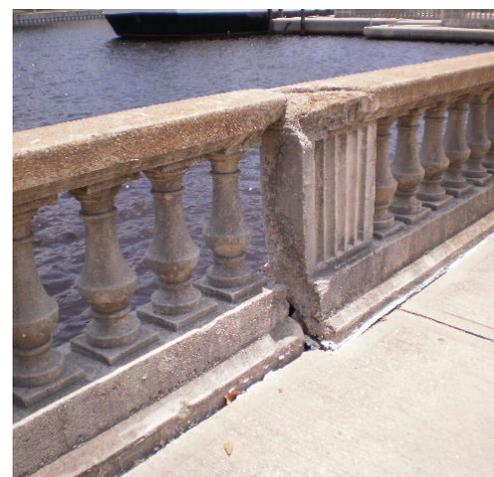
Common crack in the top rail of the balustrade attributed to expansion and contraction.
