CASE STUDY

FRENCHMAN'S REEF

Owner: DiamondRock Hospitality Company Bethesda, MD

Project Engineer/Designer: Tadjer Cohen Edelson Associates Silver Spring, MD

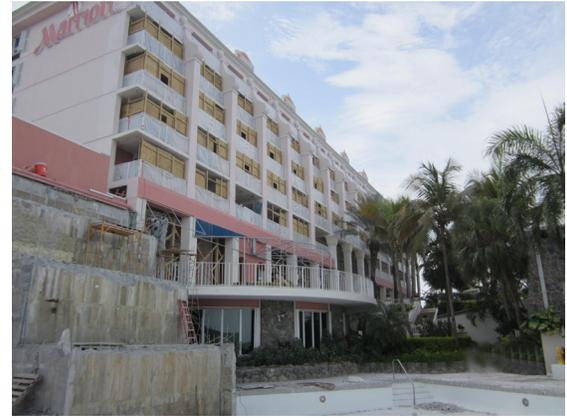
A structure needing repair

Plywood was installed on the undersides of balconies to prevent injury from falling concrete. Sika® Armatec® 110 was applied to exposed and treated rebar for corrosion inhibition and improved bonding to the repair mortars. The repair mortars, SikaTop® 122 Plus and 123 Plus, contain a corrosion inhibitor, Sika® FerroGard® 901 for further protection. A breathable, water resistant coating, SikaTop® Seal 107, was applied on the underside of the balconies and on the topside of the balconies underneath tile. Stud and anchor damage on the exterior walls was prevalent due to severe weather and new studs and anchors were installed. On one side of the hotel, the balconies form a portion of the roof over the ballroom and restaurant.

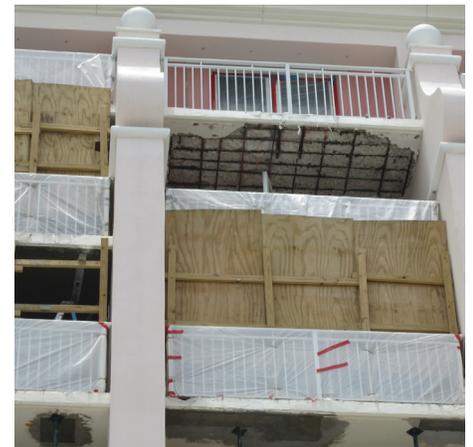
Plywood protection for rain water damage

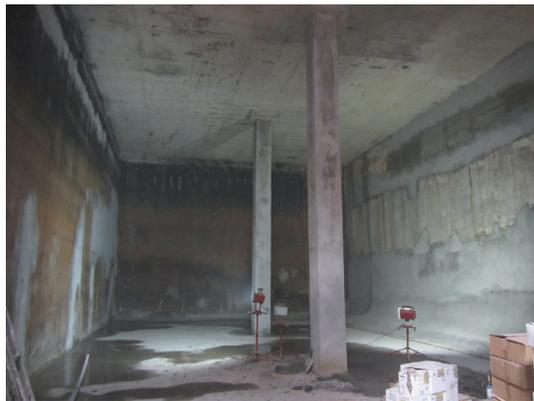
Repaired Cistern

For additional protection an asphaltic modified urethane waterproofing was utilized to waterproof both the concrete and the flashing since the flashing was in serviceable condition. The leaks from the 100,000 gallon grey water cistern and the 150,000 gallon freshwater cistern made of 12" thick concrete were seen in parts of the Sea Cliff Building contiguous with the cisterns. For both cisterns, leaking was caused by failure of the waterproof liners. All spalling concrete was repaired before the installation of a new PVC liner for the cisterns. Impressed current was used on the Sea Cliff Tower but because of the budget constraints the engineer had to use a surface applied inhibitor, Sika® FerroGard® 903 for the Ocean Tower.

SikaTop® Seal 107 - a polymer-modified waterproofing and surface sealing mortar for tanks and reservoirs. Used on the inside of the tank walls it prevents water-loss (seepage) and prevents surface erosion. Used on exterior walls it protects water quality by preventing infiltration.
