# Project Profile

Marriott Long Wharf Hotel  
Boston, MA

## **Sika Sarnafil Helps High-End Hotel Stay High and Dry**

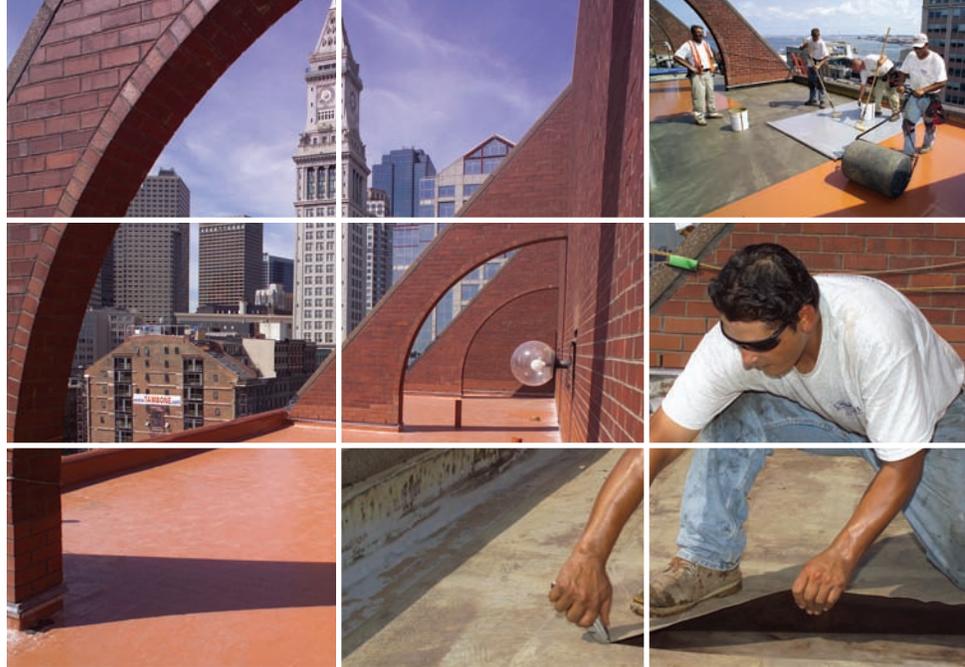
The new Sika Sarnafil membrane installed at the Marriott Long Wharf, Boston, MA. At right, a worker cuts the old membrane, which was recycled and will go back into new membrane production.

Planning the logistics of this project took several months before they even stepped foot on the job. "The project involved masonry demolition and the installation of new thru-wall flashing; removal of the old roofing membrane and ballast followed by installation of the new adhered membrane; and then sheet metal work," Hillcoat said. "We had to come up with a logical sequence of events that maximized production but minimized disruptions. We were limited as to which roof areas we could work on each day, yet we still had to meet a very tight schedule. It wasn't easy figuring all of this out, but it was a lot of fun."

As Hillcoat pointed out, another unique feature of this installation was the amount of materials recycled. "At least 95 percent – by weight – of the existing materials were recycled, including the original Sarnafil roof membrane, metal flashings, insulation and the gravel ballast," he said. The stone ballast was shipped to a landscape supplier for resale and the Sarnafil roofing membrane from the previous roof was processed by Conigliaro Industries for reuse in new Sika Sarnafil products. The roof insulation was also sent to Conigliaro to be recycled for other applications. "We had to make some logistical changes to make sure materials were shipped to the proper places instead of the usual practice of sending everything to a landfill, but it was worth it," Hillcoat said.
