**Concrete Repair & Protection**

**Corrosion**

<b>Project:</b>	<b>Waterside Tower Condominium</b>
<b>Owner:</b>	<b>Waterside Tower Condominium Association</b>
<b>Engineer:</b>	<b>B.P. Taurinski Structural Engineers</b>
<b>Contractor:</b>	<b>Phoenix Concrete Restoration</b>
<b>Year:</b>	<b>2008 - 2009</b>

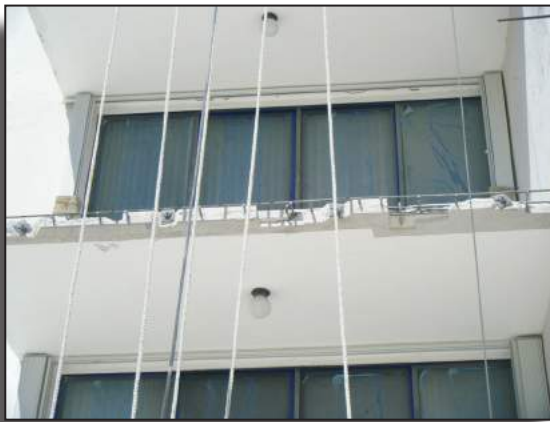
The Waterside Tower Condominium is a 10 story building located in the coastal area of Miami, Florida. The 118 unit high-rise building was constructed in 1972 with post-tensioned concrete. After 30 years of the highly corrosive environment of South Florida the building started to show signs of deterioration. The most evident sign of failure was at the balcony slab edge.

The initial visual and sounding investigation revealed spalled and delaminated concrete conditions at the slab edge of the balconies.

When the demolition of the concrete started it was found that the spalled condition was a result of insufficient concrete cover at the slab edge. The lack of concrete cover accelerated corrosion of the post-tension anchors and the steel reinforcement.

A decision was made to extend the balcony slab six inches, full depth, to provide sufficient cover for the post-tension anchors and steel reinforcement. The existing hand rails and coatings were removed from the balconies. The delaminated concrete on the slab edge was chipped away carefully not to disturb the post-tension anchors.
