# Project Profile

Man at Work Sculpture Garden  
at the Grohmann Museum  
Milwaukee, Wisconsin

## Man at Work Collection Employs Sika Sarnafil Waterproofing System

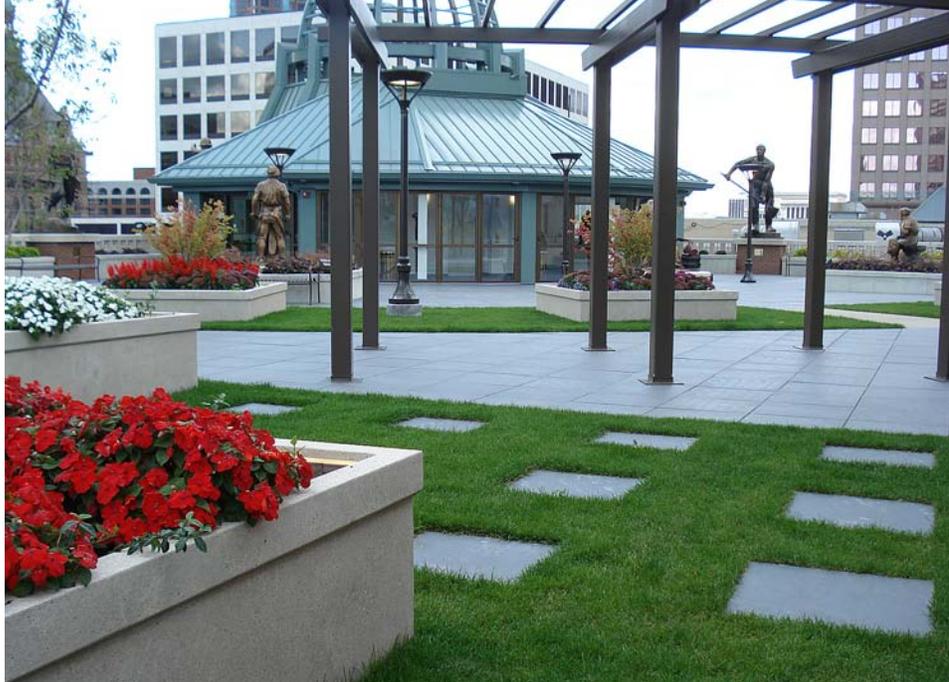
The Sculpture Garden at the Grohmann Museum is perhaps the most interesting roof in the city of Milwaukee. Created for relaxation and entertaining, this rooftop garden features sod, rather than the typical ‘green’ roof vegetation.

Fortunately, the previous built-up roof had already been torn off, so Christiansen Roofing could start with the installation of a two-ply vapor barrier. Tapered extruded polystyrene was installed over that, and then the EFVM’s foil-faced sheet was applied. Finally the Sarnafil G476 membrane was loose-laid on top, followed by the vegetative cover and / or the pavers, which were installed on a pedestal system.
