# Project Profile

Ronald Reagan Washington National Airport  
Terminals B and C  
Washington, DC

## **Sika Sarnafil's Décor Roof System Solves Problems with Leaking Metal Roof**

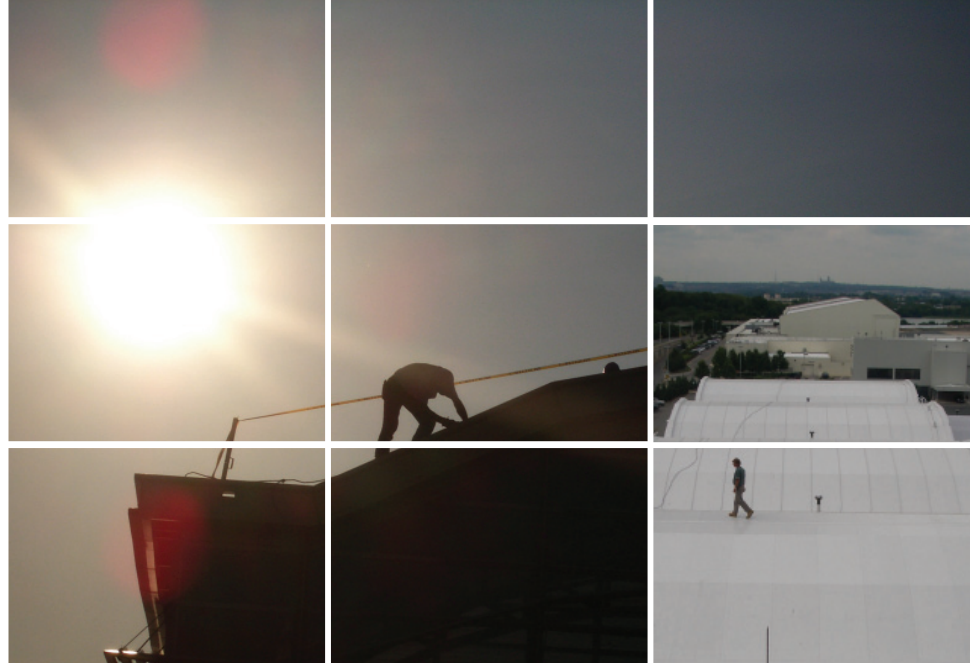
The Sarnafil Décor Roofing System being installed by Pioneer Roofing Systems on the Ronald Regan Washington National Airport Terminals B and C.

According to Wann, the installation involved tearing off the stainless steel metal and replacing any damaged submembrane. Dens-Deck™ was then installed over the existing insulation assembly, and then the 80-mil feltback Sarnafil membrane was adhered.

explained. “Once the copings were in we installed them and the Décor profiles, which went up and over the barrel. That process only took about three days to install.”
