# Project Profile

University of Iowa Chemistry Building  
Iowa City, Iowa

Adhered roof system using Sarnafil®  
feltback waterproofing membrane and  
Grid System using G459 membrane  
along perimeters

## “Hybrid” Sika Sarnafil System Keeps University of Iowa Chemistry Building Dry

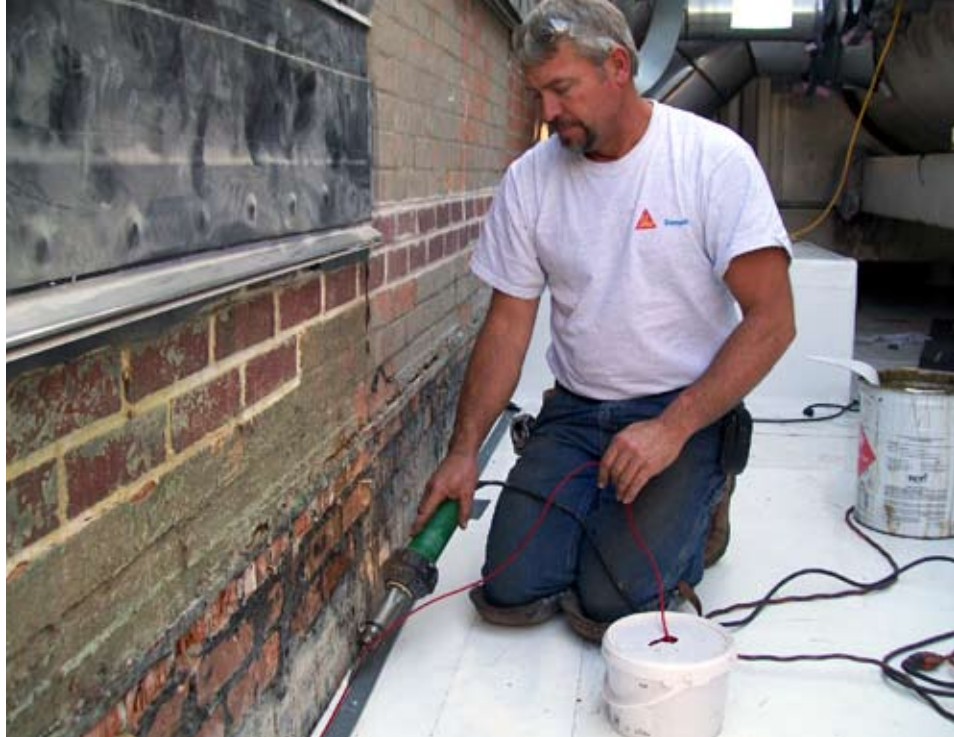
All of this work was done on a roof featuring numerous overhead obstructions and penetrations, creating a very tight work space. "We had to hand-weld seams and flashings because of the limited space,"

Jodsaas pointed out. "It made seaming more time-consuming, but it was the only way to complete the work."

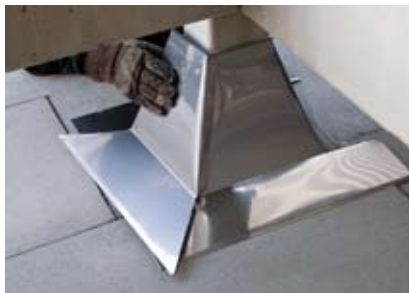
Horizon Roofing also restored the previously covered overflow scuppers, installed new insulation and jacketing on several roof top pipes, and installed new pipe supports on the horizontal pipes. "We also installed new 22 gauge stainless steel flashing and custom-

made pipe jacks, and anchored them to the paver system," Jodsaas stated. "We then soldered all the metal joints and finished the project."
