EXTENDED CASE STUDY

PROJECT – INTERMOUNTAIN HEALTH CARE'S POCATELLO
REGIONAL MEDICAL CENTER ROOF
POCATELLO, IDAHO

MEMBRANE SYSTEM – DECOTHANE

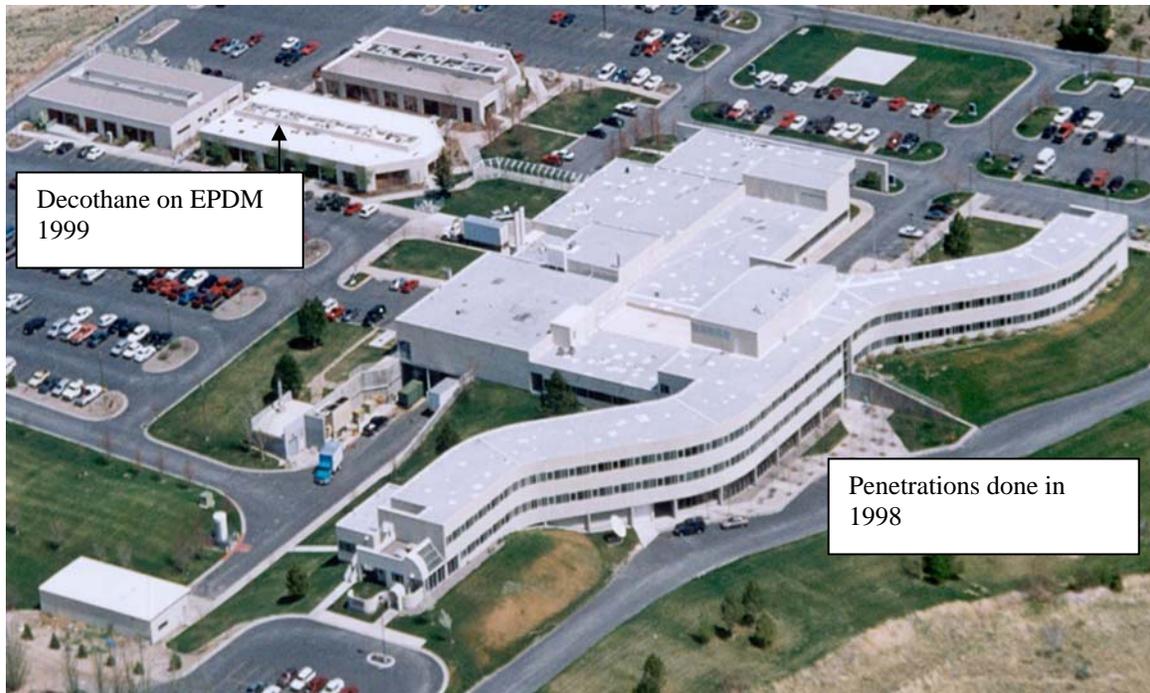
Picture taken Spring of 2000. Note Medical Office Building EPDM Roof and Decothane on main hospital roof.

Since the writing of this case study, two of the medical office buildings in the main hospital picture have been done with the Decothane Omega-15 system over top of EPDM rubber mechanically fastened to the roof deck. Each roof is approximately 10,000 square feet.

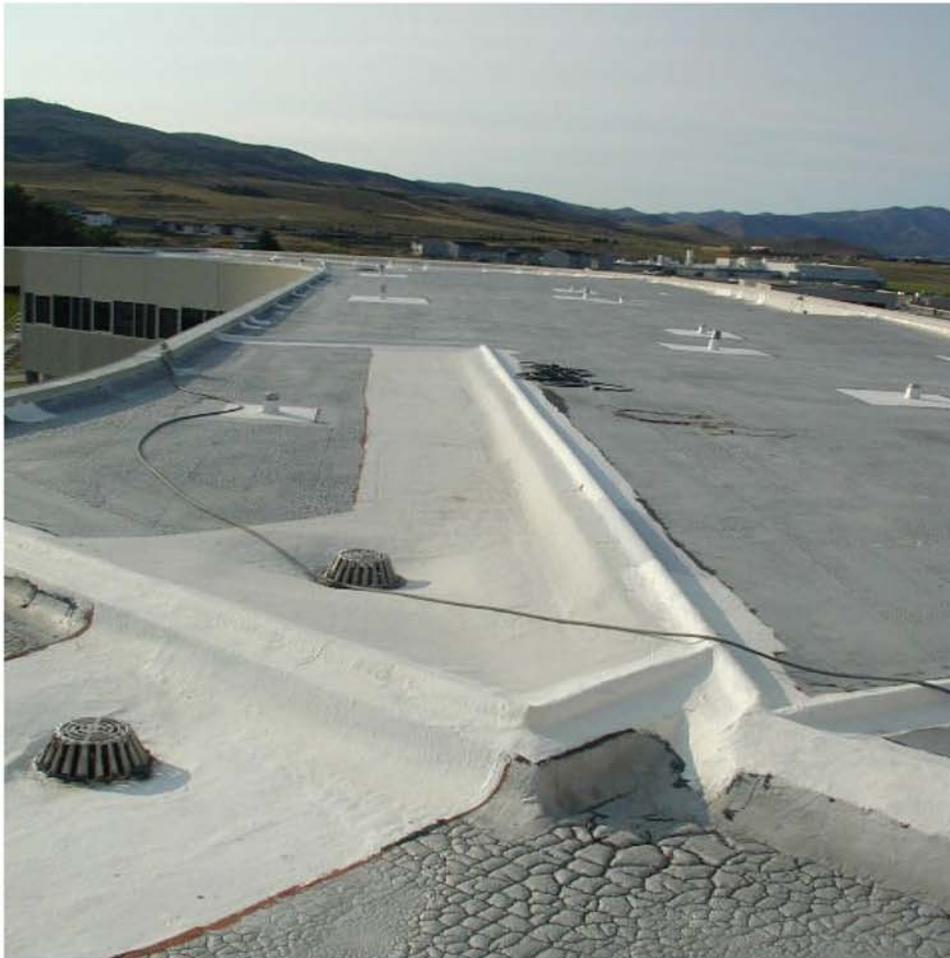
Complex drain and expansion joint configuration after 4 years of service.
