COMMON CONDOMINIUM PROBLEMS AND REPAIR SOLUTIONS

PRESENTED BY: KATIE WALTHER, PROJECT SALES REPRESENTATIVE - SOUTH FLORIDA

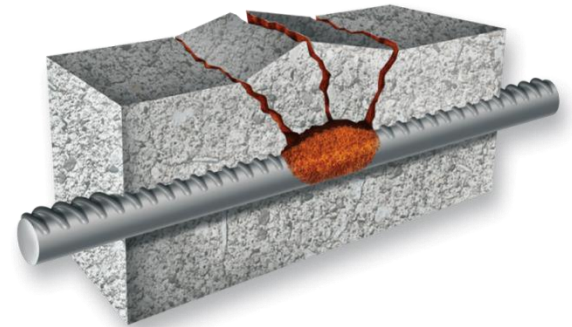
- Concrete and steel start off compatible
- Corrosion is caused by a breakdown of the passivating layer formed on the rebars at new construction
- Chlorides (salts) and Carbonation are the two leading causes of corrosion
- As steel corrodes it expands up to 12x its volume, causing cracking initially, and eventually spalling

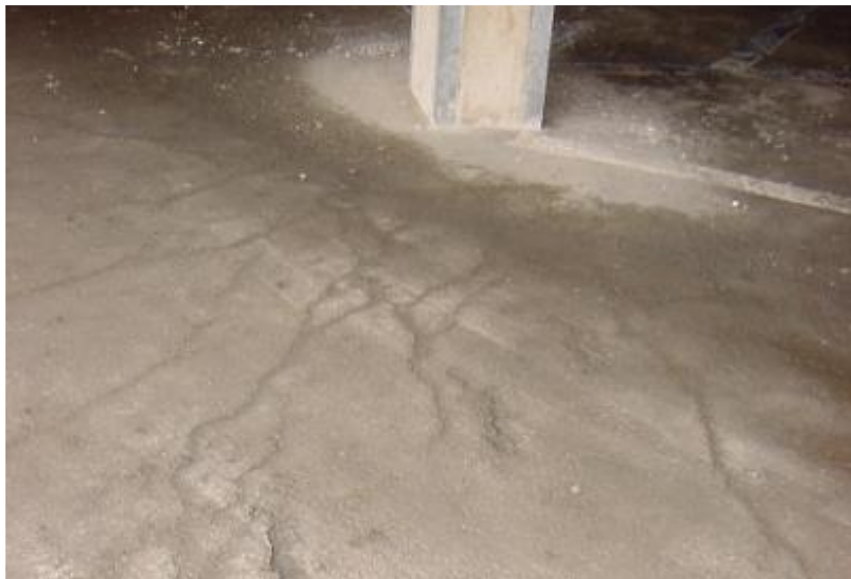
Punching Shear Cracks

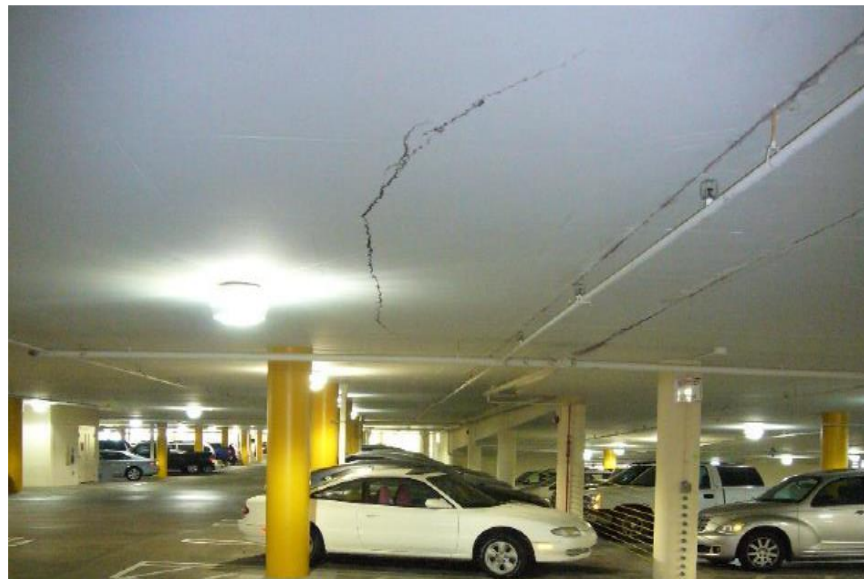
PT Slab Cracking

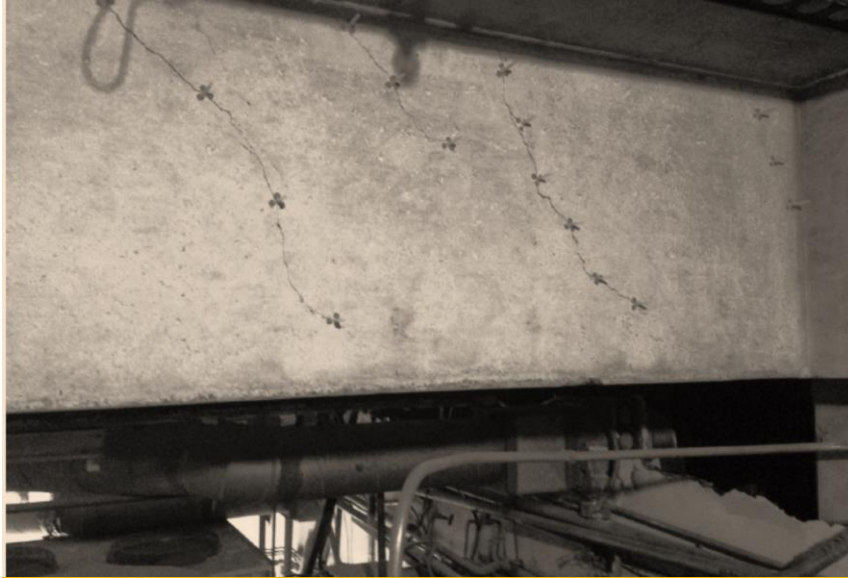
Shear Cracks on Beams

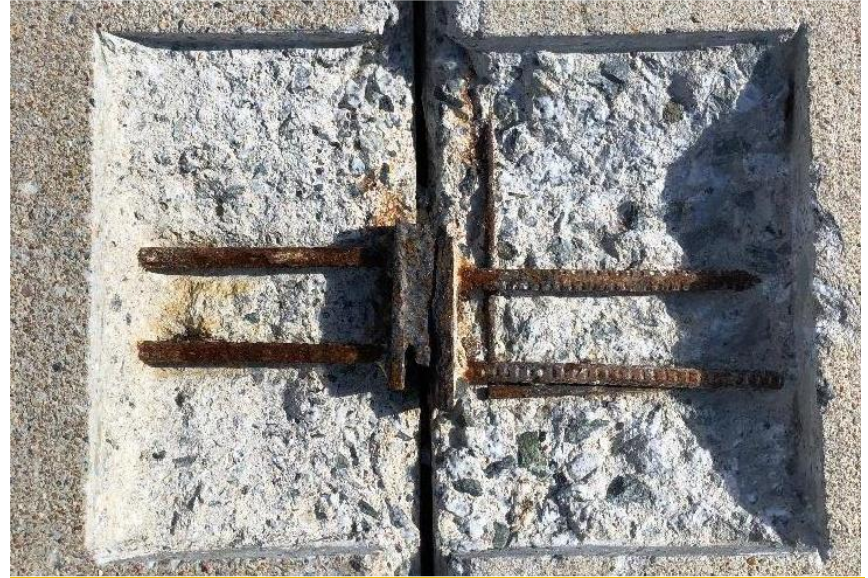
Double Tee Welded Connection Issue

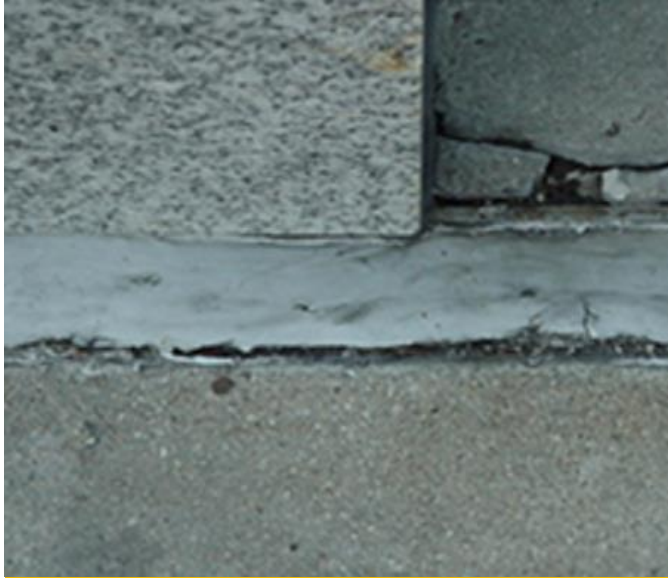
Joint Sealant Failure

- Joint Issues
 - Determine mode of joint failure. Remove and replace with suitable sealant, using appropriate primer if needed
- Concrete Spalling
 - Saw cut perimeter, use appropriate mortar to repair
- Waterproofing Failure
 - Remove or recoat existing coating, use appropriate primer and waterproofing membrane

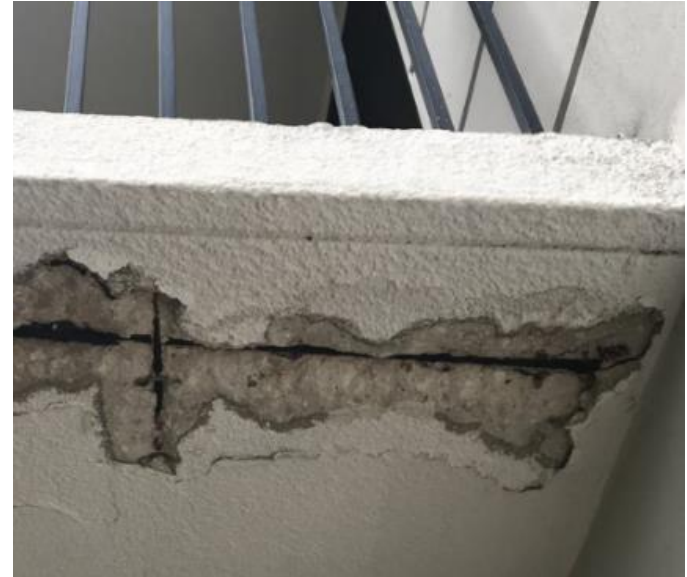
Concrete Spalling on Balcony

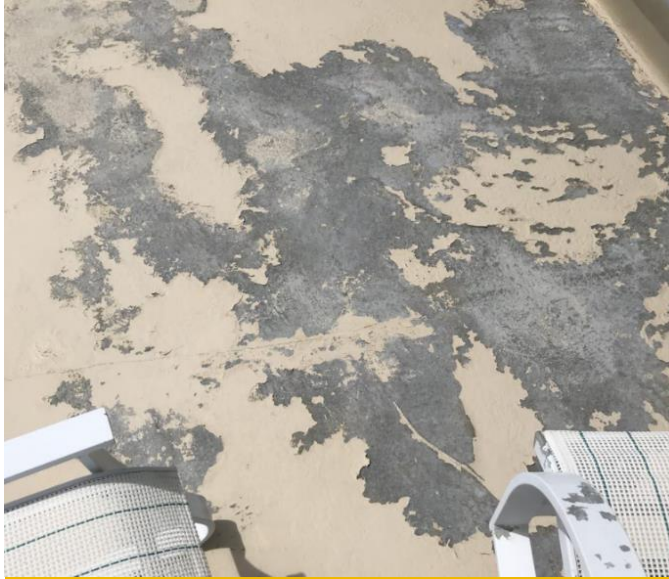
Waterproofing Failure

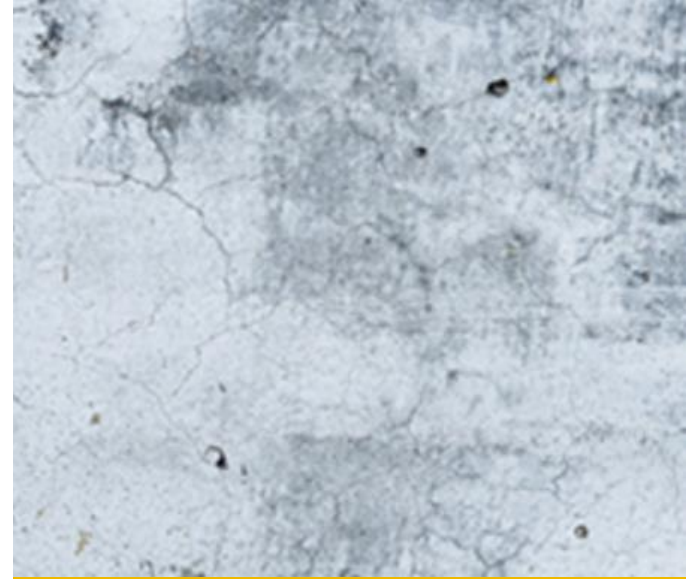
Cracks

- Rout & Seal cracks over 1/16"
- Injection or coating to repair smaller cracks

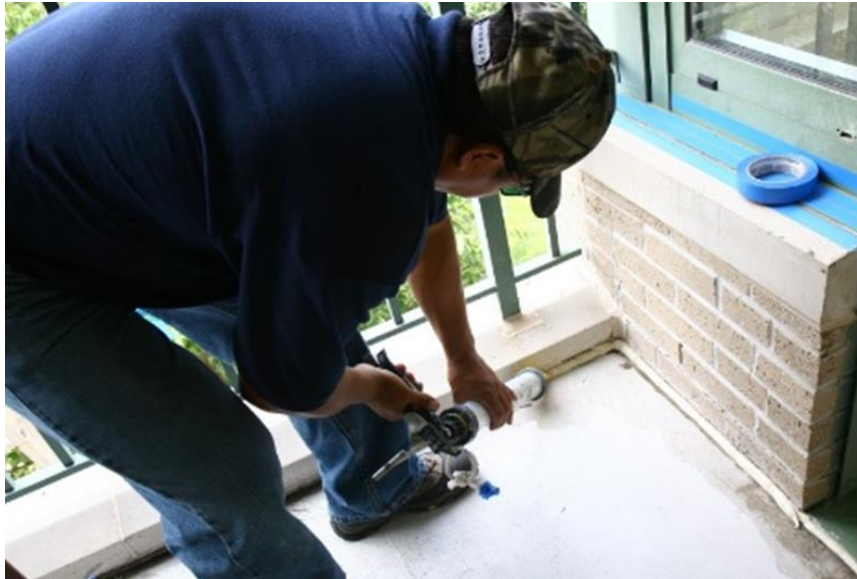
Joint Sealant Replacement

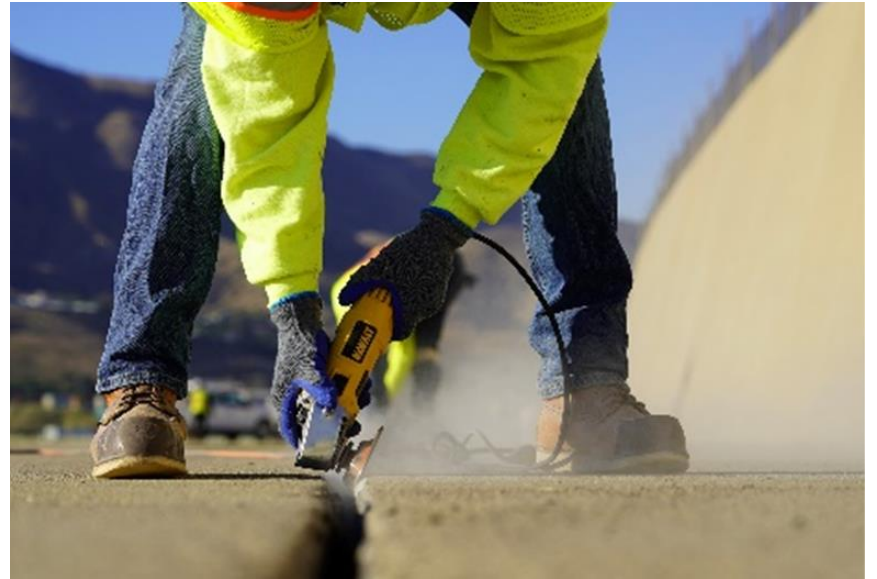
Preparing Joints for Sealing

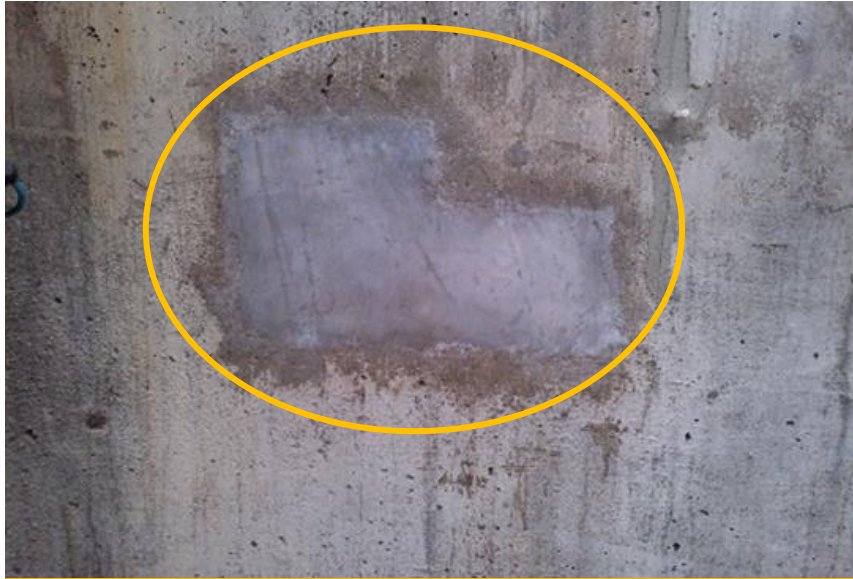
Concrete Spall Repair

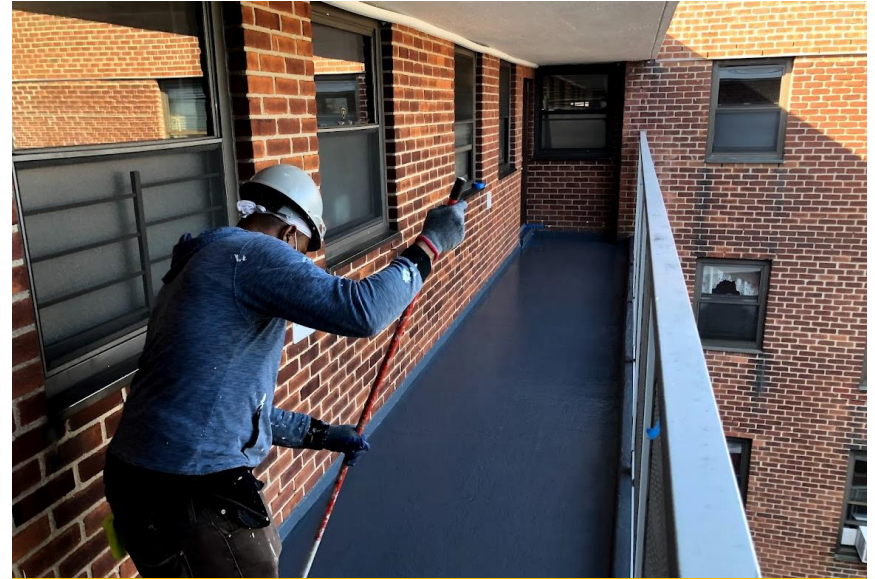
Waterproofing Replacement

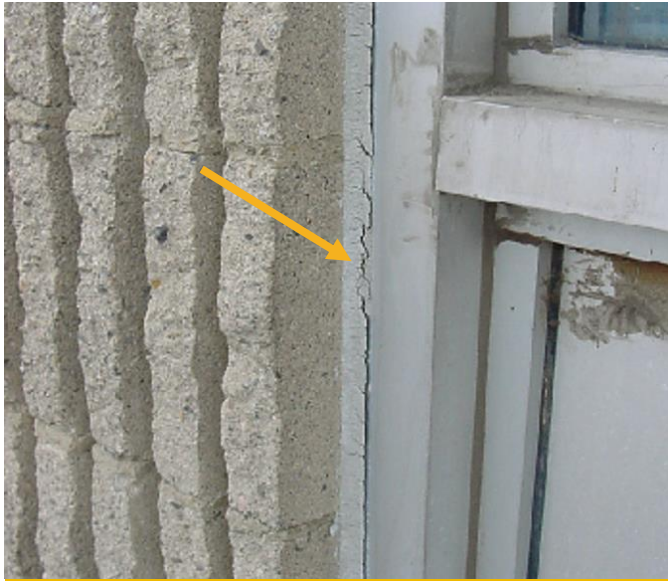
Adhesive Failure in Window Joint

- Joint Sealant Issues
 - Remove and replace sealant
- Waterproofing/Flashing Failure
 - Remove existing coating or flashing
 - Use appropriate primer and waterproofing membrane
- Improper Material Selection
 - Ensure products that are installed are compatible
 - Ensure chemistry of products is suitable for application
 - Remove and replace with appropriate products

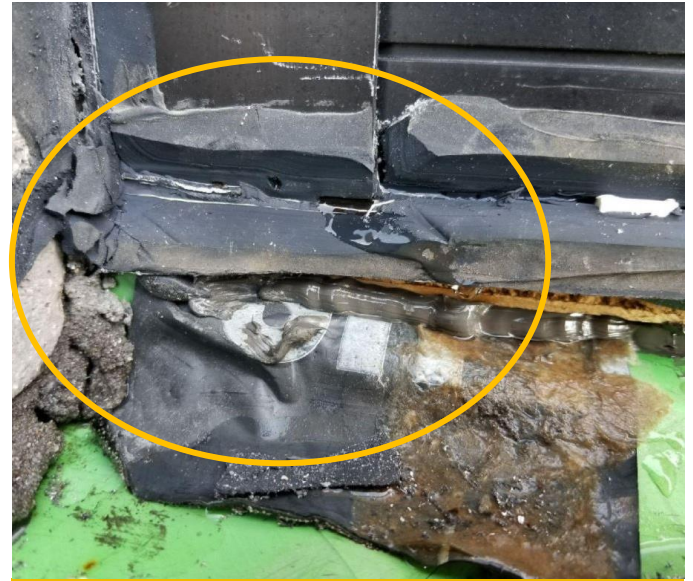
Window Flashing Failure

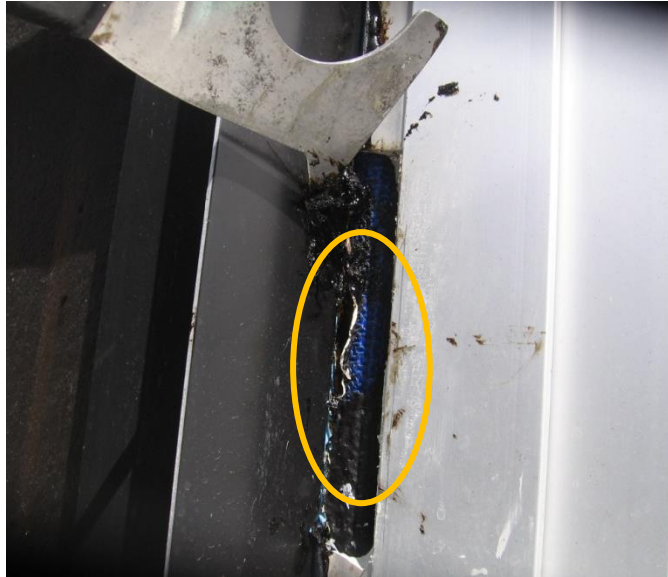
Incompatible materials

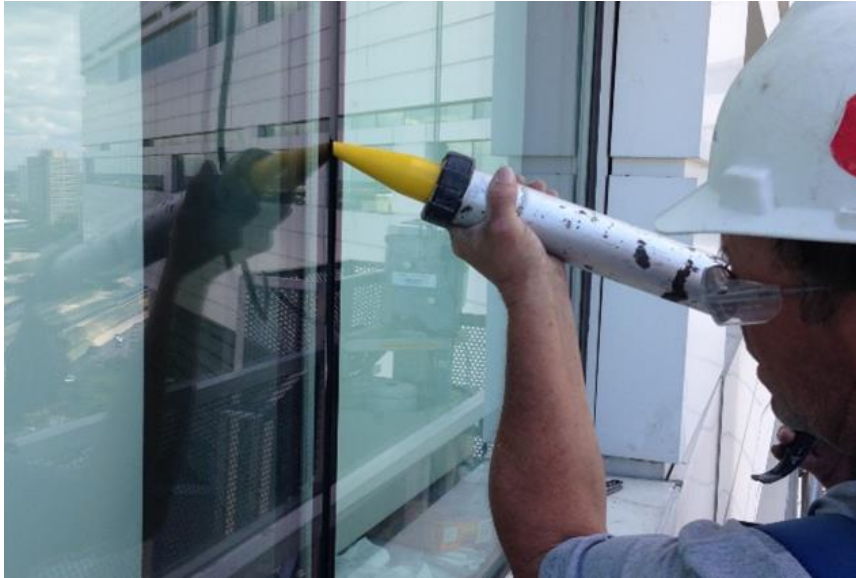
Sealant Replacement

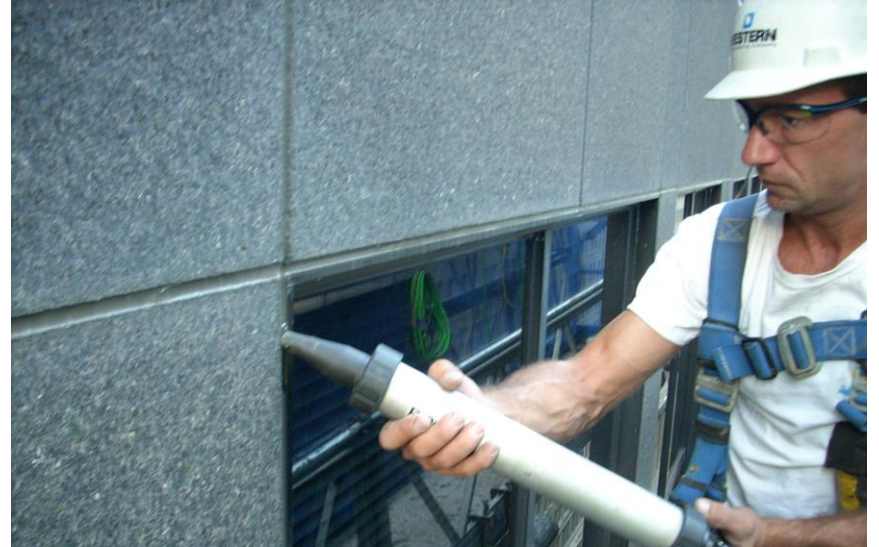
Ensure Sealant is Properly Installed

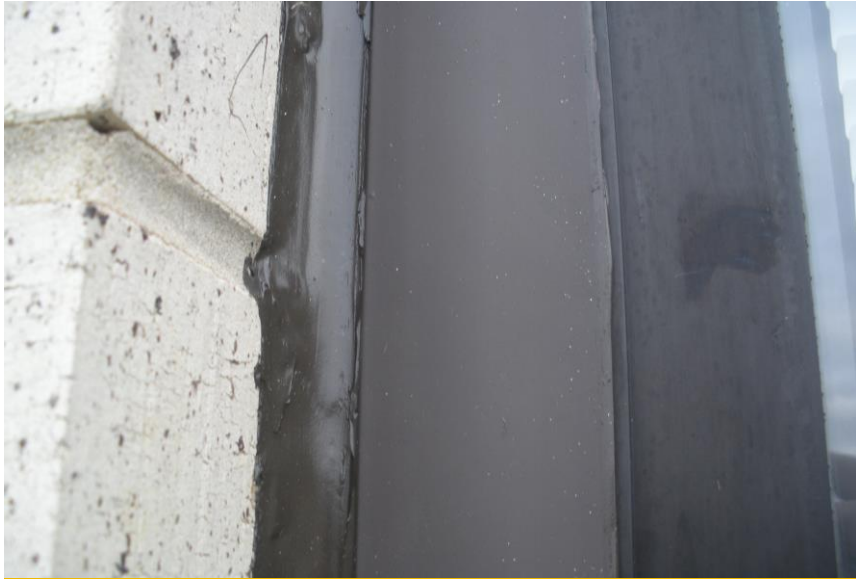
Proper Material Selection

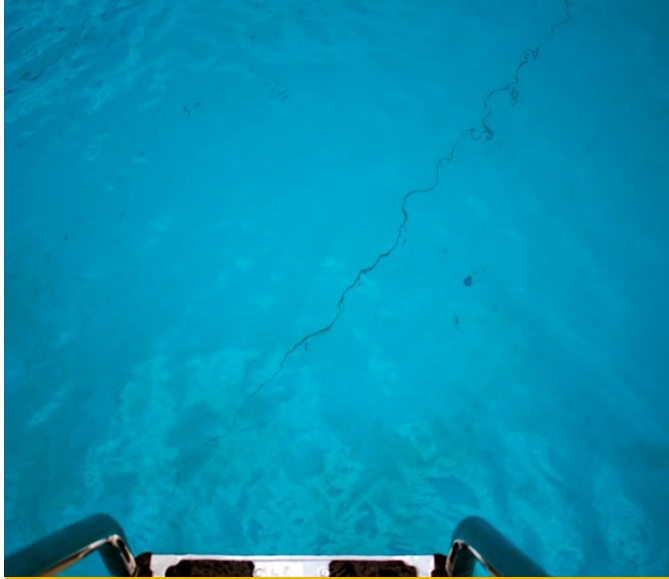
Pool Basin cracks

- Clean and remove concrete surface coating
- Repair static cracks and cold joints using epoxy injection
- Seal moving joints or cracks with flexible sealants
- Repair any honeycombs or spalls
- Apply a waterproofing topcoat
- Do a water tightness test

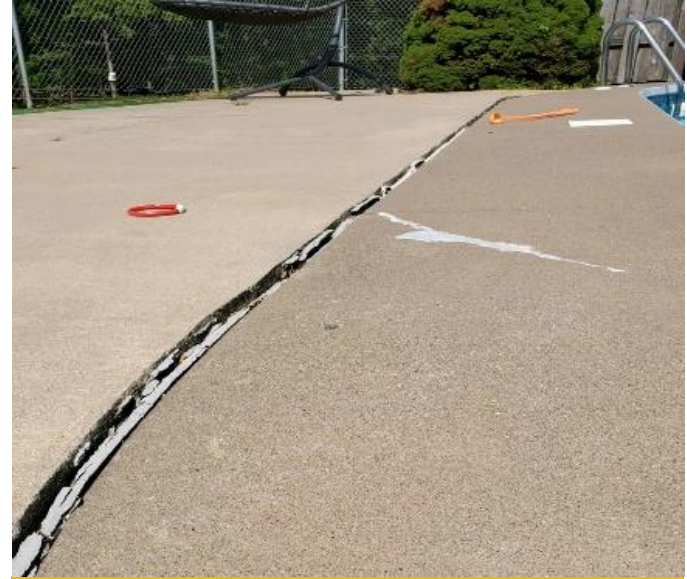
Joint Material Deterioration

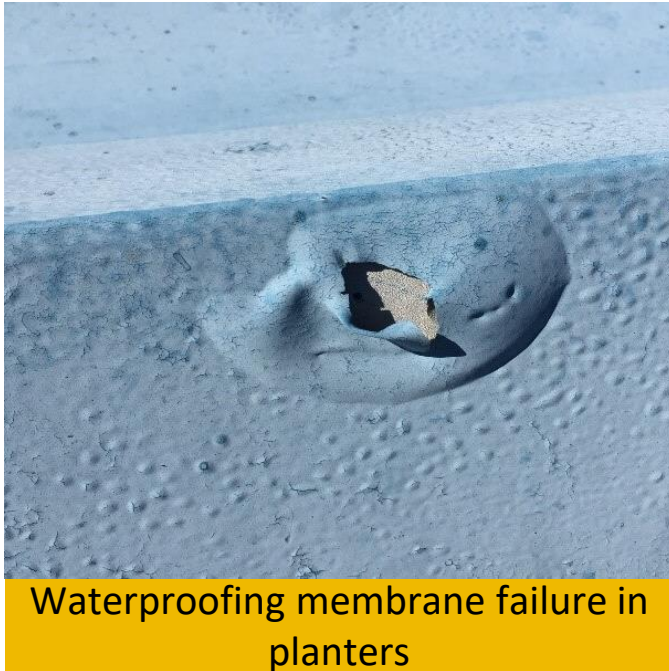
Waterproofing membrane failure in planters

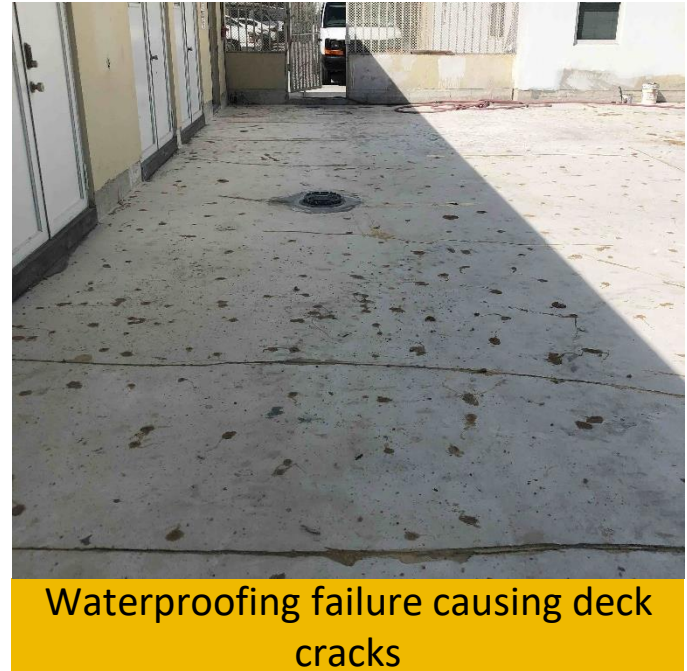
Waterproofing failure causing deck cracks

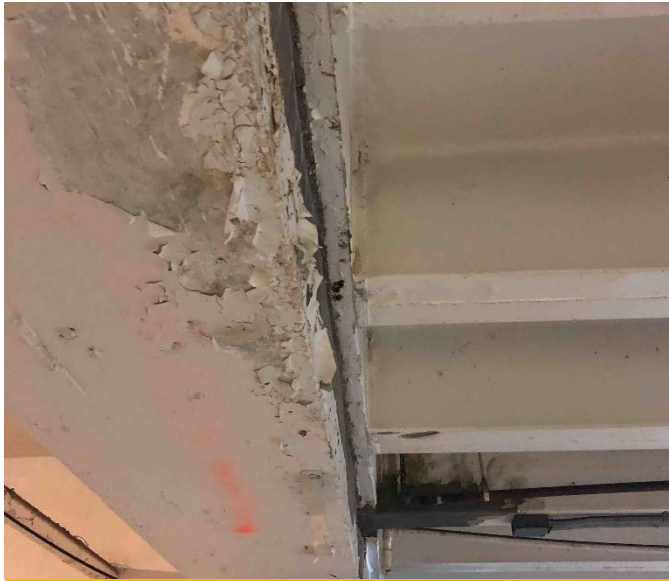
Water intrusion below pool deck

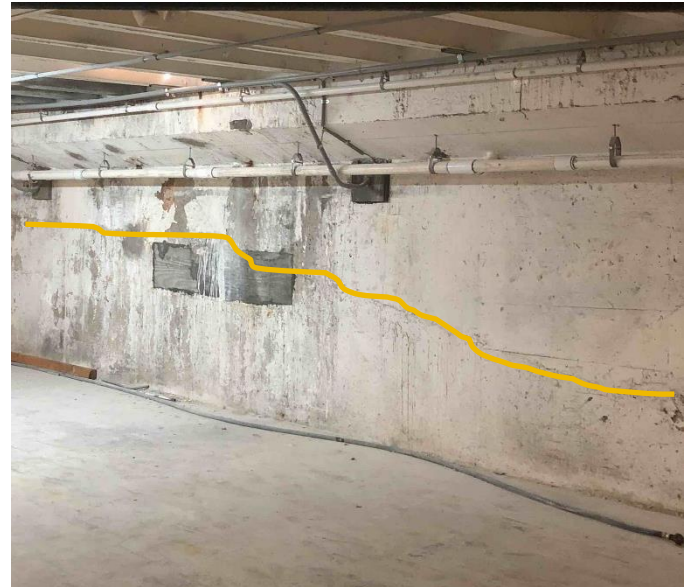
Pool vault wall cracking

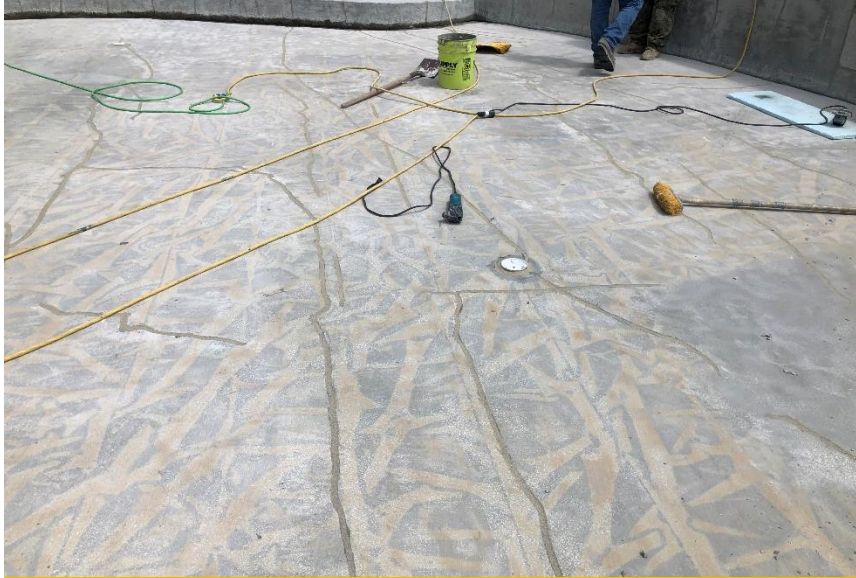
Crack Sealing Inside Pool Basin

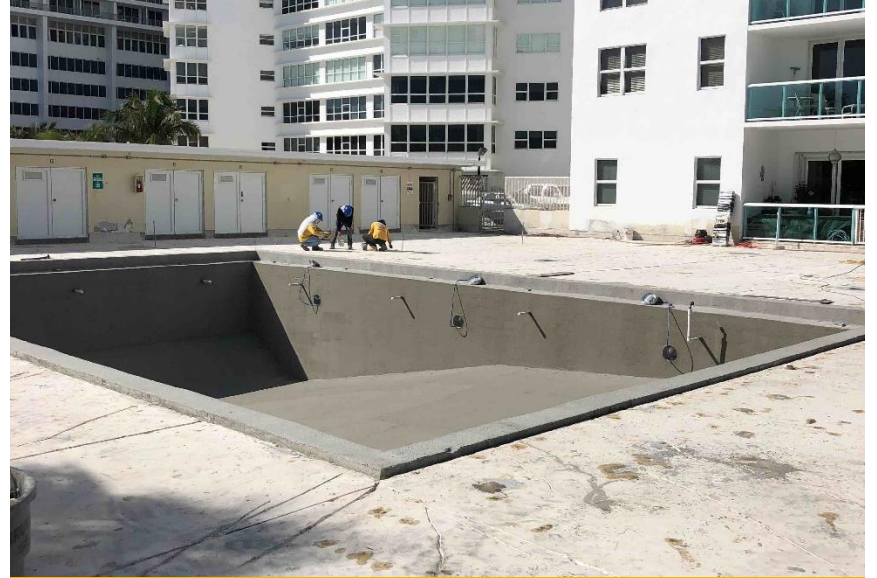
Waterproofing of Pool Basin

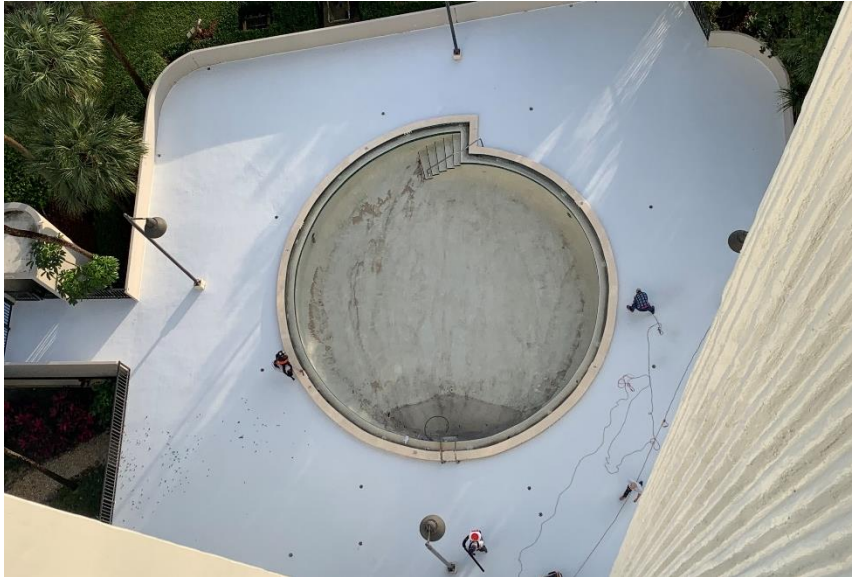
Application of Waterproofing Membrane on Pool Deck

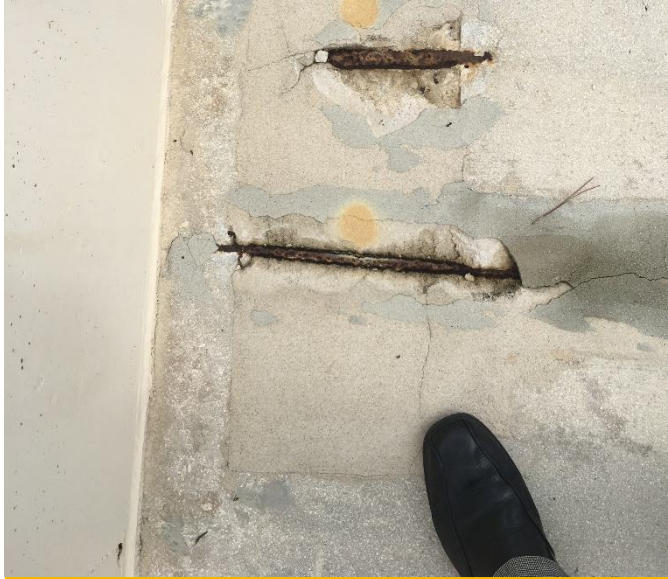
Parking Deck Spalling

- Accurate survey & investigation by an experienced engineer
- Proper repair material selection
- Repair and protect approach
 - Remove and replace unsound concrete
 - Clean and coat exposed steel reinforcement
- Apply proper patching material
 - Cracks: rout and seal
 - Replace joint material
 - Waterproof/protect decks via coatings
- Monitor overall health

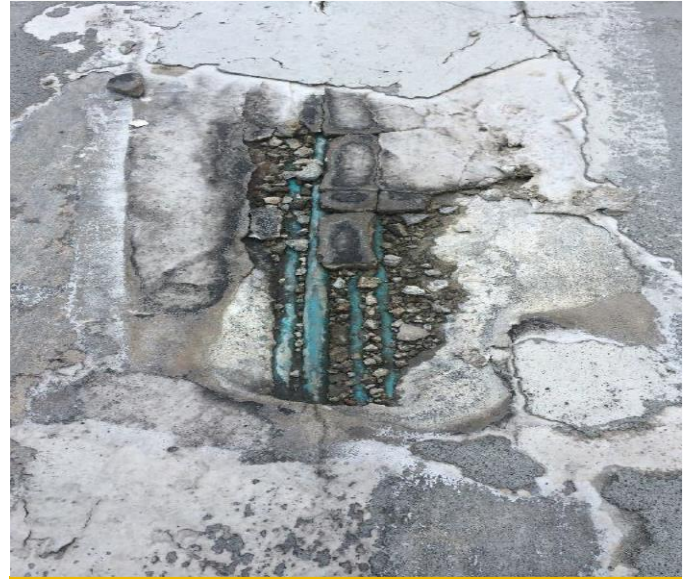
PT Exposure Due to Low Cover

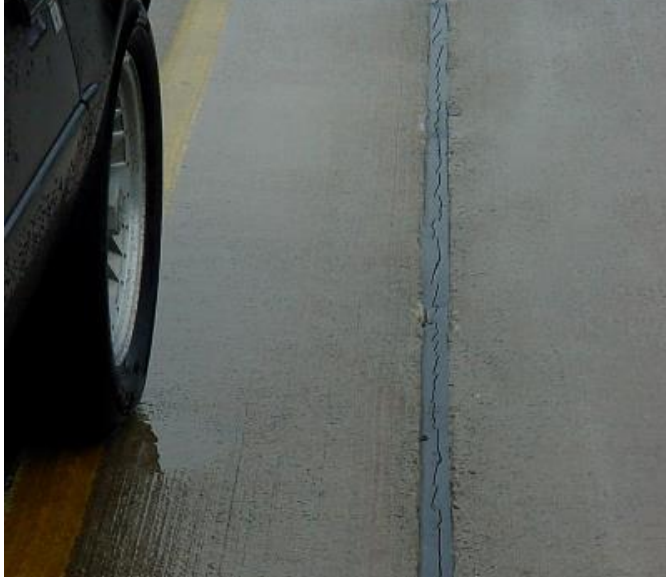
Failing Joint Sealant

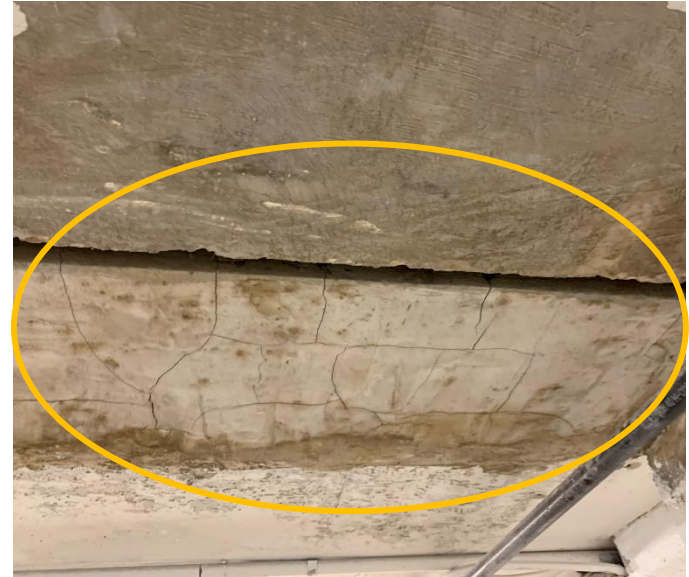
Garage Soffit Damage Under
Expansion Joint

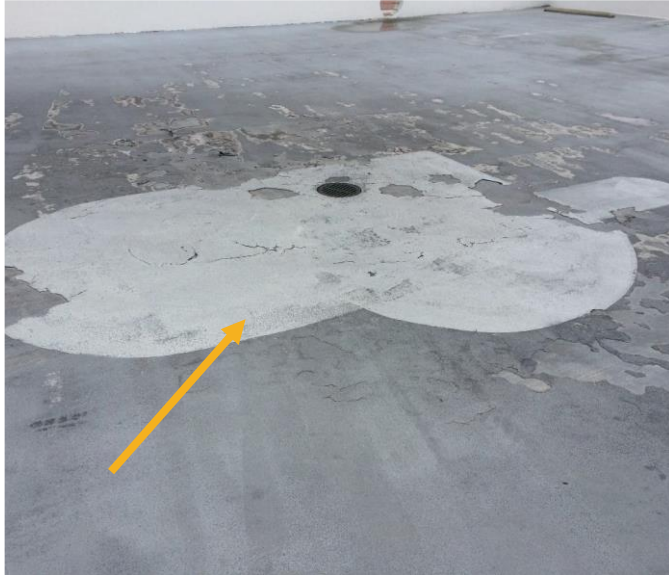
Failed Deck Coating

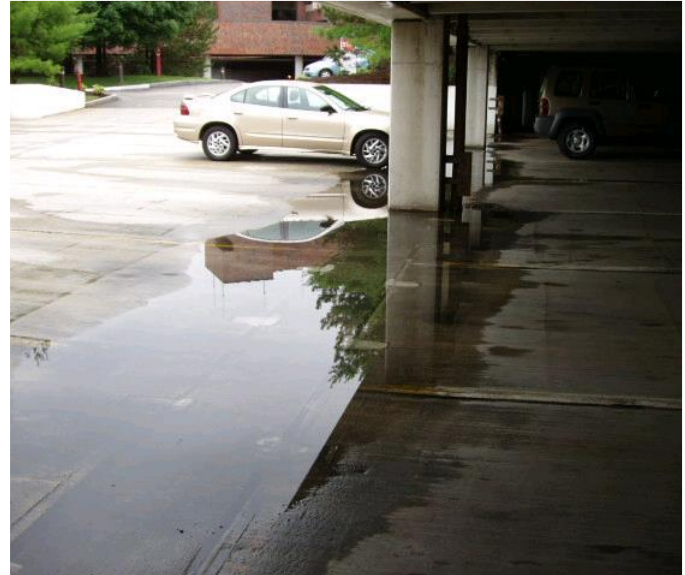
Poor Drainage/Clogged Drains

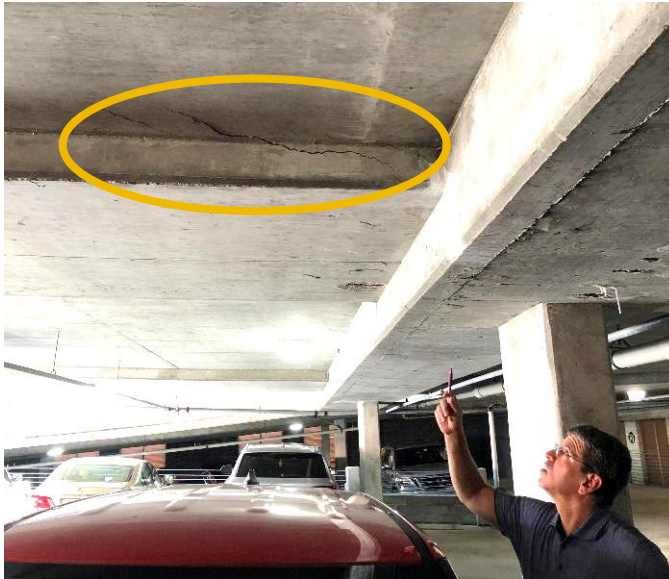
PT Slab Cracking

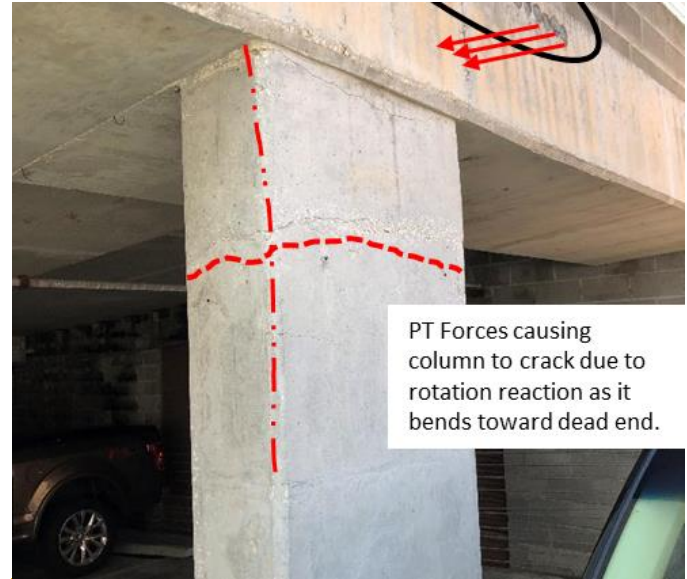
PT Forces causing column to crack due to rotation reaction as it bends toward dead end.

Column Damage due to Dead End
PT Failure

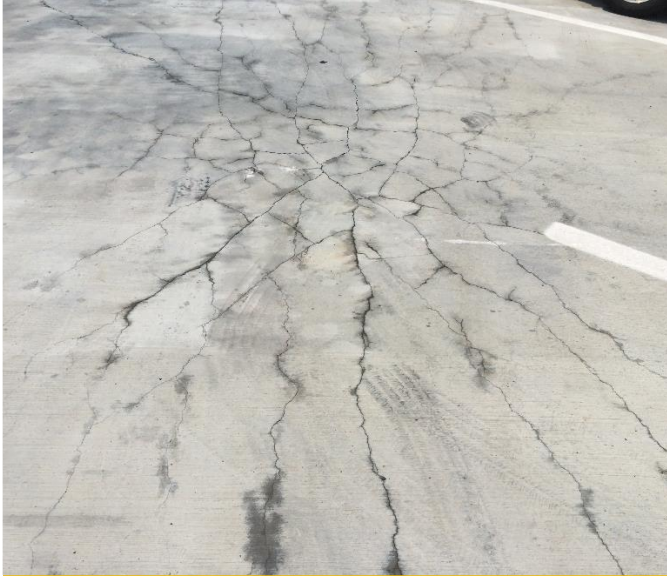
Punching Shear Cracks

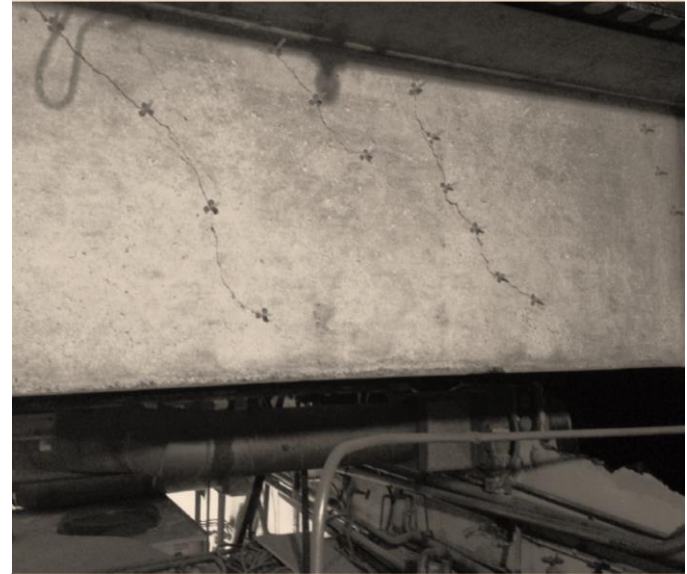
Beam shear Cracks

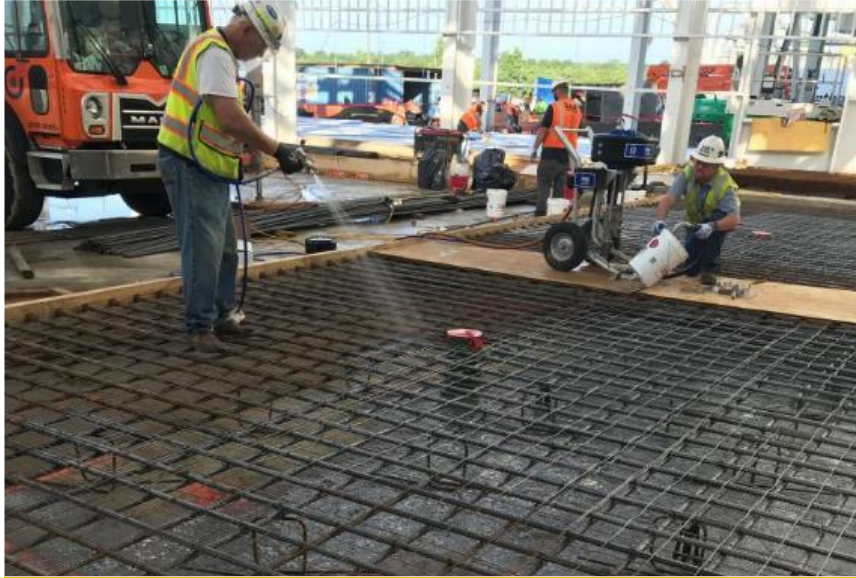
Clean Rust and Treat Exposed Rebar

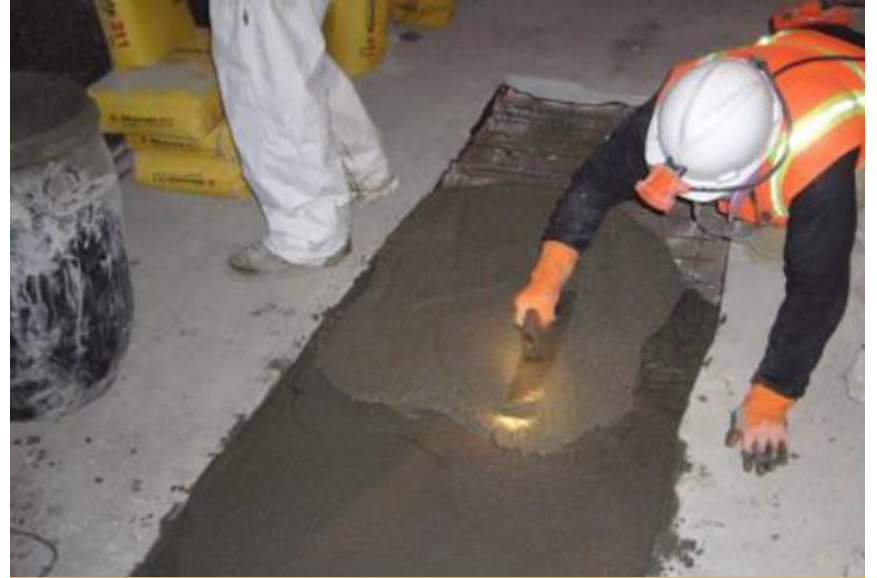
Repair Spalls

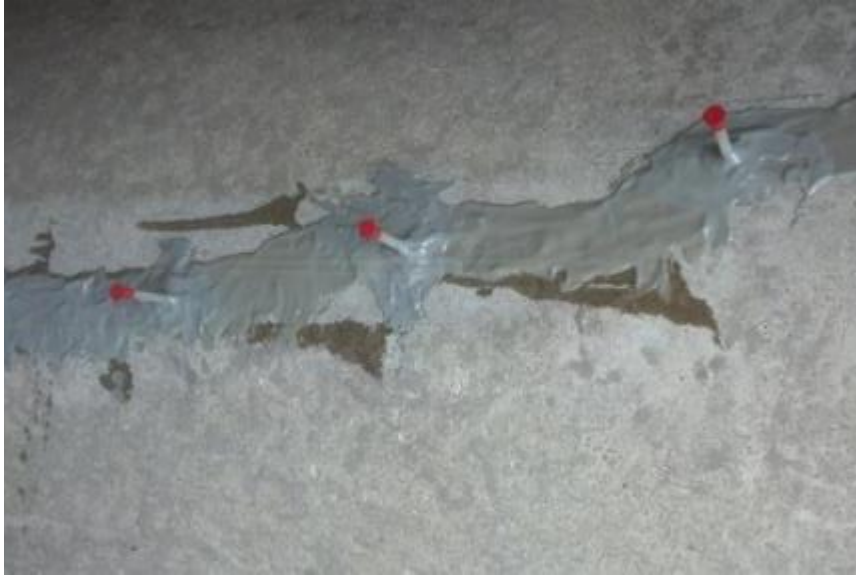
Inject Cracks with Epoxy

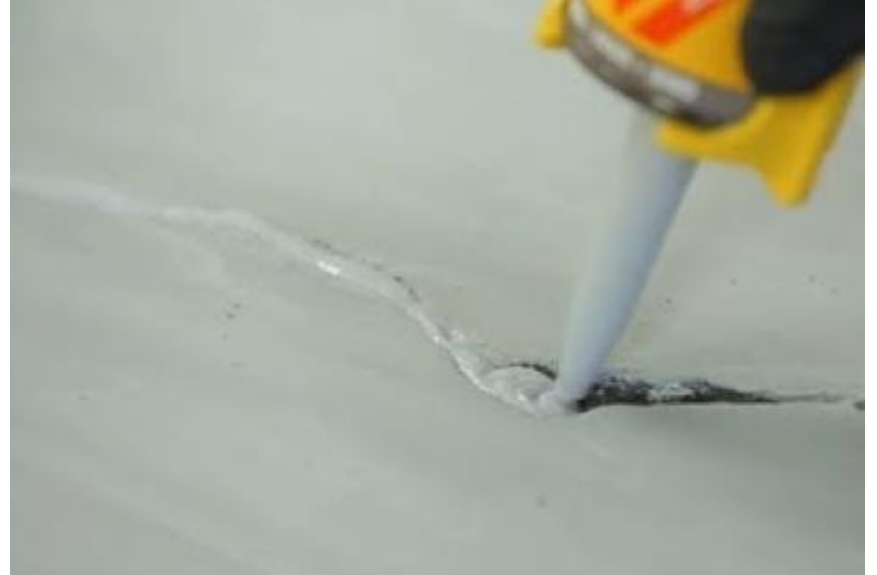
Rout and Seal Surface Cracks

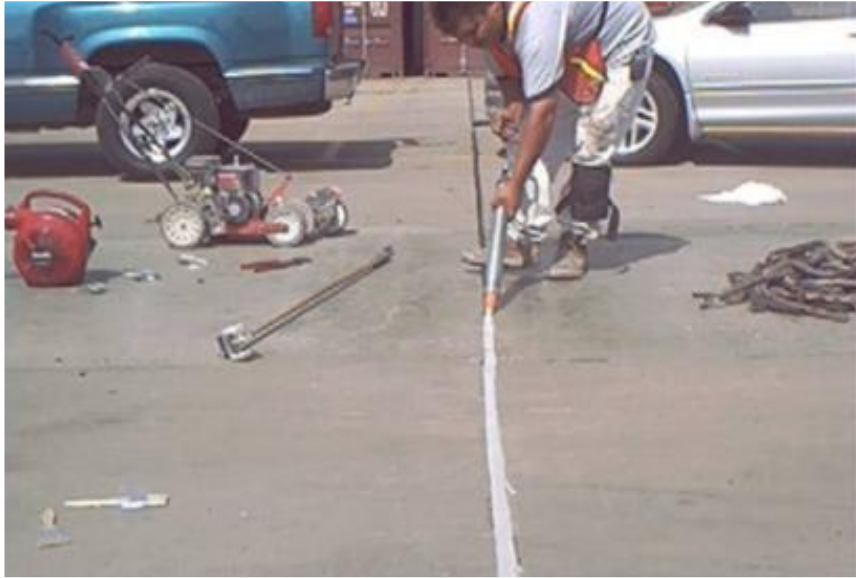
Replace Deteriorated Joint Material

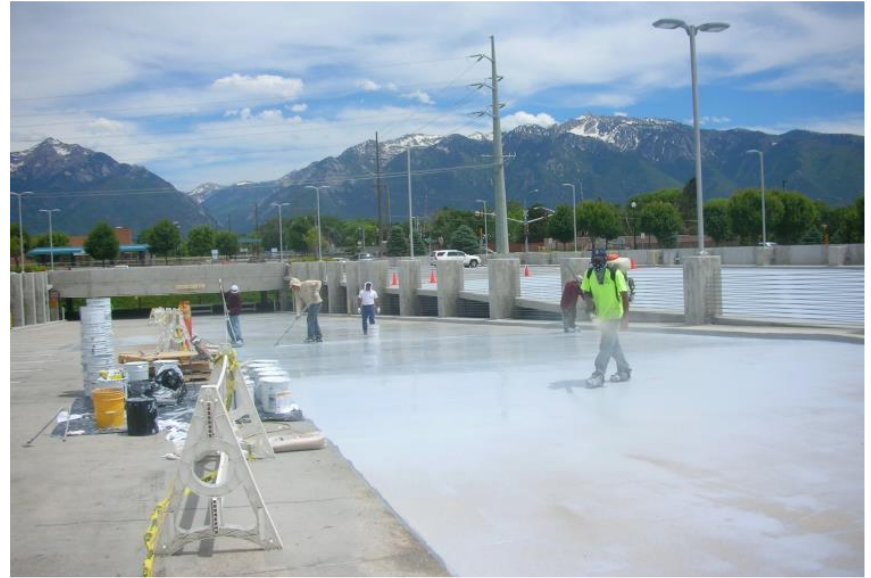
Replace Deck Coating

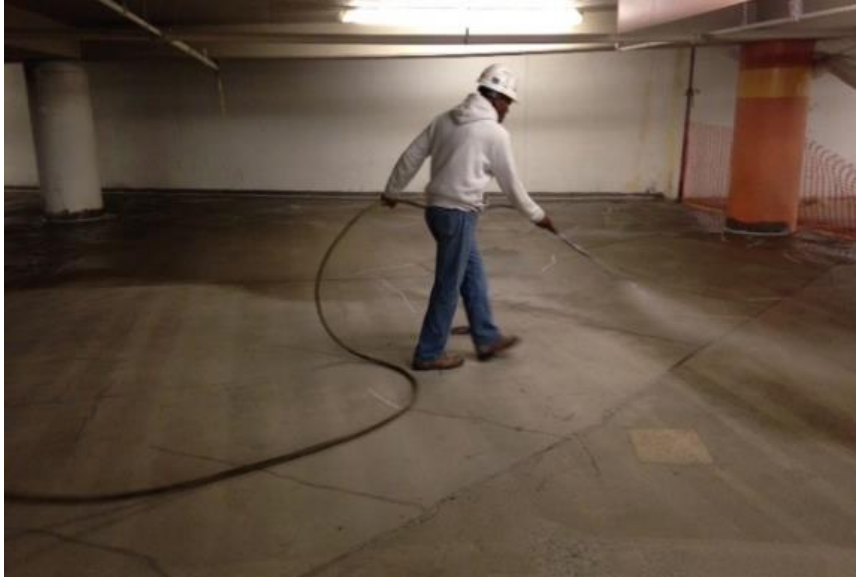
Surface Applied Corrosion Inhibitor

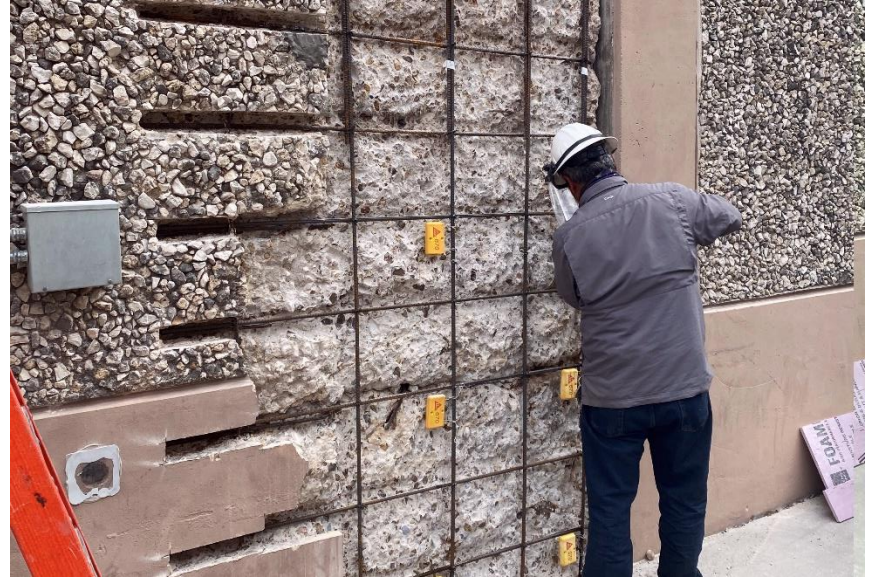
Galvanic Anodes

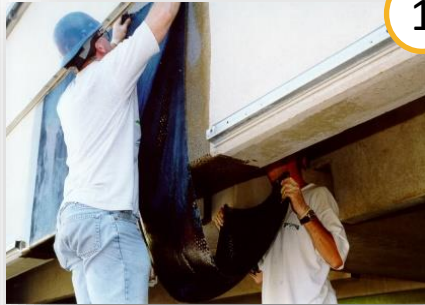
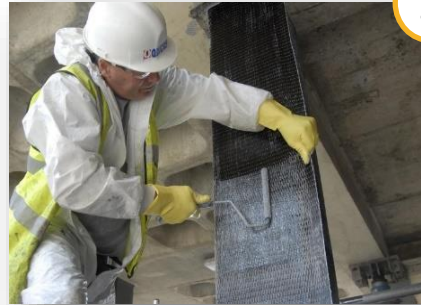
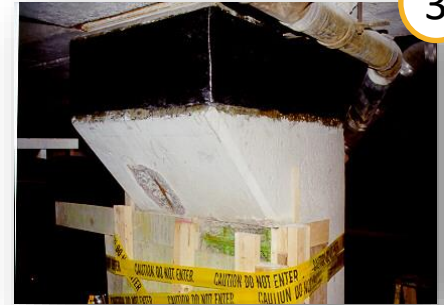
STRUCTURAL STRENGTHENING USING CARBON FIBER

- Strengthen beam, slabs, and columns
- Corbel Upgrades
- Corrosion deteriorated structures
