Project Profile

Hallmark Resort
Newport, OR

Décor Roof System, Adhered,
using lead grey, 60 mil G410
Feltback membrane

Sika Sarnafil Décor Roof System Keeps Oregon Resort "INN" Business

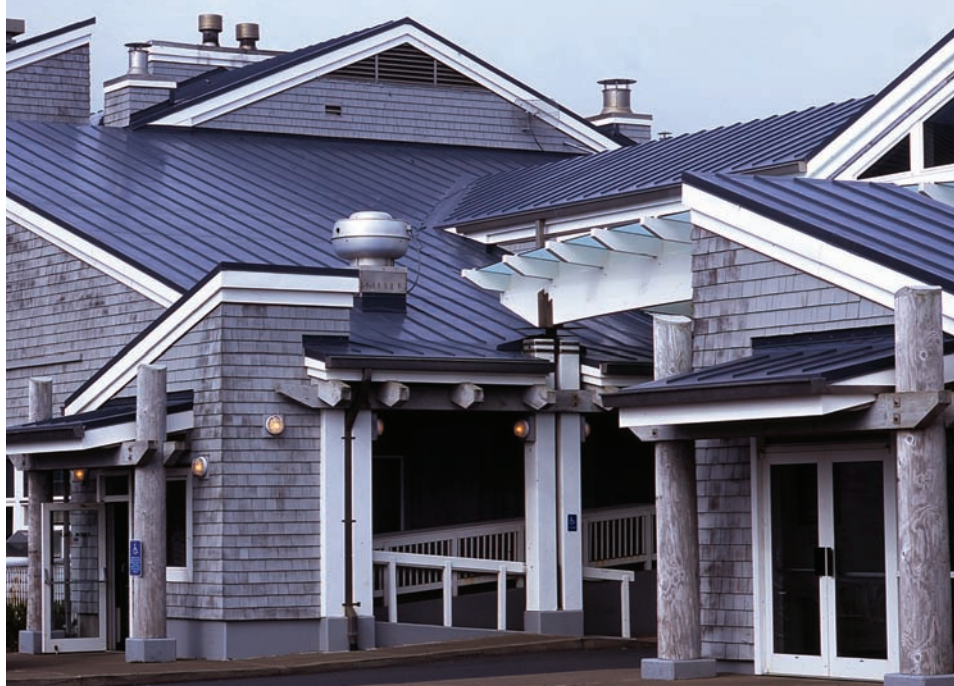
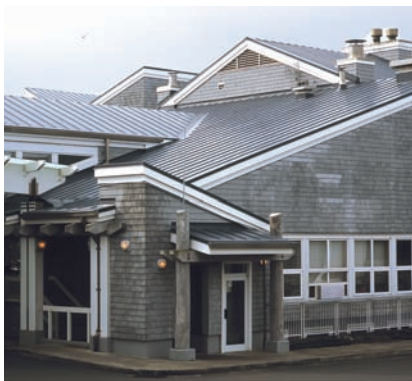
The Hallmark Resort was a challenging roofing job, due to a variety of slopes and drop-offs. An outbreak of rain made the membrane somewhat slippery, as well, which prompted Umpqua Roofing to make safety even more of a priority.

Umpqua Roofing Company, Inc. of Eugene, Oregon was chosen to install the Décor System on the Hallmark Resort — a sometimes daunting and challenging project. "This was a very scary job, due to the different slopes and drop-offs of the roof," Bob Tidrick, president of Umpqua Roofing stated. "Some of these roofs had 3 and 12 inch pitches. The membrane can be slippery when it's wet, so safety was very important. Especially since we did this job in the fall and early winter, which is the rainy season here."
