Project Profile

DSC Logistics Warehouse
Colonial Heights, VA

Emergency Re-Roof Needed

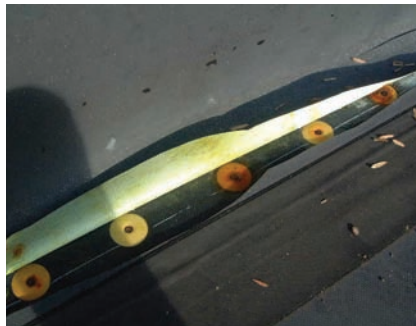
After only six years, the steel fasteners used to secure the former TPO membrane were rusted due to water infiltration through thousands of tiny pin holes that had been developed.

Extensive repairs had already been made on the roof system, but the building's leakage problems continued. The six-year-old TPO roof membrane experienced advanced oxidation and loss of thickness of the exposed membrane surface to the point that pin holes appeared around the reinforcement scrim.

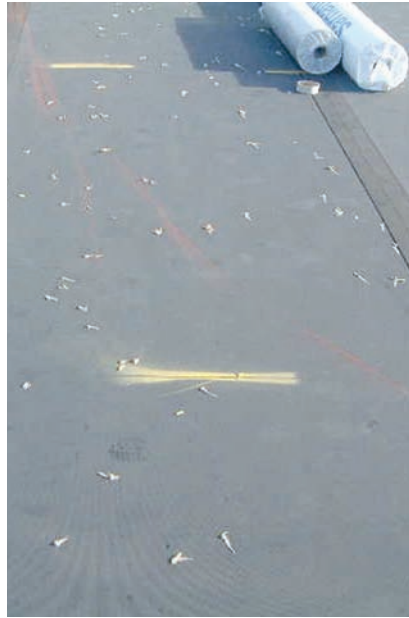
Advanced oxidation and loss of thickness of the exposed TPO membrane surface caused thousands of tiny pin holes to appear around the reinforcement scrim. To speed the installation process, grey caulking was used to cover many of the pin holes before the Sarnafil membrane was installed. The yellow lines were used to mark areas of the TPO that were leaking.
