CASE STUDY

POINT ARENA LIGHTHOUSE

Owner: Point Arena Lighthouse keeper, Inc., Point Arena, CA.

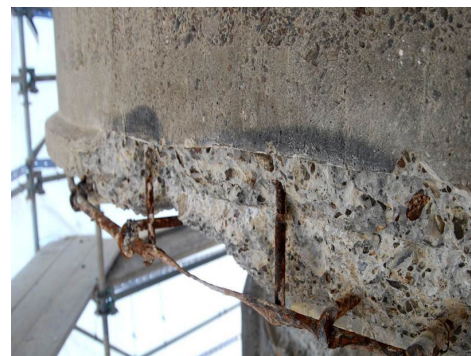
In 2005, portions of the lighthouse were closed to the public because sections of the concrete and the corbel supporting the balcony were falling to the ground from corrosion and water intrusion. The harsh marine environment was a major contributor to the acceleration of concrete degradation. Another contributor to water intrusion and concrete failure was inadequate waterproofing and poor slope-to-the-exterior architecture of the tower gallery and observation deck. Over the years of exposure to the marine environment, chlorides had accumulated near the concrete surface due to the wet environment causing a wetting and drying effect. A concentration of chlorides diffused toward the reinforcement steel causing corrosion and delamination in the concrete cover. The great majority of spalled concrete was not much deeper than the rebar. In some areas there was total loss of original reinforcement steel. Approximately 200 feet of new steel reinforcement was corroded beyond acceptable limits and was required to be replaced.

Concrete cornice with delaminated concrete

The main goal of the project was the preservation of the lighthouse and protection from future harm. A cementitious, anti-corrosion coating, Sika® Armatec® 110, was applied to the existing and new steel reinforcement. Sika® Galvashield® XP+ cathodic protection anodes were connected at key locations for large spalls and random areas based on square foot coverage. The repair areas were formed and a two-component, polymer-modified mortar, SikaTop® 123+, was trowel applied over the repair area. A polymer-modified, cementitious resurfacing compound, SikaTop® 121+, was also trowel applied over the entire face of the tower to fill small pores to prohibit water intrusion. A low pressure sprayer was used to topically apply a surface penetrating, corrosion inhibiting coating, Sika® FerroGard® 903, over the entire structure in order to inhibit corrosion caused by chlorides and carbon dioxide.. This was applied at the end of the first phase which protected the exposed concrete until it was scheduled to be parged at the beginning of the second phase of the project. For the second phase, the SikaTop® 123+ structural resurfacing compound was once again trowel applied over the entire face of the tower. All surfaces of the tower were then primed with a one component, penetrating, adhesion promoter, Sikagard® 552W, specific for priming concrete and other masonry surfaces prior to the application of acrylic emulsion coatings. Sikagard® 550W Elastocolor, an elastomeric, crack-bridging, anti-carbonation, acrylic protective coating, was applied for protection of aggressive gas ingress. This coating also enhanced the aesthetic appearance of the structure while having both UV resistance and water vapor permeability.

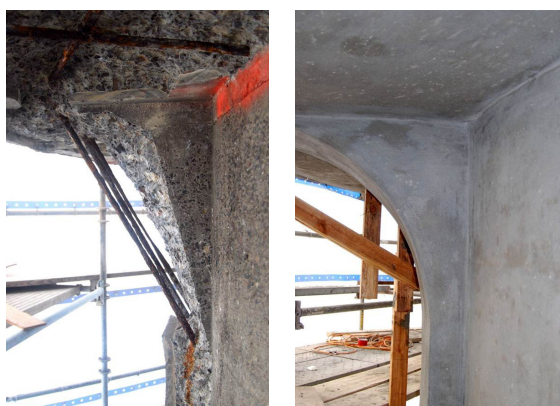
A cornice support before and after protective coating applied
