Project Profile

AT&T Tennessee
Headquarters Building
Nashville, Tennessee

Adhered EnergySmart® Roof
using with white 60 mil Sarnafil®
G410 membrane

Sika Sarnafil Fills Superhero Needs on 'Batman' Building

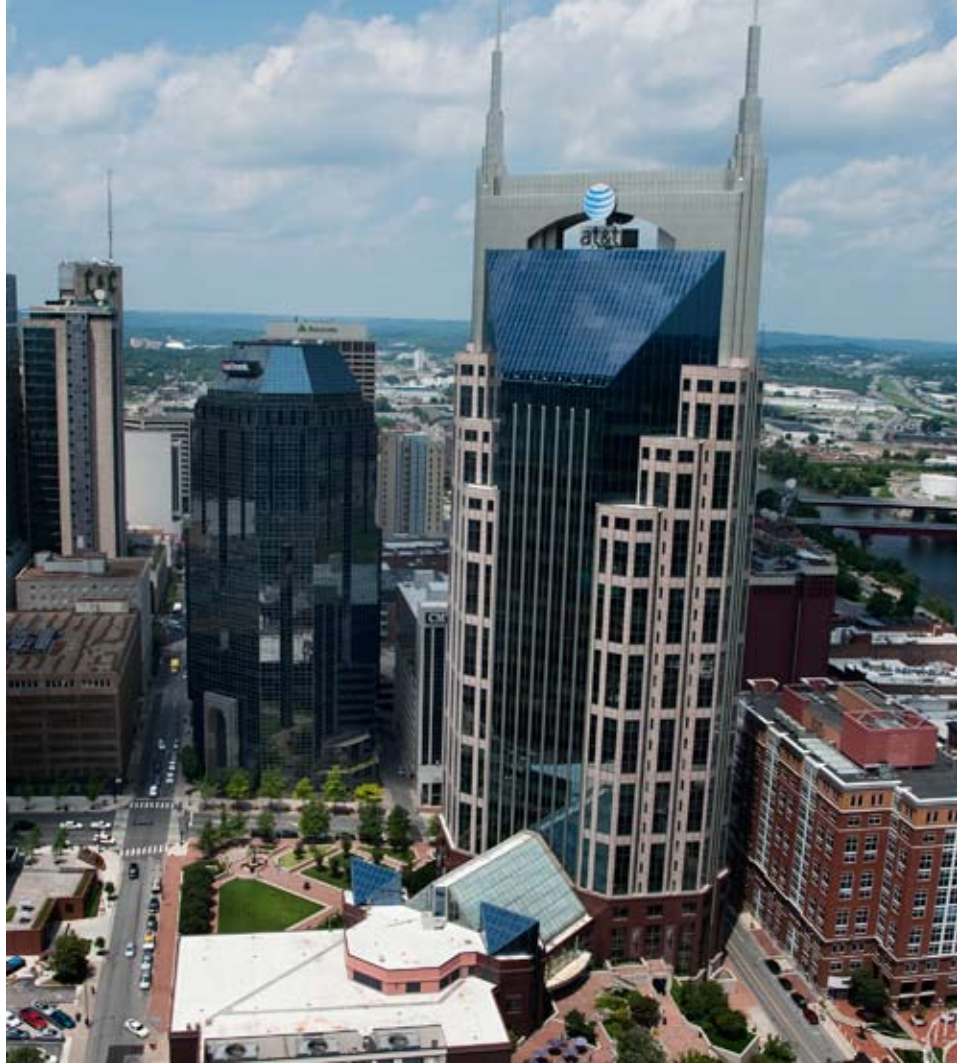
The TBM crew worked hard even away from the roof areas. "We used rain days to precut the membrane and insulation in the loading dock areas, as well as to haul material around from the attic or to the dumpsters," Fetty explained. Some creative problem-solving was done off-site as well. "We had one 44 square foot roof area that had 131 projections, and the contract manager

required that all work be completed 100 percent each day," Fetty stated. "So we constructed steel models of the projections and shop-fabricated the membrane flashings to them, which enhanced production, quality and field installation."

Hinesley mentioned that the use of clad metals helped to simplify flashing of the numerous odd transitions and penetrations throughout this roof.
