Project Profile

Veterans Memorial Coliseum
Madison, Wisconsin

Adhered EnergySmart Roof®
using 80 mil Sarnafil® G410
membrane

Sika Sarnafil Breaks the Ice on Coliseum Roof

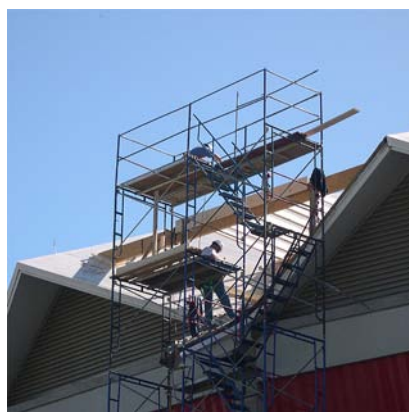
Installation of the new roof was very challenging, due to the "intimidating" steep slopes, Walsdorf said. To keep the workers safe, each Walsdorf Roofing crew member was tied off and a special railing system was installed at the lower edge of the valleys as a secondary fall protection system. Materials and tools were brought up to the top of the roof using what Culliton referred to as an "ingenious" trolley system built by Walsdorf.
