# SIKA AT WORK

## BOCAIRE COUNTRY CLUB

### BOCA RATON, FLORIDA

# CORRECTING THE CLUBHOUSE

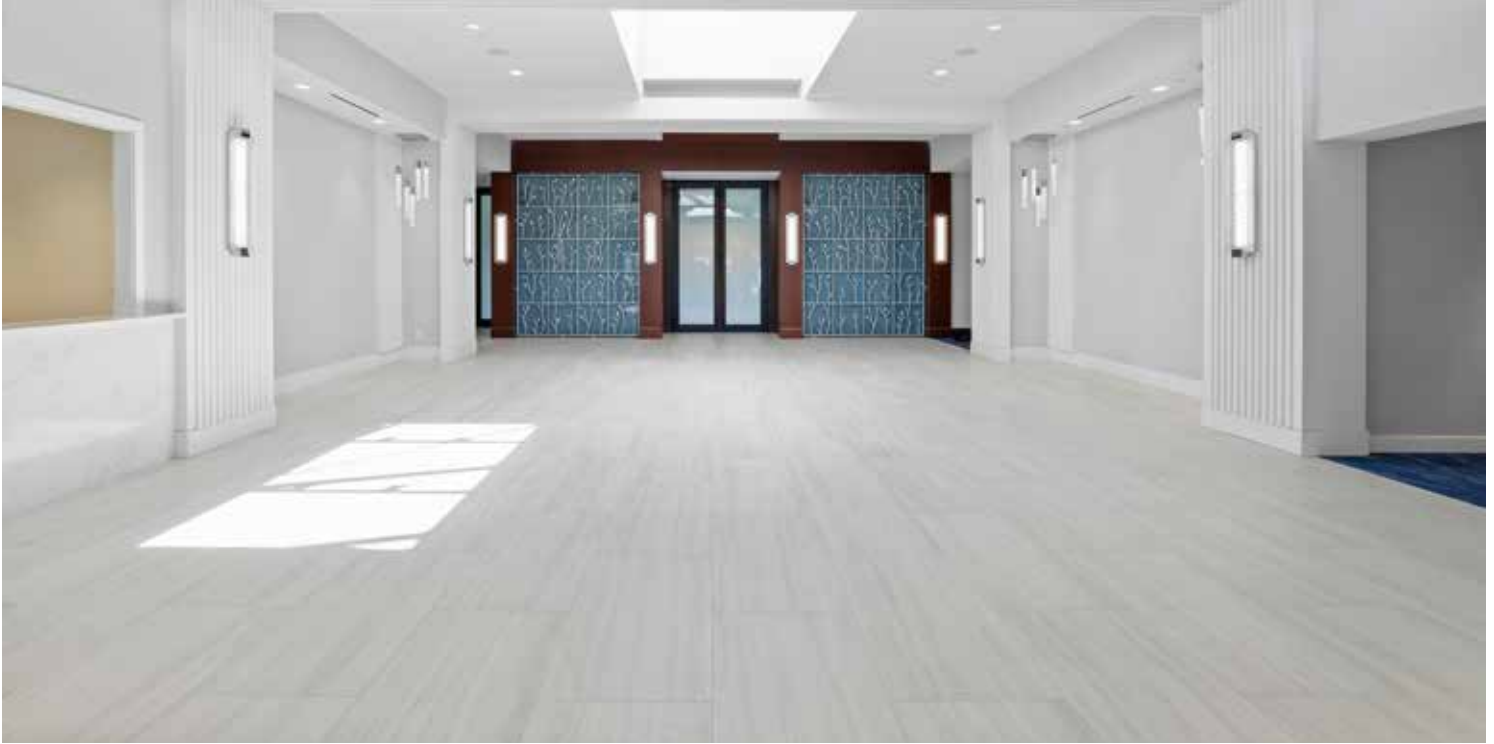
SikaTile®-200 Fracture Guard Rapid prevents cracks from damaging the new clubhouse floors.

Zaharion's crews began removing the old adhesive from the tortured, timeworn floors in June 2023. Once cleared, the crews followed up with several extensive pours of SikaLevel®-225 self-leveling underlayment to fill sunken portions of the unfinished floor and reestablish surface flatness. The leveling would make the surface suitable for the variety of tile and planks to be installed, however its impact on the installations' longevity would be limited. To protect the new surfaces from the effects of apparent subsurface movement, Zaharion's crews applied SikaTile®-200 Fracture Guard Rapid. Sika's liquid-applied crack-isolation membrane lent a flexible layer of elongation that extenuates present or eventual in-plane substrate cracks up to 1/8" wide, preventing damage from transmitting through to the installed tile.

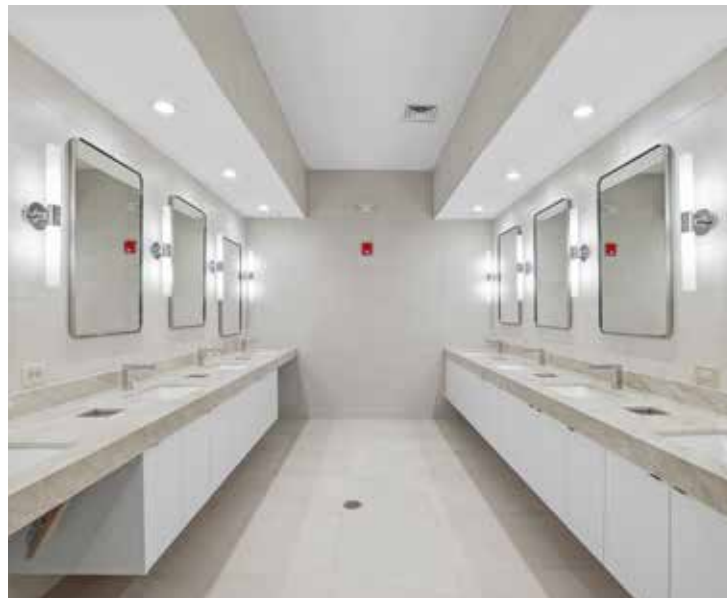
Zaharion's used SikaTile®-475 LHT Premium Set throughout the clubhouse's floors.

"SikaTile®-475 [LHT Premium Set] we used for the lobby for adhesion pur-

poses since it's a stronger thinset. That was something new that we used on this project," Zaharion said. "It's a higher-end product that people tend to overlook. We used it because it was recommended, and our installers liked it. The product was well worth it."

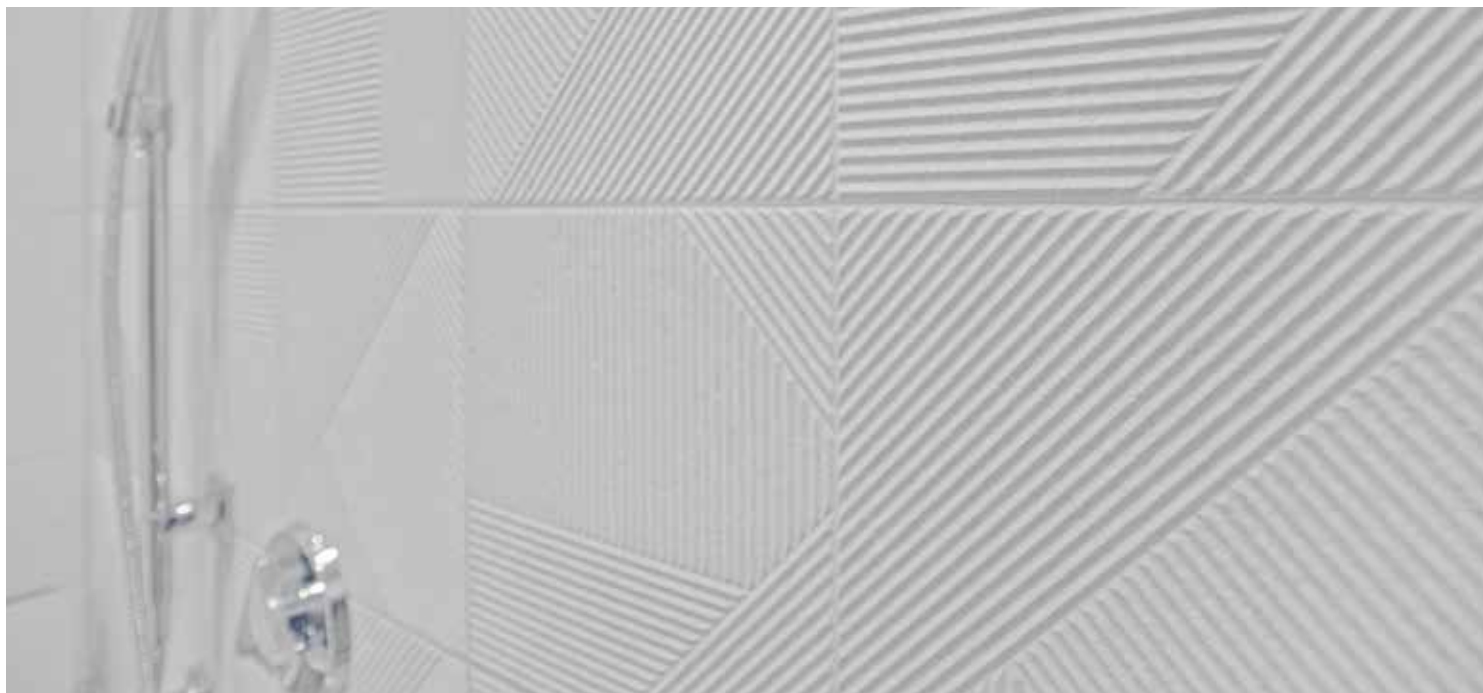
SikaTile®-500 LHT Lite bonds Kertiles Verse Concept tile in the men's locker room shower.

Zaharion was no stranger to the Sika line of construction solutions. As one of the go-to flooring installation companies for commercial properties in South Florida, Zaharion's Flooring understood the benefits derived from a full Sika solution for projects. "We used a lot of the SikaTile®-500 LHT Lite in all areas for the walls," he pointed out. The lightweight mortar's instant bond prevented the oversized tiles from sagging during installation. For the property's horizontal surfaces, the crews deployed a product they had not used before.

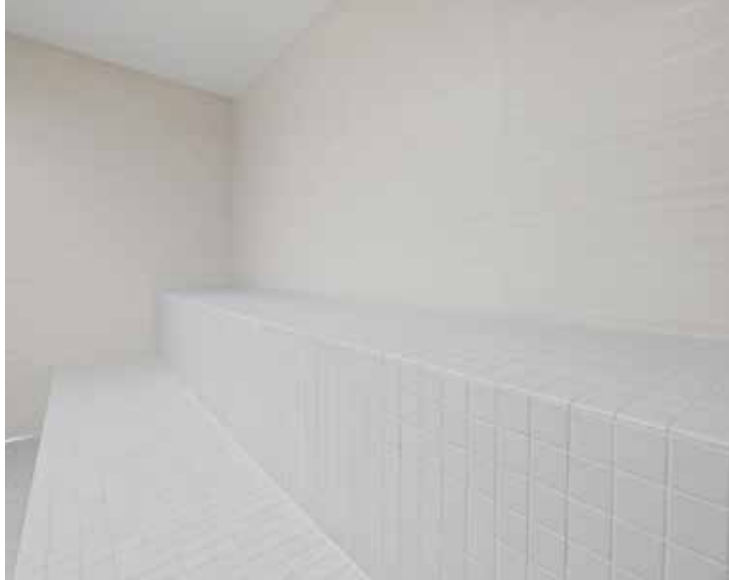
Snow White SikaTile®-825 Epoxy Grout and SikaTile®-815 Secure Grout blend with the steam room's tile. service level of its solution provider and the quality of the materials underneath," Carroll stressed. "Bryan and his team unquestionably supplied that first component, and we are proud to prescribe a system solution that addressed the Bocaire Country Club's unique conditions."

With the tile and planks installed, Zaharion's crews applied two of Sika's maintenance-free grouts to bring the hard-surfaces portion of the project to a close. High-performance SikaTile®-815 Secure Grout finished off the clubhouse's vertical surfaces with hard, efflorescence-free joints. The

floor surfaces were trusted to SikaTile®-825 Epoxy Grout for its ability to guarantee stain-resistant, color-consistent joints under punishing conditions. Together, the grouts intermingled with the finished surfaces' muted tones to grant the Bocaire Country Club's main hub a graceful, sober presence.

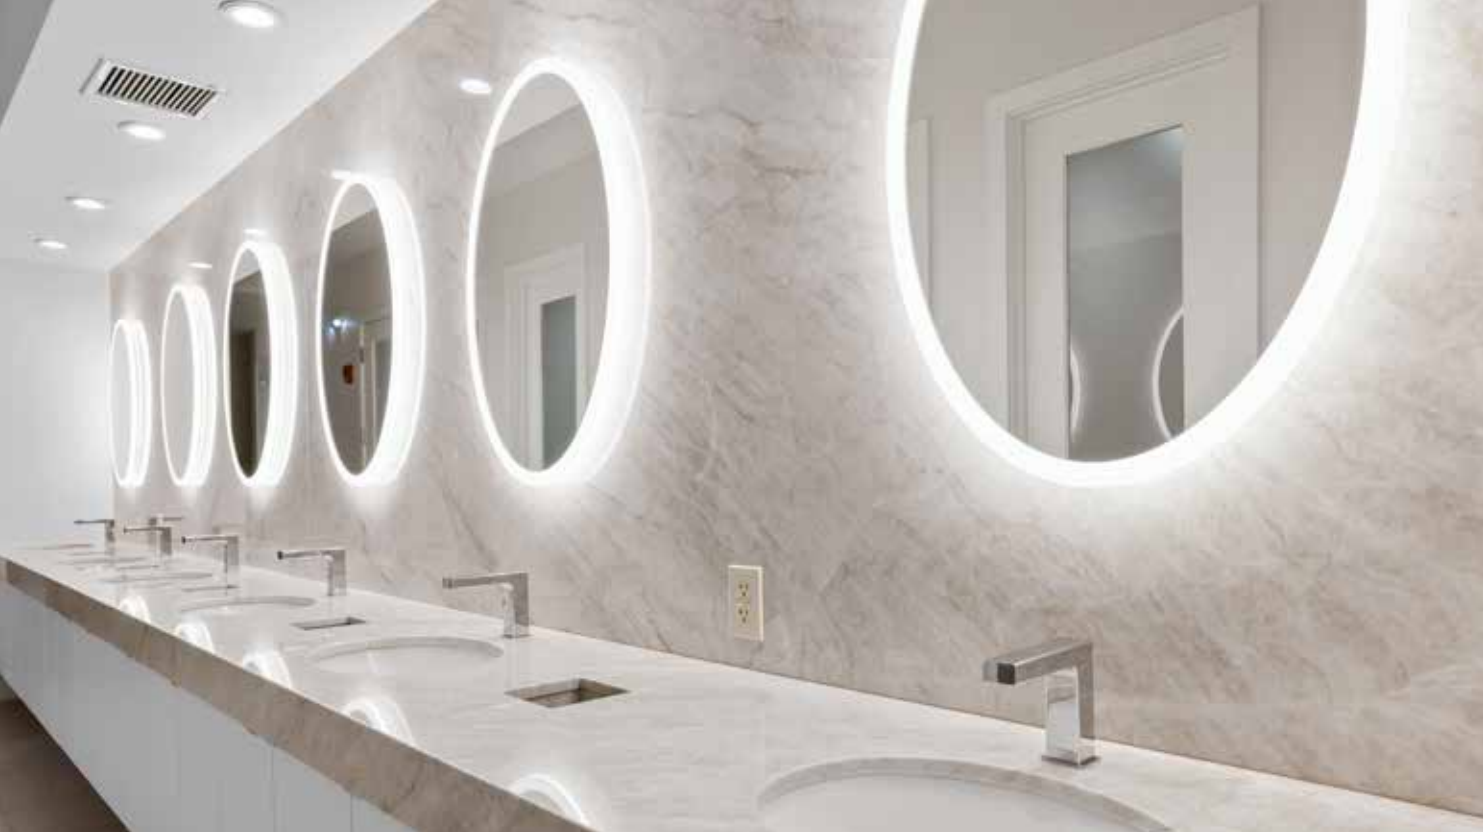
Zaharion's used SikaTile®-500 LHT Lite on the women's restroom's porcelain slabs.
