Keeping the faith

Thomson Roofing and Metal Co.
installs a PVC membrane roof
system on a Georgia temple

Project name: The Walton Way Temple Congregation Children of Israel-Reform

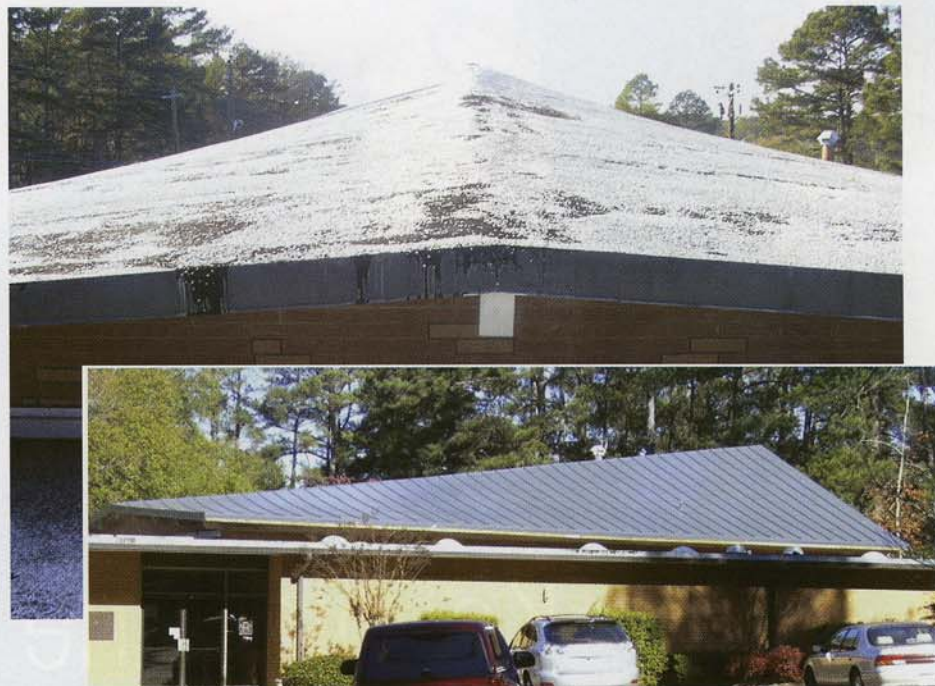
Top: The temple’s built-up roof system before the tear-off
Bottom: The new PVC membrane roof system Photos courtesy of Thomson Roofing and Metal Co., Thomson, Ga.

At the final pre-bid session, Thomson Roofing and Metal recommended a Sarnafil PVC membrane roof system that incorporated heat-welded standing-seam décor ribs. The roof system was approved.

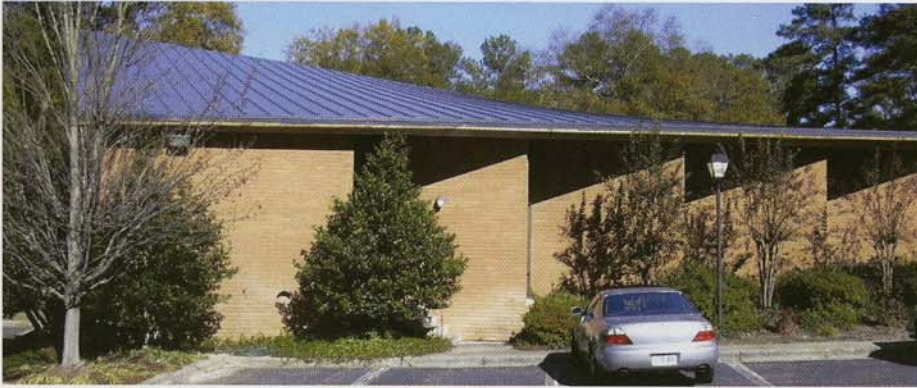
The seams on the temple project needed to lay parallel to the slope to accommodate the décor ribs.

Without the temporary roof, the tear-off, rotted wood replacement, new insulation and PVC membrane installation would have had to be done almost simultaneously to ensure the building was kept dry at all times. The temporary roof allowed the roofing crew to take the time needed to properly install the roof insulation and lay out the PVC membrane field seams. Although traditional membrane roof systems have seams installed perpendicular to roof slope, the seams on the temple project needed to lay parallel to the slope to accommodate the décor ribs.

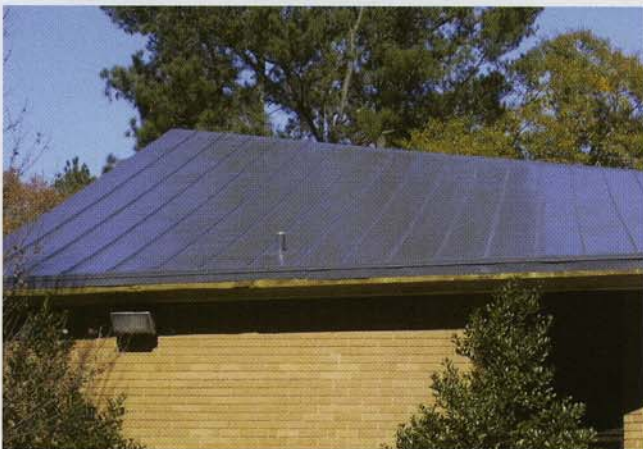
The PVC membrane roof system was chosen for its metal appearance and ability to accommodate the roof line.

The company installed a Sarnafil PVC membrane, which was 60-mil- (0.06-inch- [1.5-mm-]) thick G410 fleece-back material in lead gray. The matching heat-welded décor ribs were installed 18 inches (457 mm) on center, and two layers of 1½-inch- (38-mm-) thick polyisocyanurate insulation were mechanically attached to the deck at one fastener per 2 square feet (0.2 m²).
