# Project Profile

Munson Medical Center  
Traverse City, Michigan

Adhered EnergySmart®  
Roof using 80 mil Sarnafil®  
G410 membrane

## **Sika Sarnafil Roof System Gets Munson Medical Out of a Tight Spot**

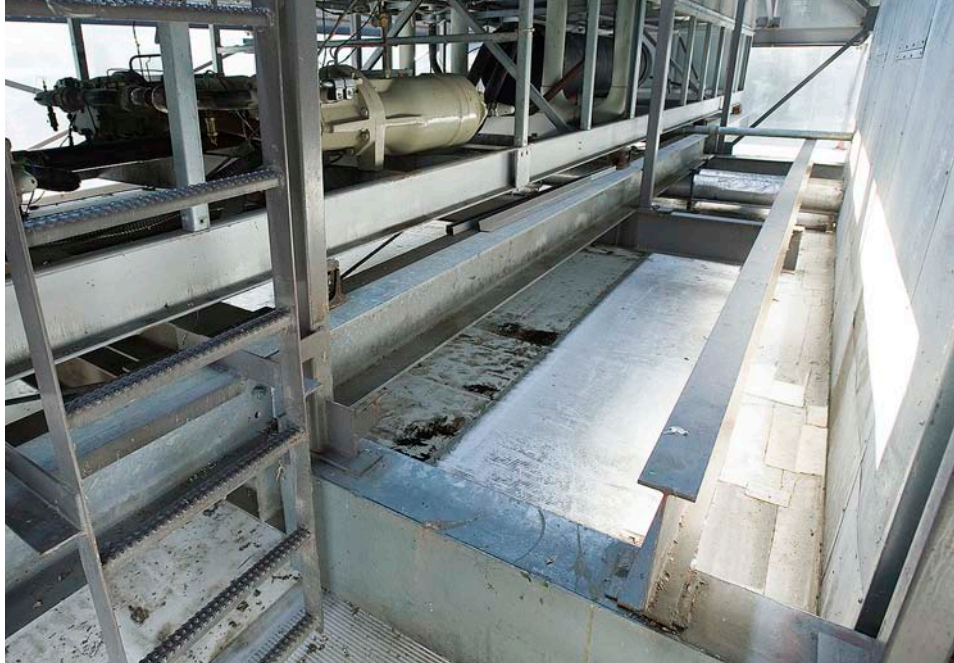
A look "inside" the massive HVAC unit suspended just above the roof at the Munson Medical Center. Bloxsum Roofing had to contend with the unit's stairways, suspended walkways and wall built for soundproofing.

Working around the HVAC unit and its associated webbing of cross members and support beams was also very difficult. "It looked like someone took an erector set and dropped it on the roof," Bloxsum stated. "At times we were working in clearance areas of only 18 inches or so, which required the crew to lie on their stomachs."

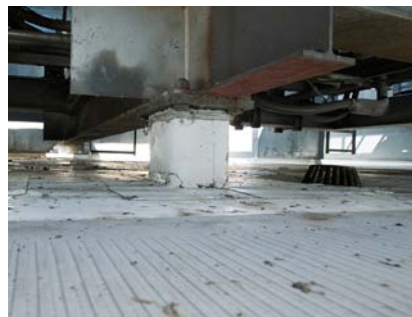
Close quarters forced Bloxsum Roofing workers to complete much of the work while lying on their stomachs.
