# CASE STUDY

## BILTMORE PALM BEACH

**Sikalastic RoofPro – Biltmore Palm Beach**

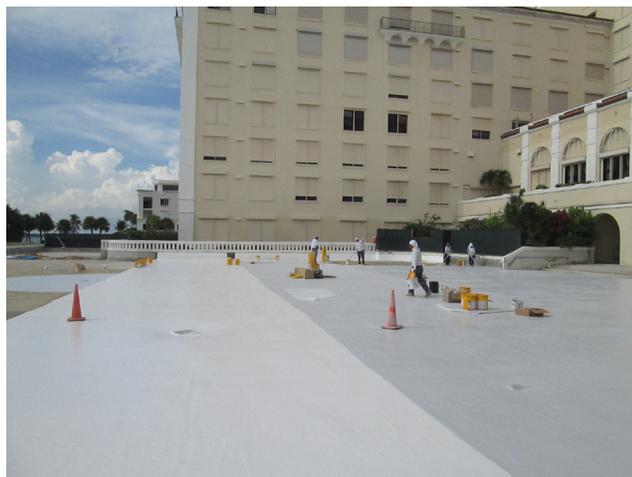
Application of the RoofPro

During the restoration process, all existing overburden materials and original bituminous waterproofing materials were removed. The concrete deck was repaired with Sikaquick® 1000 and Sikaflex® 2C and then primed with Sikalastic® Concrete Primer. All cracks were detailed with Sikalastic® 624 AR resin and Sika® Flexitape Heavy. Sikalastic® 624 AR, an alkaline-resistant waterproofing membrane and flashing, was installed with Sika® Reemat® Premium directly to the primed deck to achieve the most reliable, long-term watertight installation. Once the Sikalastic® RoofPro membrane and flashing installation was complete, new overburden materials were installed to return the promenade and plaza to their former glory. Planter areas were lined with Sika drainage mat and filled with growing media and plantings. The main deck received a layer of Sika drainage mat prior to the installation of a concrete topping slab. Decorative tile was then applied in a cementitious setting bed over the topping slab to create walkways and terrace areas. Following completion of the work, a Sikalastic® RoofPro 20 year materials and workmanship warranty was issued for the Sikalastic membrane installation. The building owners were so pleased with the trouble-free RoofPro application and its leak-free performance following installation that Sikalastic® RoofPro has been selected as the waterproofing for the Biltmore's penthouse terrace areas.

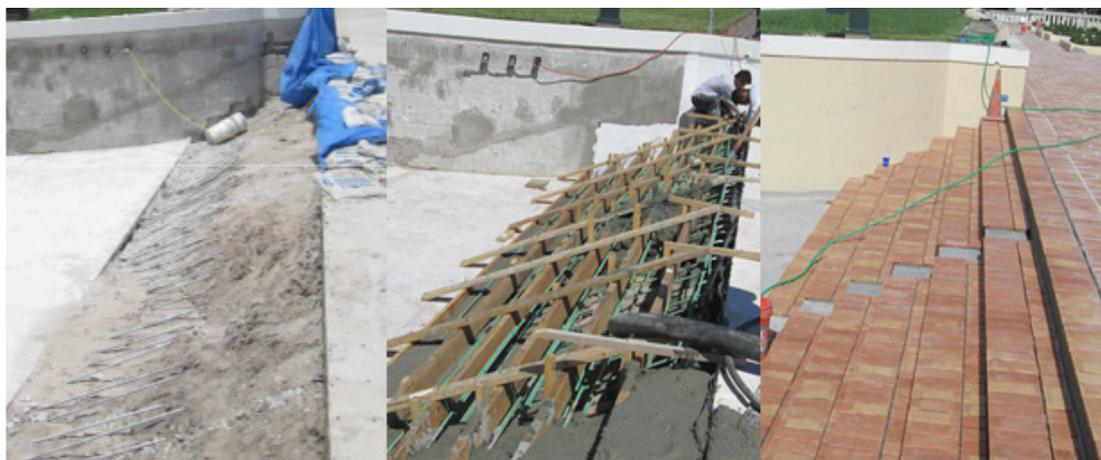
Various stages of Step Repair
