Project Profile

Olympia Medical Center
Olympia, Washington

Adhered EnergySmart Roof using
72 mil Sarnafil® G410 membrane
in white

Sika Sarnafil System Keeps Medical Center Up to Snuff

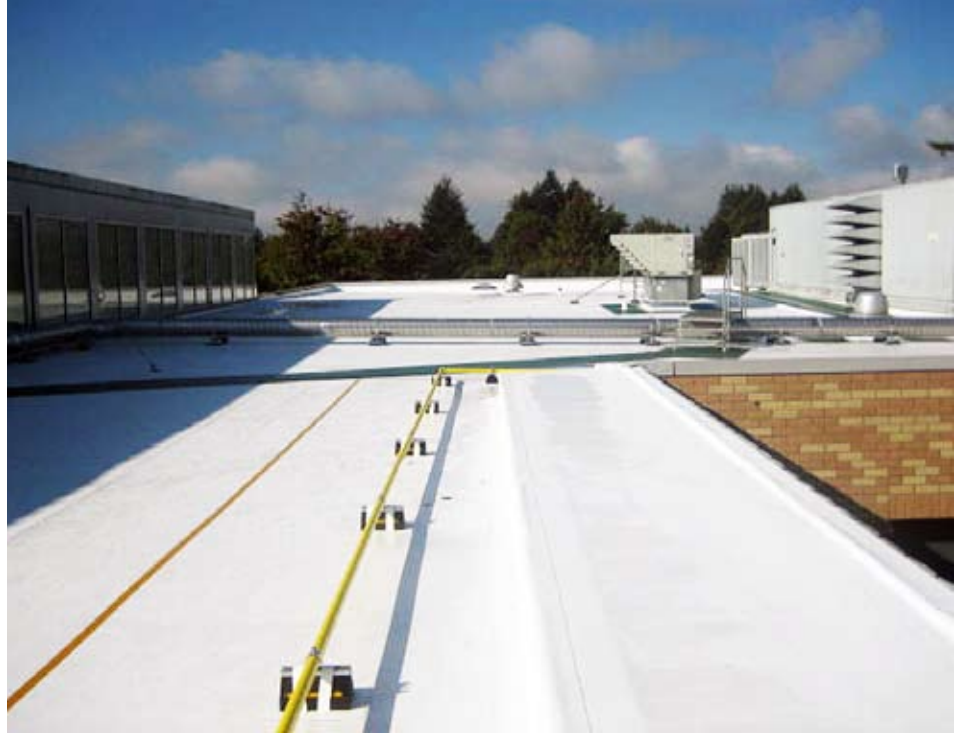
There were, however, a few areas where the roof installation was very challenging – especially under the three, 50-foot air handlers with sleepers (risers or curbs that elevated the air handlers off the roof) that were 30-feet long and eight-feet wide. "When we installed the new roof we increased the insulation thickness, which made it a real challenge to install the new roofing system under the air handlers," Anderson stated. "In some places we only had three to four inches of clearance between the top of the sleeper and the roof."

effective solution: they jacked up the air handlers just enough to remove the sleeper covers and old roofing system and install the vapor barrier and insulation; and then they took one 10-foot-wide sheet of the Sika Sarnafil membrane and slid it up and over the sleepers at each of the air handlers. This way the edges of the sheets could be welded to the outside edges, eliminating any welding underneath the air handlers.

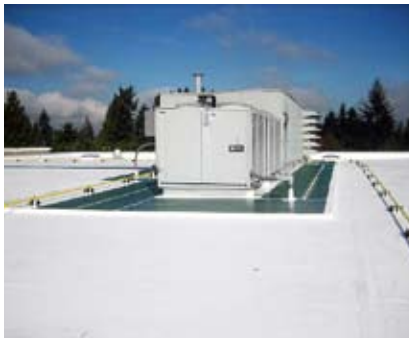
A chemotherapy vent extending approximately 25' above the main roof deck and attached to a large penthouse roof for stability also posed some problems. "When we began planning the removal and replacement of that particular penthouse roof it occurred to us that perhaps some precautions needed to be taken due to the vent's proximity," Anderson stated. "We ended up putting a 90 degree elbow in the

vent pipe just at the level of the penthouse roof and extending the vent horizontally approximately 20' away from the area of the work, making it safe for everyone."
