# Project Profile

Parkland Memorial Hospital  
Dallas, Texas

Inverted Roof Membrane Assembly  
using 60 mil Sarnafil® G410  
membrane

## **Sika Sarnafil Cures Parkland Memorial Hospital's Leaking Roof**

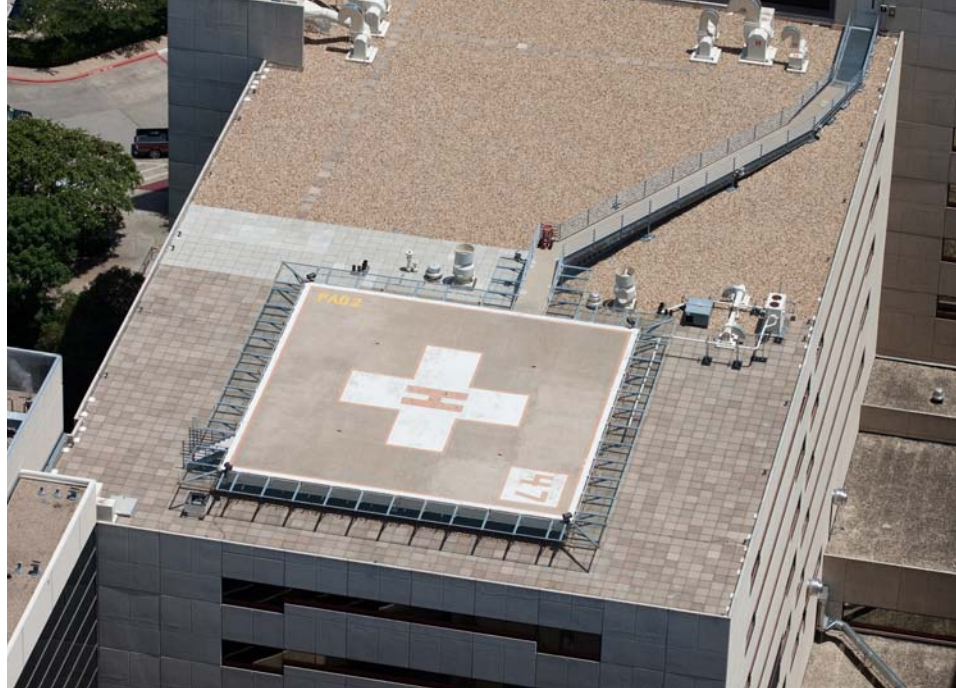
After the old system was removed, SLR Roofing installed the Sika Sarnafil membrane, as well as a drainage mat. Two layers of 2 ½ inch Sarnatherm extruded polystyrene insulation covered the entire roof assembly, followed by large river rocks which were used for ballast on half the roof. On the other half of the roof, which included the heliport (a steel structure about six feet above the main roof) and surrounding areas, precast concrete pavers were used to provide wind-uplift resistance and to protect the roof. SLR Roofing pulled the existing pavers off the roof, cleaned and sealed them, and then installed them on the new roof.
