Project Profile

Ronald Reagan Washington National Airport
Terminals B and C
Washington, DC

Sika Sarnafil's Décor Roof System Solves Problems with Leaking Metal Roof

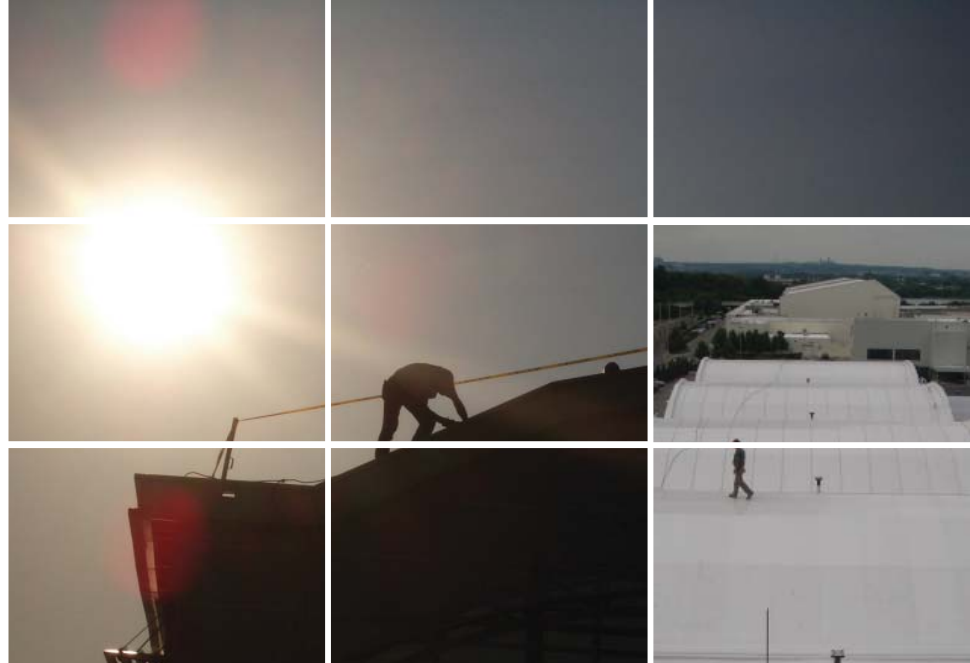
The Sarnafil Décor Roofing System being installed by Pioneer Roofing Systems on the Ronald Regan Washington National Airport Terminals B and C.

According to Wann, the installation involved tearing off the stainless steel metal and replacing any damaged submembrane. Dens-Deck™ was then installed over the existing insulation assembly, and then the 80-mil feltback Sarnafil membrane was adhered.

two months to get the metal, so we actually left the job site during that time," Mowry explained. "Once the copings were in we installed them and the Décor profiles, which went up and over the barrel. That process only took about three days to install."
