Risks of Roofing Over Concrete Decks

By Joe Schwetz

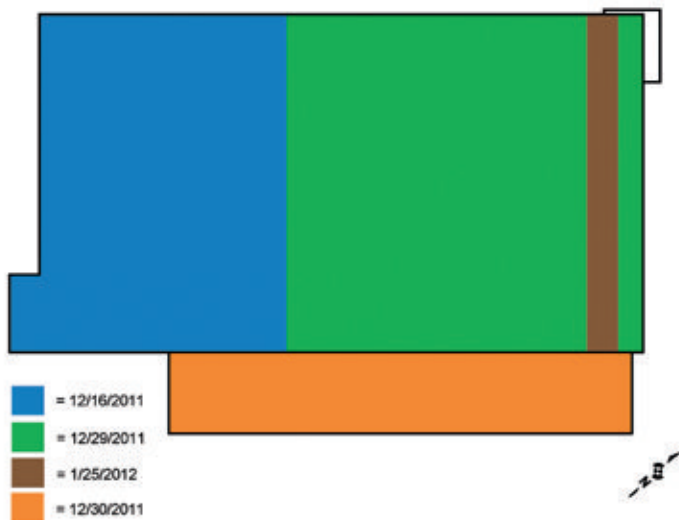
Figure 1 – Dates for the new concrete roof deck pours for Case Study 1.

The roof deck was poured in four sections on December 16, 29, and 30, 2011; and January 25, 2012 (*Figure 1*).

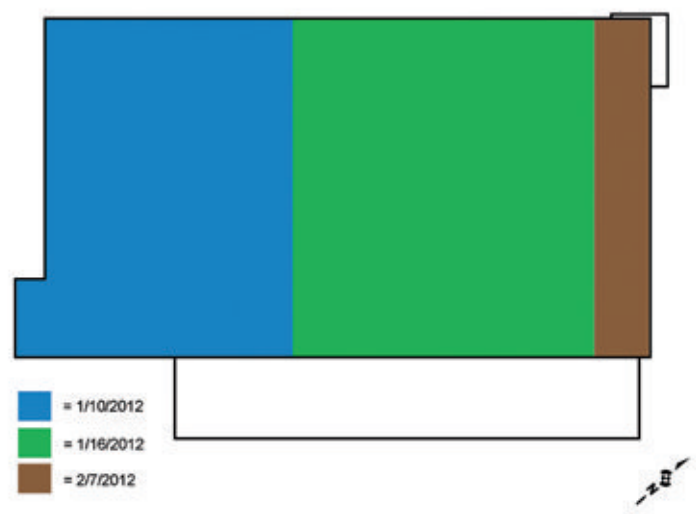
Figure 2 – Dates for the installation of the self-adhered vapor barrier, Case Study 1.

The air temperature on the days of the pours ranged from 3° to 33°F. With interior finish work already in progress, the general contractor (GC) pushed the roofing contractor to dry-in the building as quickly as possible. The vapor barrier was installed over three days (January 10 and 16, and February 7, 2012), when the temperature ranged between 7° and 43°F (within the acceptable temperature installation range for the vapor barrier). (See *Figure 2*.) The roofing project reports state that the concrete was visibly dry and the GC, roofing contractor, and FM Global representative witnessed and accepted the adhesion testing of the vapor barrier to the concrete deck. According to the project records, on the south section of the roof, the initial concrete pour was exposed for 25 days, and the north sections were open for 12 to 18 days.
