Market Application Focus

Project: Morris Sheppard Dam & Powerhouse
Owner: Brazos River Authority
Engineer: Jaster-Quintanilla
Contractor: Restek Inc.
Year: 2007

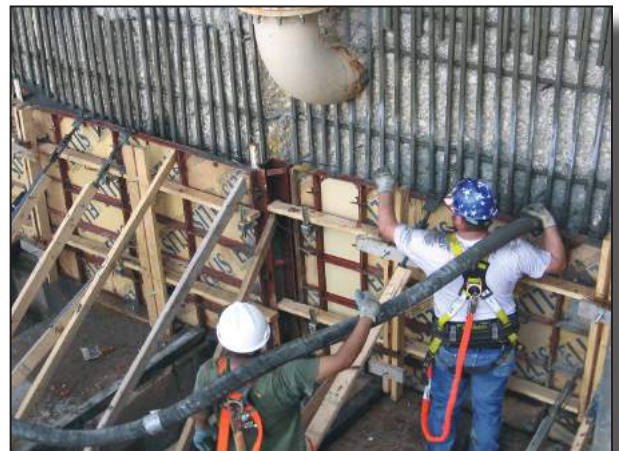
bars spaced 4 inches on center at portions of the outer face of the Powerhouse walls. Further investigation of the existing conditions revealed that extensive corrosion of the embedded reinforcing steel was causing the 4 to 6 inch thick concrete cover to shear off at the exterior face of the reinforcement.

Other areas of concern included delaminated concrete on the sloped top and vertical face of large encasement blocks that anchored the 12-foot diameter Penstocks and spalling concrete was also found beneath several of the large concrete struts located between the massive buttresses that support the dam's concrete slab.

Repair areas with significant concentrations of reinforcing steel were called to have ¼ inch diameter stainless steel pins installed 24 inches on center each way to mechanically anchor the repair material to the substrate. To help ensure effective material placement in small, hard-to-reach areas, wall systems below designated elevation were specified to be repaired using Sika MonoTop 611, a free-flowing, polymer-modified, silica fume enhanced, form and pour repair mortar. Repair areas above the
