# CASE STUDY

## BELLAIRE TOWER

**Owner:** The Bellaire Homeowners Association, San Francisco, California

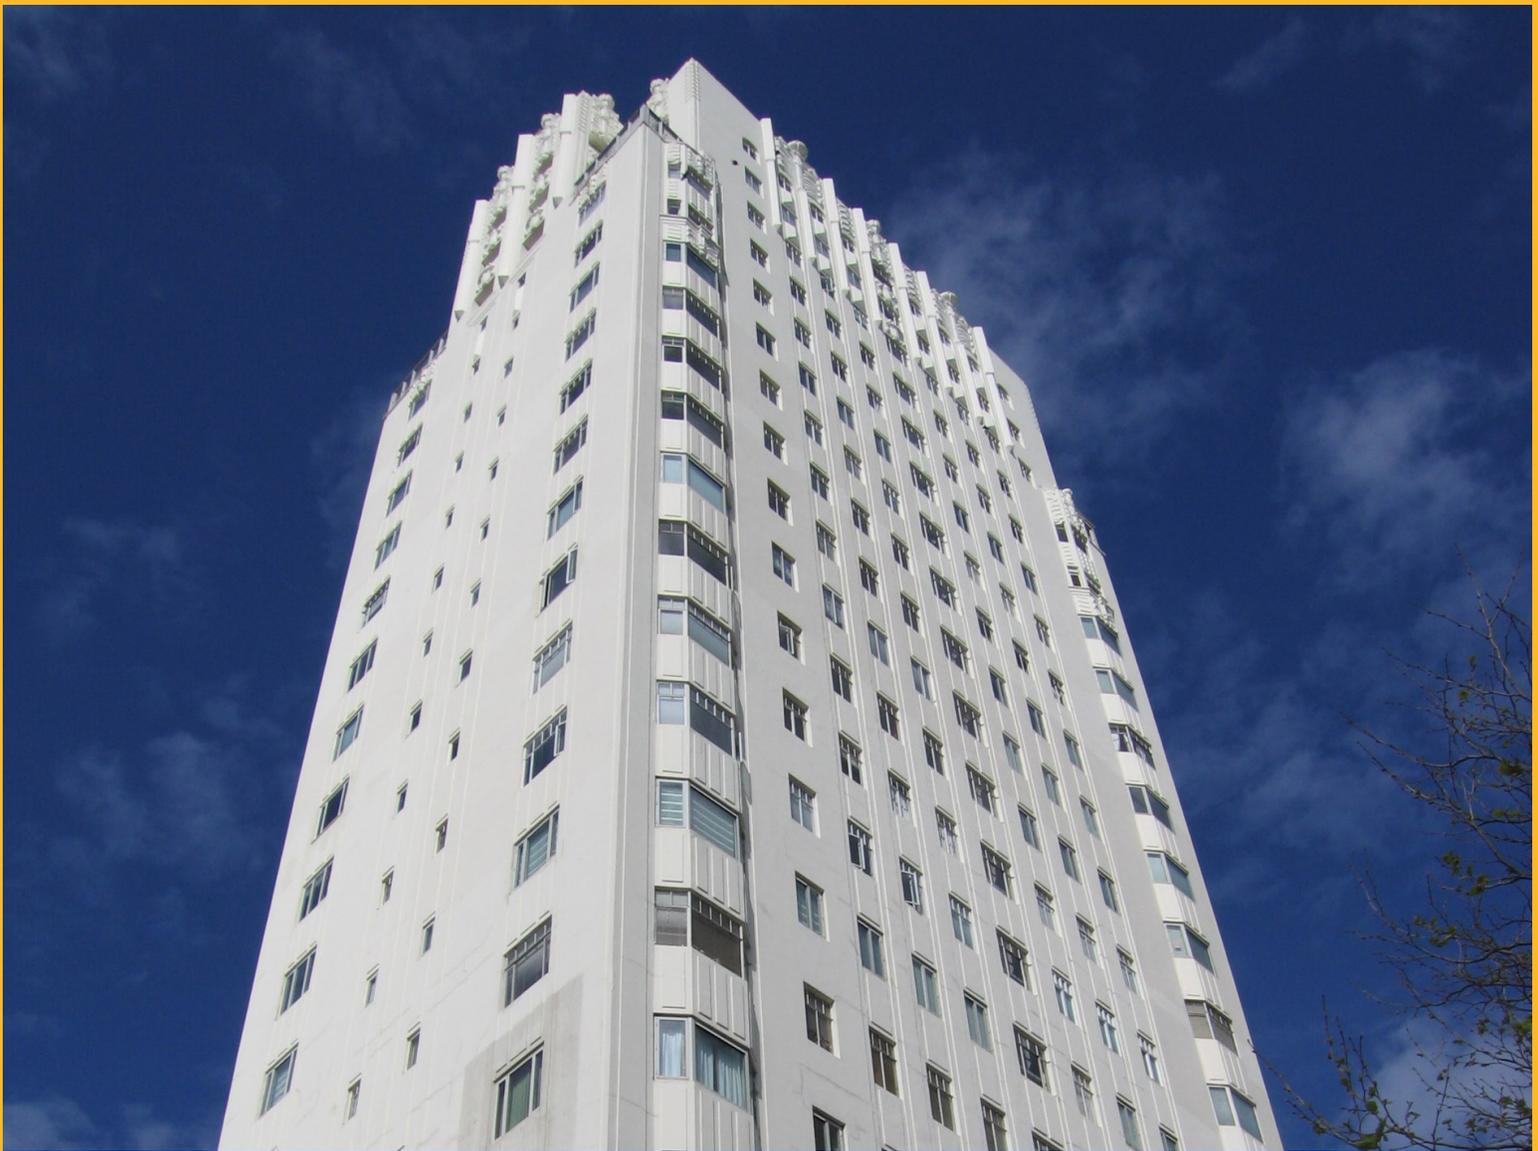
Bellaire Tower is home to many affluent residents however over the past two decades it has become infamous for the most water leaks of any building in the Bay Area. The leaks occurred mostly around the windows and repeated attempts of recoating left over 90 mills of nonbreathable coating on the beguiling exterior. ‘Dress’ beads of sealant were also applied in failed attempts to correct the leaks. Furthermore, concrete spalling posed a safety hazard in addition to unappealing exterior inconsistent with a luxurious building.

An old window showing signs of its age.

The planning department insisted on keeping the original appearance of the building and restoring the elaborate ornamental features while protecting the building from future damage. Moving cracks were routed and sealed with a polyurethane sealant, Sikaflex® 1A. Reinforcing steel was coated with an epoxy-cement coating,

Sika Armatec® 110. Spall repairs were either hand-applied or formed and poured with polymer-modified repair mortars, SikaTop® 123+ and SikaRepair® 223. Sika® Galvashield® XP+ and CC galvanic anodes were used along with Sikacrete® 211 and SikaGrout® 212 to protect the steel window flanges and select areas of the reinforcing steel near the windows. On the north and east elevations, some windows had to be removed and replaced without refurbishment as they were beyond repair. After the windows were addressed, the exterior walls were power washed and coated with an elastomeric, breathable, waterproof coating, Sikagard® 550W.
