Traffic Membrane Troubleshooting Manual

Technical Manual
May 2019 Edition

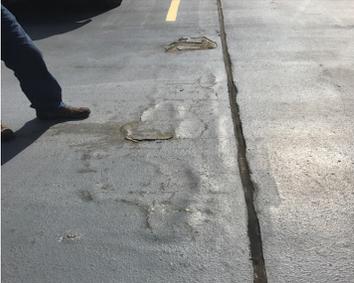
<p>Bubbling Due to Encapsulated moisture in the substrate</p>	<p>Bubbles in the coating surface which have not popped. When the bubble is cut water comes out or the surface underneath the bubble is wet</p>	<p>3-4</p>

- High surface moisture content prior to application of membrane
- Trapped moisture in insulated split slab construction
- Trapped moisture in metal pan deck construction
- Application during winter months – problem may not appear until the following summer when temperatures rise drawing moisture in the slab to the surface
- Water contamination prior to application of the coating (rain)
- Application above 4% moisture content without using a special moisture barrier

- Completely remove affected area down to the concrete substrate
- Let the surface dry
- Re-apply the system paying special attention to avoid the causes listed above

- Check the substrate moisture content and follow the guidelines if the moisture is higher than 4% by Tramex. One more testing method to check vapor moisture drive strongly is recommended (plastic sheet test)
- Determine if the structure is a split slab or metal pen deck
- Check the dew point and ensure you are a minimum of 5F above the dew point
- Avoid outside application during late fall or winter (what about our winter grade?)
- Minimum temperature and humidity should be within the range specified in PDS
- If ambient conditions are critical apply the product during falling temperatures

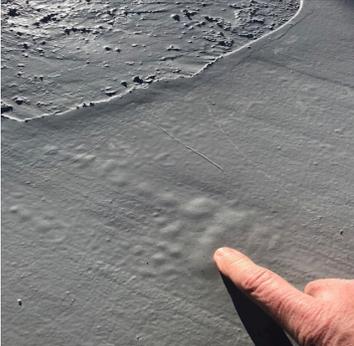
<p>Blistering Due to Thick Coating</p>	<p>These blistering feel spongy and the coating is usually very thick and soft. When the blister is cut the coating is excessively thick and may be as much as 60-120 mils (DFT) thick and looks like a sponge with unbroken or circular blisters. It happens mostly to top coats especially single component top coats. The affected coating wears very quickly and aggregate usually settles completely into the coating leaving a smooth surface.</p>	<p>5-6</p>

These blisters feel spongy and the coating is usually very thick and soft. When the blister is cut the coating is excessively thick and may be as much as 60-120 mils (DFT) thick and looks like a sponge with unbroken or circular blistering. It happens mostly to top coats especially single component top coats. The affected coating wears very quickly and aggregate usually settles completely into the coating leaving a smooth surface.

- Check the wet film thickness during application
- Detailing - Fill up low spot areas of the substrate prior to application
- Detailing - Check CSP (CSP 3-4 required)
- During application backroll to move the material from low spot areas
- Check your tools – use the recommended size squeegee
- Use a booster or accelerator with single component products

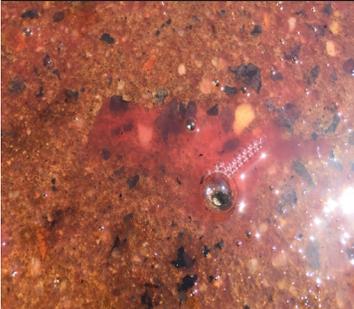
<p>Pinholing/Bubbling</p>	<p>Pinholing is a result of outgassing when air escapes from porous concrete and becomes trapped in the coating. As the air escapes through the coating, the first sign is generally small bubbles that appear shortly after the application of the coating. When the bubbles pop they leave behind small craters in the coating. The pinhole can usually be seen at the bottom of these craters.</p>	<p>7-8</p>

- Porous concrete surface
- Insufficient primer application
- Aggressive surface preparation
- Moisture (damp substrate)
- High ambient temperature (rapid curing)
- Freshly applied coating exposed to direct sunlight
- High substrate temperature at 90°F and above

- Prime substrate precisely following required coverage rate
- If substrate is very porous or rough, 2 coats of primer are strongly recommended
- Avoid aggressive surface preparation
- Consider application in afternoons or evenings as temperatures are falling in order to avoid rapid temperature increase during application
- Prevent direct sunlight exposure during initial cure
- Temperature and humidity should be within the range specified in PDS
- At the first appearance of bubbles a spike roller can be used to pop the bubbles
- Check substrate moisture and follow the guidelines if the moisture is higher than 4% by Tramex.

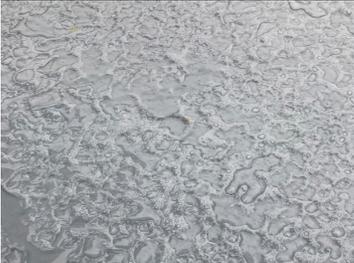
<p>Water Damage</p>	<p>Water damage occurs as a result of deterioration of the membrane before the material has fully cured. This occurs when there is poor membrane adhesion due to the presence of water or dampness during the application.</p>	<p>9-10</p>

Water damage occurs as a result of deterioration of the membrane before the material has fully cured. This occurs when there is poor membrane adhesion due to the presence of water or dampness during the application.

- Inclement weather during application (Rain , Snow)
- Accidental water leak (floors above, sprinklers)
- Human sweat
- Contamination by machinery liquids

- Avoid application during or shortly before anticipated inclement weather
- Protect the area from any potential accidental water leak from the floors above
- If possible, sequence the project from top levels to lower ones
- Workers should wear hats or head bands
- Deactivate sprinkler system prior to application

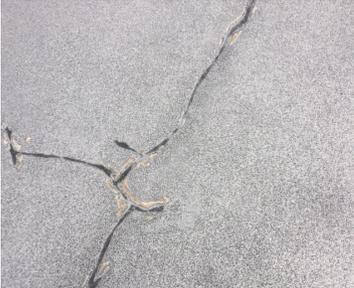
<p>Cracks/Joints</p>	<p>Substrate fractures which telegraph through the membrane caused by excessive movement. Cracks may compromise the waterproofing system causing leaks affecting water tightness of the system if not properly treated.</p>	<p>11-12</p>

Substrate fractures which telegraph thorough the membrane caused by excessive movement. Cracks may compromise the waterproofing system causing leaks affecting water tightness of the system if not properly treated.

- Structural problem - movement in the joint exceeds elongation of membrane
- Failure to route , caulk and detail every crack greater than 1/16”
- Failure to detail every crack which is less 1/16”
- Uncured sealant in routed and caulked crack
- Coating over joints greater than 1”
- Cracks in the concrete occur; especially in new construction, after the basecoat was applied

- Route existing cracks and seal with a polyurethane sealant
- Apply detail coat
- If excessive movement is expected reinforce detail coat with Sika Flexitape heavy or run the sealed joint through the traffic membrane

- Properly detail cracks
- The correct crack treatment will depend on crack width and expected movement
- Honor joints greater than 1” thorough the system
- The strip of detail coat 23 DFT should be always applied
- Use only PU sealant under PU waterproofing membrane
- Use reinforcement if movement creates crack up to 1/16 inch
- Rout and seal if movement creates crack between 1/16 inch to 1 inch

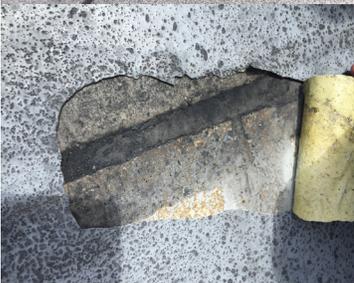
<p>Delemation/Peeling</p>	<p>The coating peels off the substrate (concrete) or previous coat (inter coat adhesion).</p>	<p>13-14</p>

- Insufficient concrete surface preparation (suitable CSP)
- Existing coating preparation (grinding, roughening, recoat window, cleaning, primer)
- Surface contamination (dirt, dust, oil)
- Moisture (damp substrate, dew point , sweat)
- Insufficient thickness (min. DFT)
- Not properly maintained (snow plows, aggressive cleaning agents, chemical impact – car liquid leaks)

- Remove loose delaminated coating
- Abrade and clean surface
- Remove all residual contamination (chemically or mechanically)
- Reapply the whole system or top coat using appropriate primers

- Follow PDS recommendations
- Surface preparation : Abrade or shot blast the substrate to achieve a CSP 3-4 per ICRI guidelines
- Surface contamination : Entirely clean substrate prior to application of primer or primerless base coat
- Remove all residual contamination on existing coating (chemically or mechanically)
- Remove all loose areas of existing coating
- Follow required maximum recoat window of new coating
- Follow required minimum coverage rates of each coat
- Check substrate moisture and follow the guidelines if the moisture is higher than 4% by Tramex
- Verify the substrate temperatures are minimally 5F above the dew point

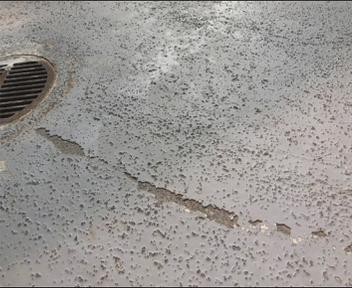
Mechanical Damage	Finished waterproofing system damaged by reckless use and insufficient maintenance .	15-16

Finished waterproofing system damaged by reckless use and insufficient maintenance .

- Reckless behavior
- Vandalism
- Snow plows
- Studded tires
- Skid marks – burned tires

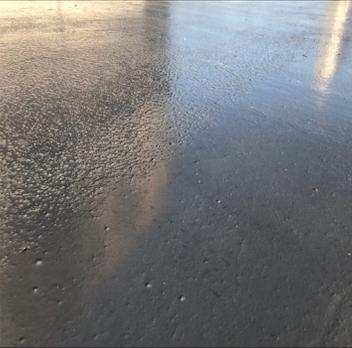
Skid Resistance and Inconsistent Texture	The surface of the finished membrane is slippery and/or there are 'bald' spots. Inconsistently seeded aggregate create bold and shiny spots on the membrane . Wear resistance and aesthetics features are also compromised.	17-18

The surface of the finished membrane is slippery and/or there are 'bald' spots. Inconsistently seeded aggregate create bold and shiny spots on the membrane . Wear resistance and aesthetics features are also compromised.

- Abrade the surface
- Clean and apply recoat primer
- Apply 2 coats of wear/top coat and broadcast depending on the type of seeding

- Broadcast sufficient amount of aggregate
- Use the right method based on the traffic and specific project need (seed & lock or seed & backroll)
- Use more coarse aggregate and adequate amount of resin to enhance slip resistance
- Use the right size aggregate according to manufacturer's PDS
- Use a pretextured topcoat
- Apply two top coats if using pretextured top coat

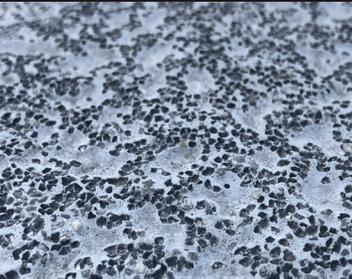
Aggregate Rolling Out	The top coat loses a significant aggregate after short a period of service.	21-22

- Clean the whole affected area from all loose aggregate and solvent wipe
- Apply recoat primer
- Apply 2 additional top coats seeded with right aggregate

- Check the source of aggregate and make sure that the aggregate is totally dry
- Aggregate can get wet if packed in plastic bags
- The aggregate should be washed silica sand
- Gradation of aggregate should be between 16 - 40 mesh
- Stock aggregate before application indoors or covered to protect from rain
- Follow the minimum and maximum thickness of the top coat
- Use textured products to avoid an issue with aggregate selection and aggregate condition

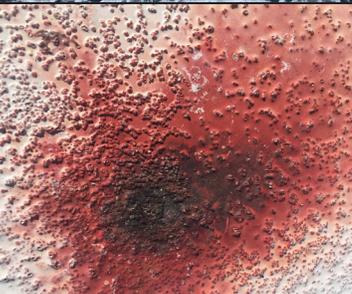
Stains	The coating has different discoloration stains	23-24

The coating has different discoloration stains.

- UV stability of top coat
- Staining due to auto liquids leak
- Metallic content in the aggregate – rusting
- Skid tire marks
- Tire marks due to longer contact with a new high performance tires (car dealerships)
- Insufficient maintenance and cleaning
- Insufficient mixing of component products

- Abrade affected area to remove the whole stain mechanically
- Clean and solvent wipe the whole affected area
- Apply recoat primer
- Apply additional top coat

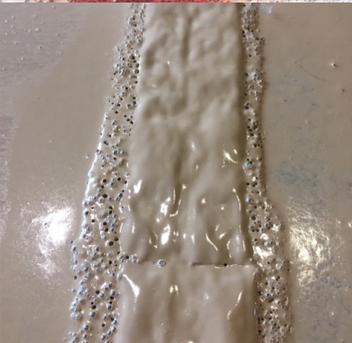
Gassing Under Reinforcement Fabric	Big bubbles occur under fabric after the resin has been cured. When the fabric is cut the big air bubbles occur below. It happens mostly to reinforced detail coat especially when the coating was applied too thick prior to saturation of the fabric. The bubbles occur after 2-8 hours after the fabric was saturated in the resin.	25-26
