Concrete Repair & Protection

Corrosion & Surface Erosion

Project: The Cotton Bowl
Owner: The City of Dallas
Engineer: Jaster-Quintanilla Dallas, LLP
Contractor: Charter Builders/L.S. Decker
Year: 2008

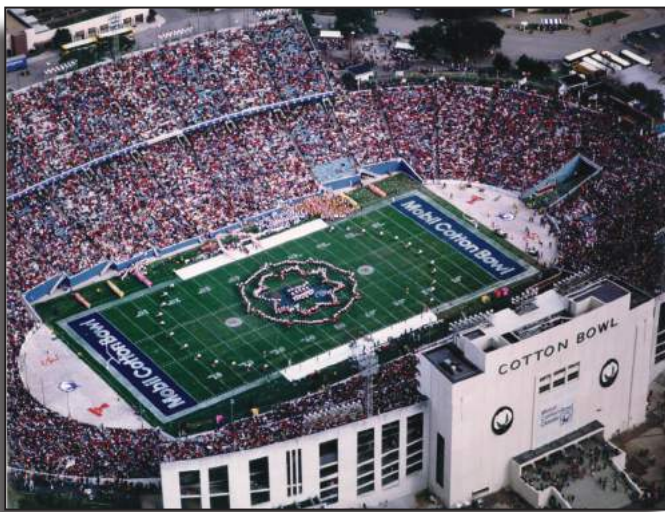
Years of "wear and tear," coupled with a failure to provide adequate funding for maintenance and repair, had taken its toll on the oldest sections of the Cotton Bowl – the original "lower bowl." Cracks, spalls, and inadequate repairs were visible everywhere. Severely eroded steps in aisle ways and unevenness across expansion joints in the seating areas were potential trip hazards for patrons. Unsealed expansion joints allowed water to penetrate into critical service areas such as concession stands, food storage areas, and restrooms.

Horizontal repair of concrete less than one inch depth and the cementitious overlay were done with SikTop 122 Pus - a two component polymer modified material with an integral corrosion inhibitor. Horizontal repairs which were greater than one inch depth were completed with a prepackaged rapid setting SikaQuick 1000 repair material. SikaQuick was extended with 25 pounds of 3/8 gravel for these deep repairs. Vertical members in need of concrete repairs were patched with SikaTop 123 Plus. Cracks in concrete were pressure injected with Sikadur 52, a low viscosity injection resin. A flexible urethane traffic deck membrane was installed on the elevated sections. An anti carbonation

water based acrylic coating was used to restore the walls, columns and front, rear and side walls of the upper deck of the Cotton Bowl.
