# Market Application Focus

**Project:** State Highway 183 MacArthur Emergency Bridge Repair  
**Owner:** Texas Department of Transportation  
**Contractor:** Gibson & Associates  
**Year:** 2005

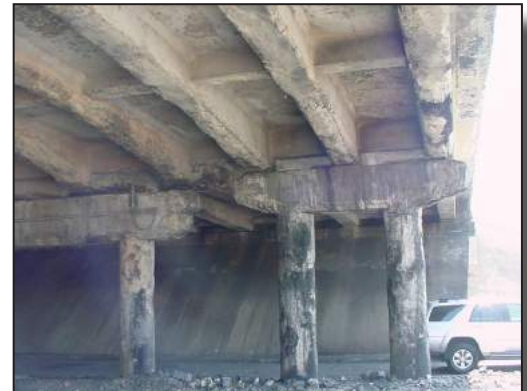
The morning of Saturday, May 28, 2005, a 3,000 gallon fuel tanker heading east on State Highway 183 barreled through a guardrail and spiraled off the bridge landing upside down and exploding several times. Visual inspections defined the general areas of needed repairs. Sound tapping with hammers defined the damaged areas. Selected demolition was performed to gain a better understanding of the concrete quality, the bond of the concrete to the steel and to identify any possible voids between the steel and the concrete. Cores were taken from the columns and caps with the most severe fire damage. Examination of the cores revealed that the fire had not damaged the inner reinforcing steel and concrete. After the thorough evaluation TXDOT engineers concluded that although the damage was extensive, the core remained in tact and the bridge could be repaired.

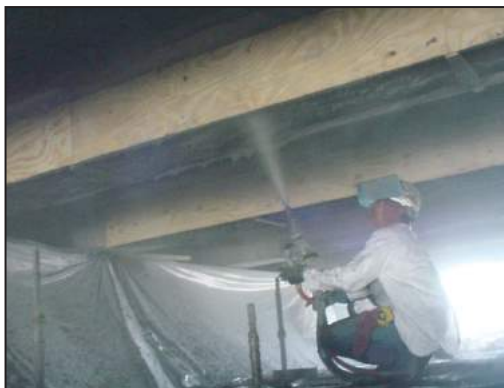
Demolition of the beams started on June 19th. 1,000 cf of concrete was removed. Columns, beams, and the bridge deck were all repaired using high-velocity, wet-spray application of

SikaRepair 224, a silica fume, fiber reinforced, mortar. The diaphragms were repaired using Sika Mono Top 611, a polymer-modified, silica fume-enhanced, mortar, which was formed and pumped into place. Damaged bearing seats for the beams were originally specified to be repaired using conventional concrete; however, a decision was made in the field to inject the seats with Sikadur 52, a high-strength epoxy adhesive. This decision saved both time and money, eliminating the need to jack the entire bridge in order to complete the repairs. Damaged beams and columns were

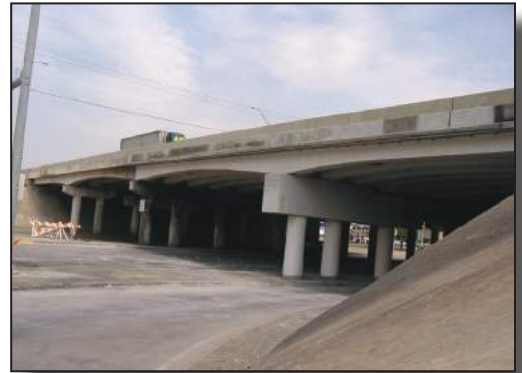
strengthened using SikaWrap Hex 117C, a unidirectional carbon fiber fabric. The carbon-fiber fabric was saturated with Sikadur 300, a high-strength, impregnating resin, and laid up wet by hand. The beams and columns were then coated with Sikagard 550W Elastocolor, a high performance, crack bridging acrylic protective coating, to provide UV protection to the epoxy/CFRP system and a more uniform appearance to the structure. The project was completed July 15, 2005; 4 days ahead of schedule and an amazing 47 days after the accident.
