Recipient of the 2001 ICRI Award of Execellence, Repair of Municipal Structures

Concrete Repair

Project:	Joint Water Pollution Control Plant - LA County		
Owner:	Los Angeles County		
Specifier:			
Contractor:			
Year:	2001

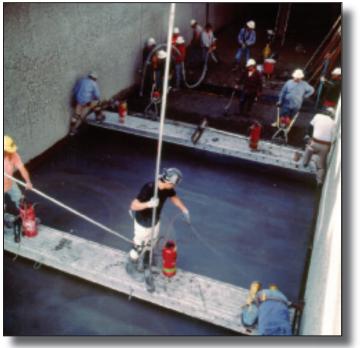
Based upon the condition survey and the owner's requirements, the engineer proposed removal of the ½ of the concrete surface by high pressure water blasting. The section of the repair material would be based upon specific material properties that included minimum compressive strength maximum absorption, maximum pore space and maximum permeability. Several products were tested and screened based on project needs and material specifications. The contractor selected. SikaRepair 224, a prebagged machine/hand-applied repair as the product of choice. SikaRepair 224 is a one-component, pre-packaged, ready-touse,

cementitious, silica fume, fiber reinforced, high strength shrinkage-compensated mortar. Formulated for application by trowel or low pressure spray, it is designed especially for repair of overhead and vertical surfaces.

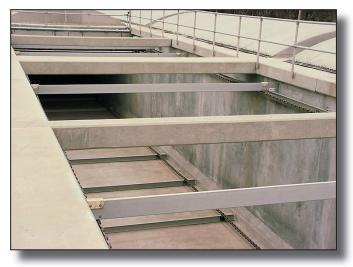
stored in a warehouse near the construction site. Material was produced in 'super sacs', each of which weighed 2,500 pounds. An average of 40 sacs or 100,000 pounds was produced daily. The surfaces were prepared using high-pressure water blasting at 30,000 psi. The equipment was operated robotically. The profile resulting from the preparation was very aggressive, approximately +/- $\frac{1}{4}$ " amplitude, matching an ICRI CSP 9 profile. Because of the aggressive nature of the preparation 1"-1 $\frac{1}{4}$ " of concrete was removed rather than the $\frac{1}{2}$ " specified. Fortunately, the contractor had ordered double the amount of material originally estimated.

Crews of 60 men worked in 10-hour shifts. Two shifts worked six days per week. Between 5,000 and 10,000 pounds of SikaRepair 224 was applied every hour. The contractor averaged an amazing 120,000 pounds of SikaRepair 224 applied daily.

Vertical and overhead overlays were applied using wet process shotcrete equipment. Horizontal overlays were pumped and mechanically screeded to the proper thickness. As indicated previously, some areas due to manhole access logistics, required to be pumped 500 feet in order to be placed.
