Stadiums

Concrete Repair &amp; Protection

Corrosion &amp; Surface Erosion

**Project:** The Cotton Bowl  
**Owner:** The City of Dallas  
**Engineer:** Jaster-Quintanilla Dallas, LLP  
**Contractor:** Charter Builders/L.S. Decker  
**Year:** 2008

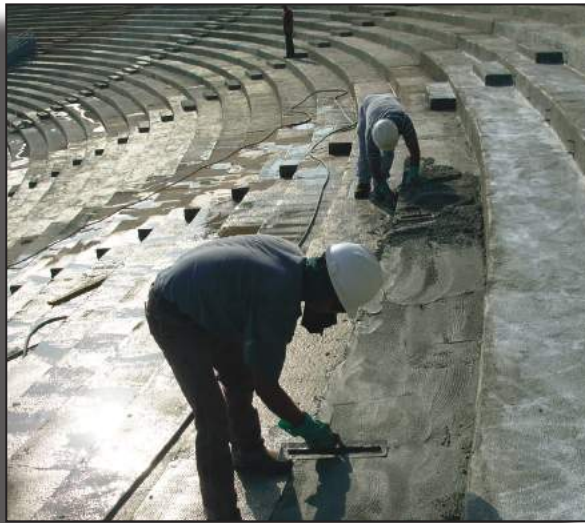
Horizontal repair of concrete less than one inch depth and the cementitious overlay were done with SikTop 122 Pus - a two component polymer modified material with an integral corrosion inhibitor. Horizontal repairs which were greater than one inch depth were completed with a prepackaged rapid setting SikaQuick 1000 repair material. SikaQuick was extended with 25 pounds of 3/8 gravel for these deep repairs. Vertical members in need of concrete repairs were patched with SikaTop 123 Plus. Cracks in concrete were pressure injected with Sikadur 52, a low viscosity injection resin. A flexible urethane traffic deck membrane was installed on the elevated sections. An anti carbonation
