Sika Technologies and Solutions for Waste Water Treatment Plants

Sika Waste Water Treatment Plant Solutions Contribute to a Sustainable Future

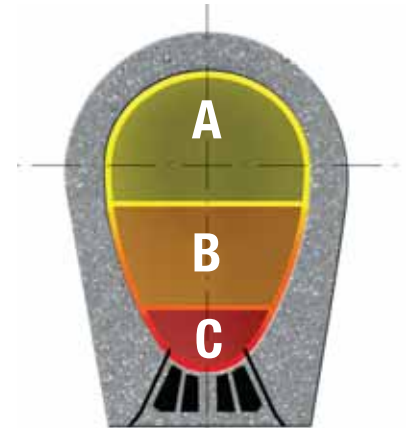
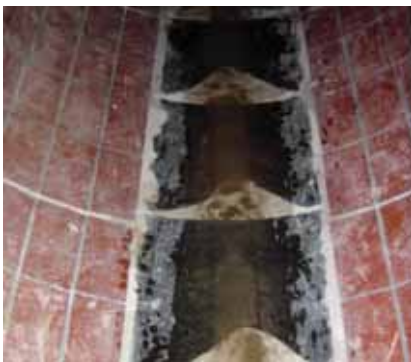
1 Damages at the bottom:

Heavy abrasion and erosion of the concrete and prefabricated elements are often found at the bottom of the sewers.

In general rules, these elements shall be replaced and reassembled properly by gluing them in place with an epoxy adhesive.

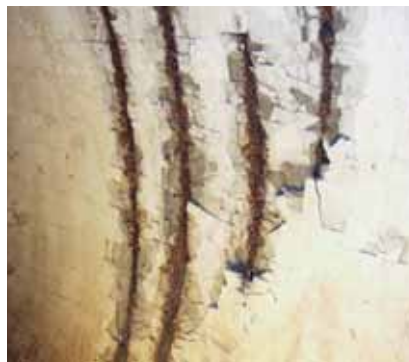
2 Localised defect of the concrete:

Lateral walls and the crown often show localised defects of the concrete and some time defects due to the corrosion of the reinforcement. After appropriate preparation, these defects can be repaired using sulphate resistant repair mortars.

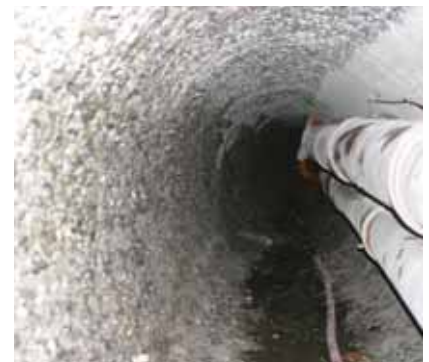
3 Full degradation of the concrete surface:

The resistance of tamped concrete against a strong water current is generally not enough and often it is found the full surface of the concrete is eroded. It is recommended in these zones to proceed with a full resurfacing.

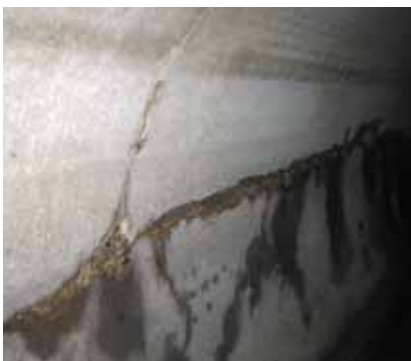
4 Cracks with water leaks:

Due to shrinkage or settlements, concrete in sewers often crack. These cracks need to be filled in order to prevent leakage of pollutant to surrounding ground water. It is often necessary to use expanding materials to fill these cracks.

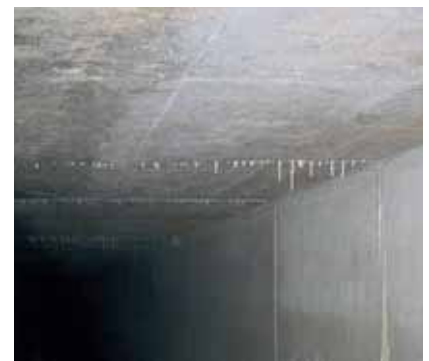
5 Damages at the crown:

Exposed tamped concrete surfaces show very low resistance against carbonation and the aggressive substances contained in the waste water. Therefore, these surfaces can be protected using **EpoCem**® technologies

which are extremely resistant and watertight against urban waste water.

At the crown area, the structure can be protected against condensation water using a hydrophobic impregnation.

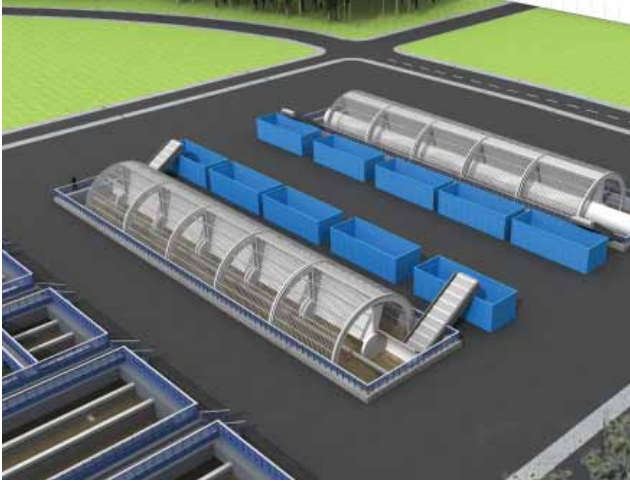
Screening Channel

- Abrasion and erosion due to sand, grit or other heavy particles
- Chemical attacks due to aggressive waste or industrial water
- Leakage due to cracks, untight joints or damaged concrete

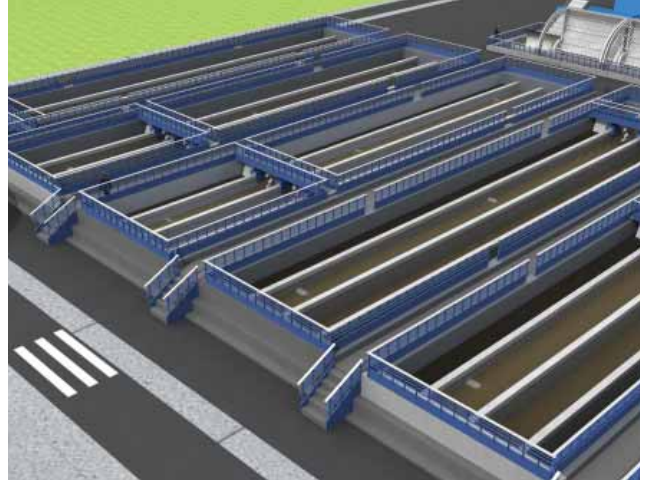
Grit, Fat & Grease Chamber

- Abrasion and erosion due to sand, grit or other heavy particles
- Chemical attacks due to aggressive waste or industrial water
- Leakage due to cracks, untight joints or damaged concrete

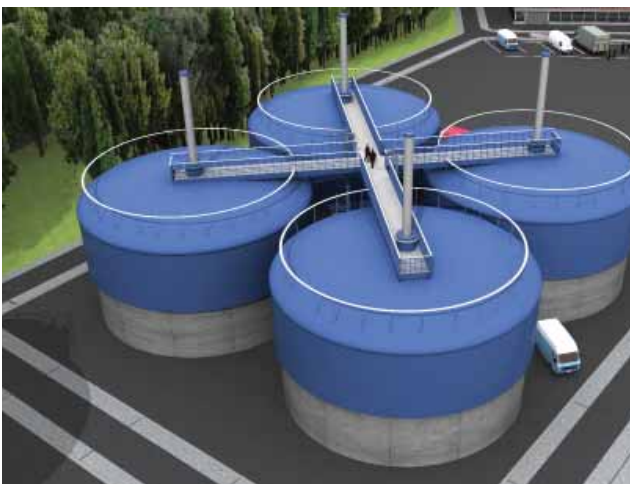
Gasometers

- Steel corrosion
- Untight joints
- Sulfuric acid damages

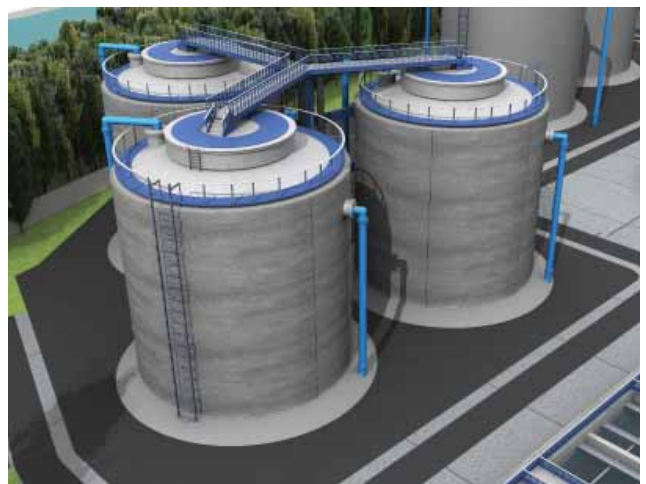
Digestion Tanks

- Concrete damage due to sulfuric acid
- Leakage due to damaged waterproofing
- Cracks due to thermal expansion or shrinkage

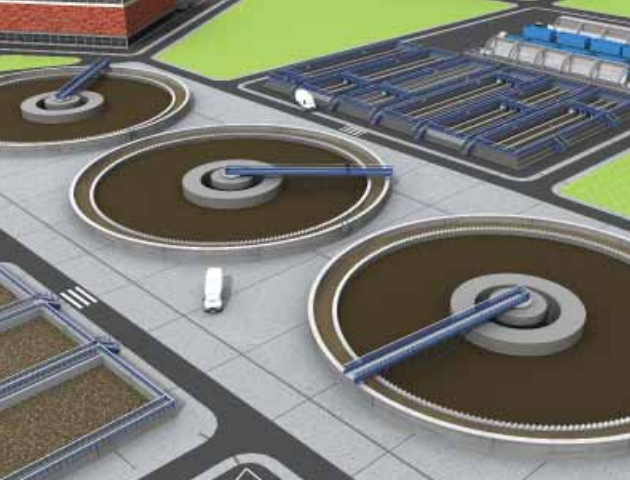
Primary Sedimentation Tanks

- Chemical attacks due to aggressive waste or industrial water
- Leakage due to improper waterproofing
- Cracks due to thermal expansion or shrinkage
- Steel reinforcement corrosion due to low concrete cover
- Mechanical abrasion at the rolling pad

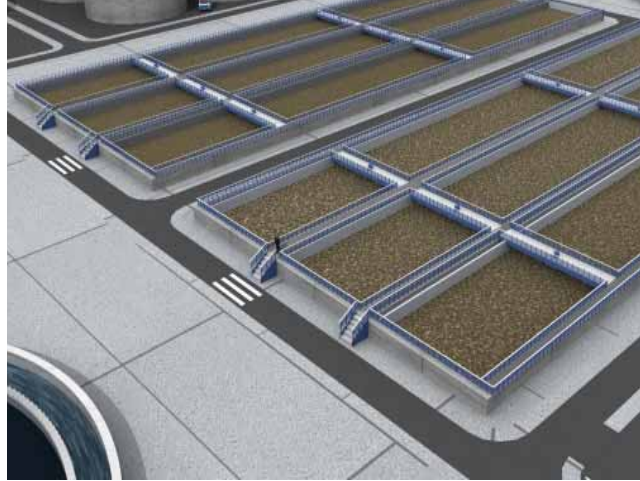
Biological Tanks

- Erosion due to water flow
- Chemical attacks due to aggressive waste or industrial water
- Leakage due to damaged waterproofing
- Cracks due to thermal expansion or shrinkage
- Steel reinforcement corrosion due to low concrete cover

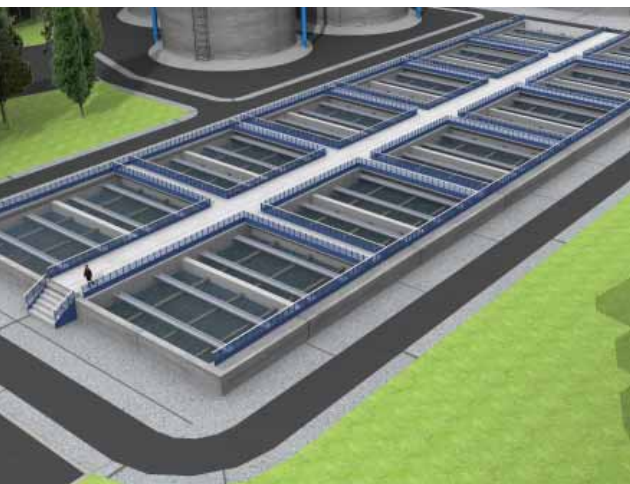
Filtration Beds

- Abrasion due to sand
- Leakage due to damaged waterproofing
- Cracks due to thermal expansion or shrinkage

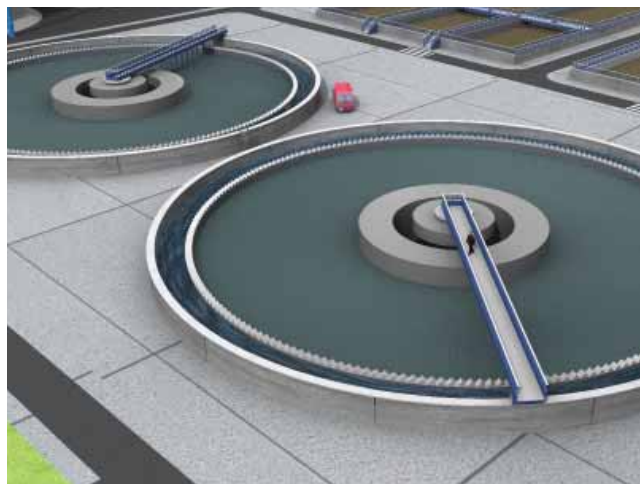
Secondary Sedimentation Tanks

- Leakage due to damaged waterproofing
- Cracks due to thermal expansion or shrinkage
- Mechanical abrasion at the rolling pad

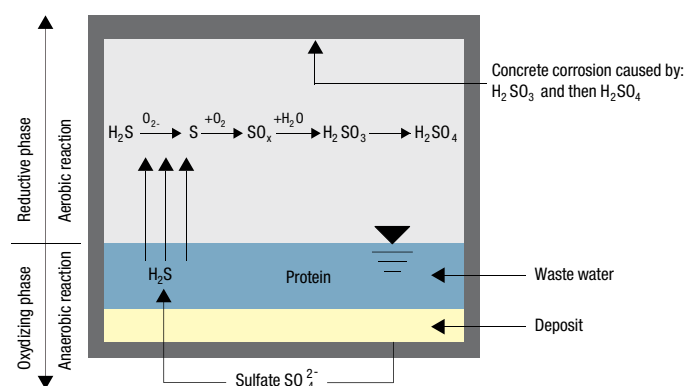
Biogenic Sulfuric Acid Corrosion

The chemical composition of biogas consists mainly of methane and variable concentrations of carbon dioxide, water vapour, hydrogen sulfide, nitrogen, oxygen and hydrogen.

The proteins present in the fermenters break down into amino acids. These amino acids and the sulfates present form, amongst other things, hydrogen sulfide (H₂S). This moves to the gas compartment by diffusion, where it is oxidised and condenses on the walls and soffits as elementary sulfur deposits. This sulfur is then used as an energy source by thiobacteria and is thereby converted primarily to sulfurous (H₂SO₃) and then to sulfuric acid (H₂SO₄). This “biogenically” formed sulfuric acid aggressively corrodes metal components and severely attacks concrete, destroying it progressively from the inside.

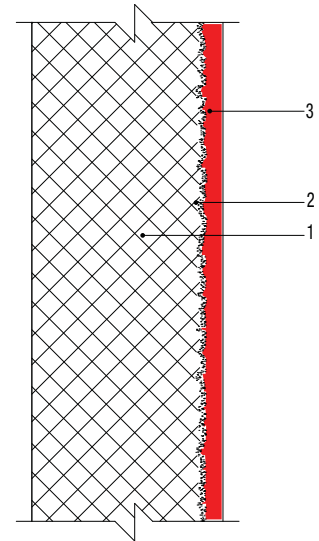
- 1 Host concrete
- 2 Abraded surface
- 3 Over laying with
Sika® Abraroc SR

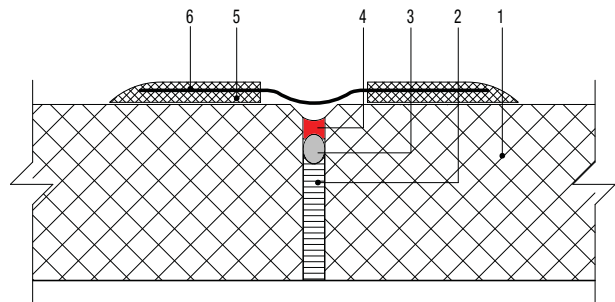
Typical Detail

| 1. Substrate | 4. Failed sealant |
| 3. Existing backing rod | 6. Sikadur-Combiflex SG Type |

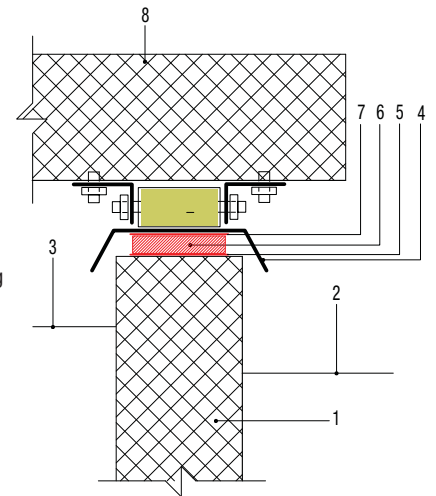
Typical Details

1. Concrete wall of clarifier
2. Ground level
3. Water level within the clarifier
4. V2A Stainless steel plate
5. Priming of concrete surface with Primer such as **Sika® Icosit® KC 330** Primer or equivalent
6. Shock absorbing, vibration damping & bonding material such as **Sika® Icosit® KC 330 FK**
7. Priming after grinding the under side of the stainless steel plate with primer such as **Sika® Icosit® KC** Primer or equivalent
8. Scraper bridge

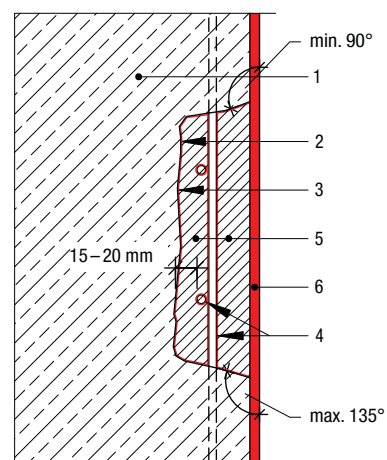
Typical Detail

1. Host sound concrete
2. Cutting line of damaged concrete, cleaned and prepared substrate
3. Bonding primer (if relevant/required: e.g. **SikaTop® Armatec®-110 EpoCem®**)
4. Corrosion protective coat (e.g. **SikaTop® Armatec®-110 EpoCem®**)
5. Repair mortar (e.g. **Sika MonoTop®-412 NFG**)
6. Smoothing coat (e.g. **Sika MonoTop®-723 N**)

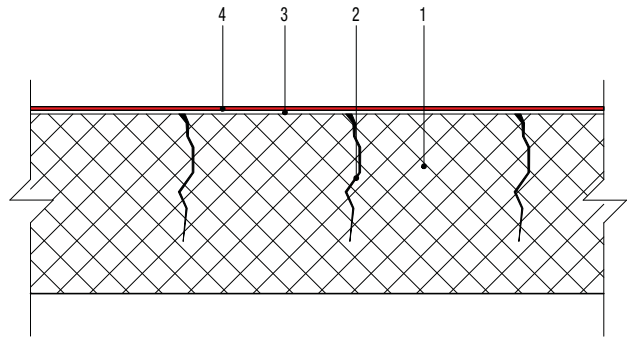
Typical Detail

1. Concrete
2. Cracks
3. Primer **Sikafloor®-156/-161** lightly broadcasted with quartz sand 0.3 – 0.8 mm
4. 1 x **Sikalastic®-844 XT**

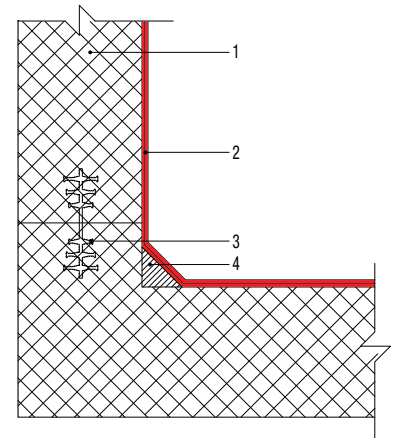
1. Concrete substrate
2. **Sikagard®-720 EpoCem®**
3. Construction joint
4. **Sika MonoTop®-412 N**

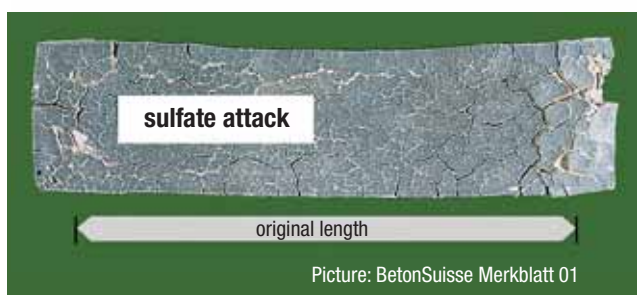
Picture: BetonSuisse Merkblatt 01

Sulfate driven attack is caused primarily by sulfates dissolved in water. By reacting with the hardened cement matrix, an increase in volume is induced which damages the structure.
