Concrete Repair & Protection

Project: Sunshine Skyway Bridge - Tampa Bay, FL
Owner: Florida D.O.T.
Engineer: SDR Engineering Consultants, Inc.
Contractor: Intron Technologies, Inc.
Year: November 2006 – September 2007

Case Study

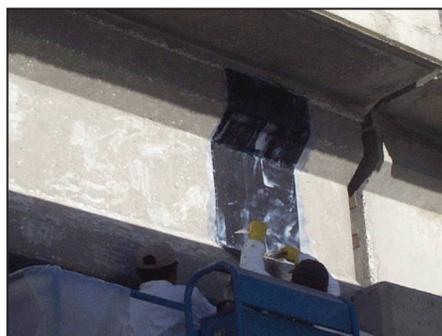
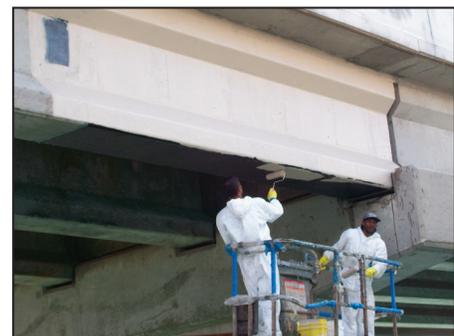
Prior to the start of construction, load testing was performed on full-scale AASHTO Type IV precast girders in the FDOT Structures Lab in Tallahassee, FL. This testing confirmed the engineer's calculations that a CFRP upgrade would be the best solution for repairing the shear deficiency in the AASHTO girders. The use of a carbon fiber system was chosen to structurally repair the girders for a variety of reasons. A bi-directional carbon fiber fabric provided reinforcement in the 0/90 degree directions. The carbon fiber system was able to conform to the geometry of the AASHTO girders very easily. The light weight nature of the fabric was able to be installed very easily, despite having to be done from a man-lift off a barge under the bridge. The carbon fiber/epoxy system is extremely durable and not susceptible to corrosion, even in a marine environment. Lastly, the high tensile strength and modulus of elasticity of the carbon fibers made them suitable for the repairs on this bridge.
