Concrete Repair & Protection

Project: Miami Beach City Hall
Owner: City of Miami Beach
Engineer: BEA International
Contractor: National Concrete Preservation
Year: 2008

Case Study

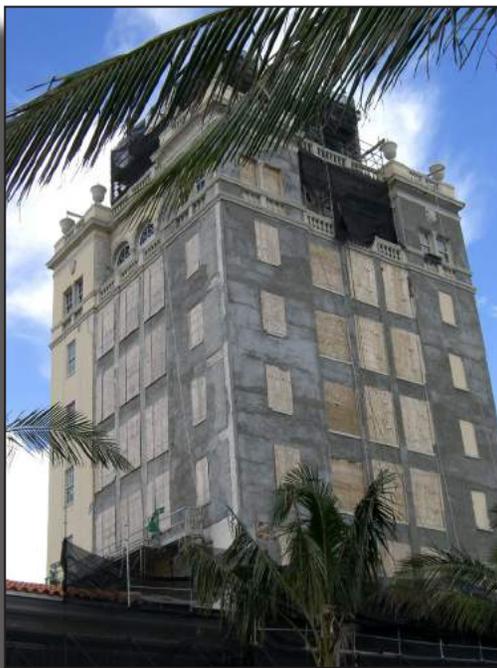
The 80 year old Miami Beach City Hall Building stands out as a strong architectural landmark and a classic example of the diverse history of Miami Beach. The old City Hall Building is one of the largest and youngest listings on the National Register of Historic Places. The structure, displaying a Mediterranean Revival style, was designed by Martin Luther Hampton and erected in 1927. The building is composed of a central nine - story tower standing 125 feet and 3 inches tall with two two-story wings. The Miami Beach police 911 communication equipment office at one time was located on the 9th floor of the building. After approximately half a century of serving the community, the old City Hall building started to show signs of aging. Structural cracks that started to appear in the exterior of the building. Water intrusion through the exterior façade and windows was slowly deteriorating the structural integrity of the historic building. In 1996, there was a fire on the roof of the South Wing. During the restoration of the fire damage, the first piece of the decorative cornice began to fall.

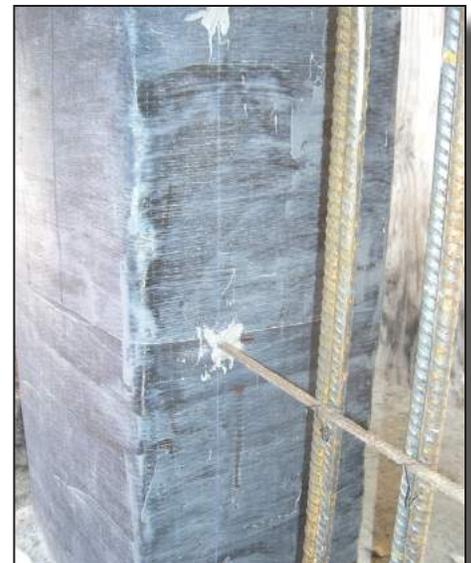
A total of 36,300 sq.ft of surface area was replaced with the fiber reinforced stucco. Columns on each floor of the building were found in an extremely deteriorated state. There was spalled concrete with damaged steel in these members. Concrete was chipped using chipping hammer to get to sound concrete. Sikacrete 211, a pre-bagged concrete, was used to restore these existing columns.

These columns were strengthened with carbon fiber reinforced fabric using SikaWrap 230 C. Columns were strengthened to allow installation of the new window system in the building. Once exposed, the Structural steel I-Beams were found in a precarious condition. Armatec 110 was applied to the steel beams for corrosion prevention and

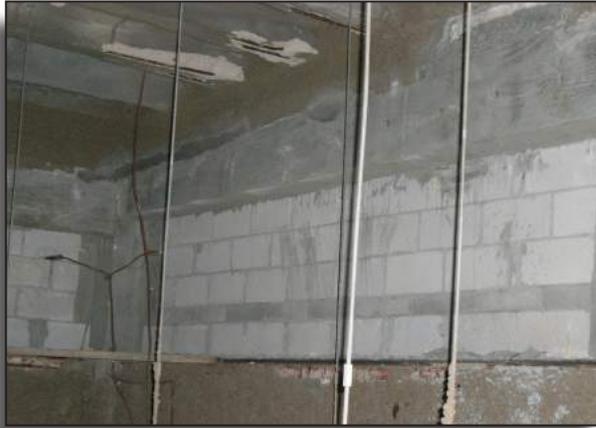
encased in concrete. The reinforced concrete beam located on the 1st and the 2nd floor was corroding and spalling. These beams were repaired by form and pour and form and pump methods. A total of 1052 cubic feet of concrete, including Sikacrete 211 and cast in place concrete, was used to restore the beams. A total of 1000 linear feet of cornices were recreated and installed to maintain the original architectural look of the building façade. Lack of cover on the rebar, aided by the waterborne chlorides had resulted in active corrosion on the concrete joist and the underside of the concrete slab. Once

the surface was adequately prepared, SikaTop 123 and Sika MonoTop 615, specialty repair materials with low permeability were used to repair these conditions. The wooden windows were replaced with aluminum windows without scarifying the original design and size of these openings.
