SIKA SOLUTIONS FOR WATER  
TREATMENT FACILITIES

# TIPPIN WATER TREATMENT FACILITY TAMPA, FLORIDA

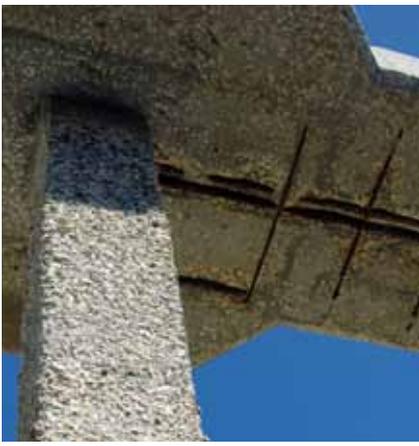
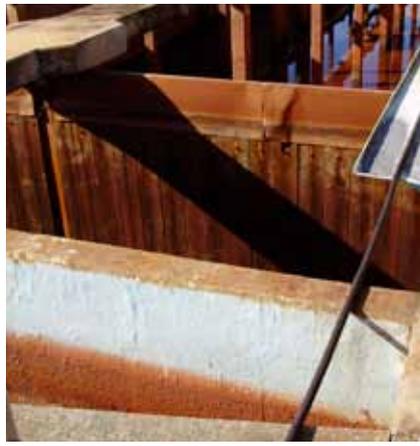
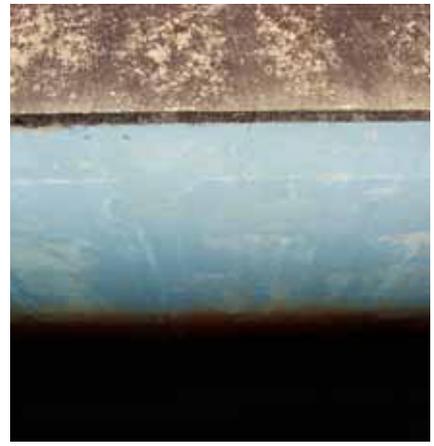
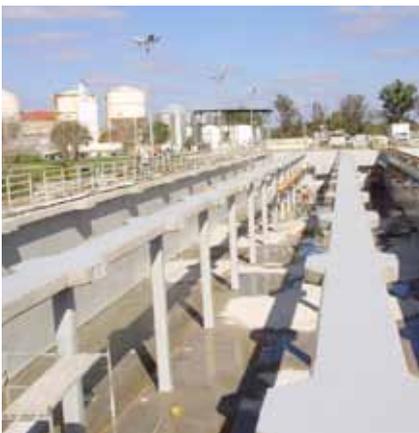
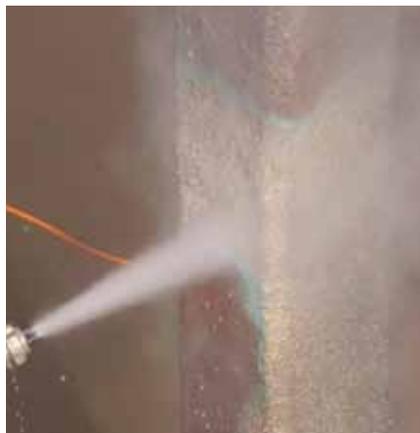
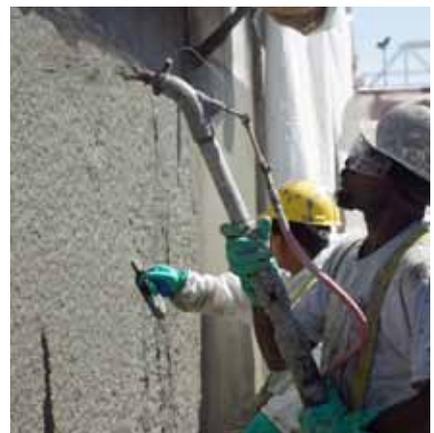
The 25 year old existing protective coating had surpassed its useful life and was significantly deteriorated. This coating deterioration permitted direct contact between the low pH water and the concrete surface resulting in a significant corrosion potential increase. Where the existing coating failed, the low pH water attacked the concrete causing the paste (cement and fine aggregate) to powderize. In addition, the moving water within the tanks eroded the cement paste/fine aggregate portion of the existing concrete thereby causing the large aggregate to fall out. As a result, the existing concrete was severely pitted. In order to mitigate the attack on the concrete and extend the service life of the tanks, the engineer recommended that the concrete be repaired and protected immediately. Recommendations included injecting all leaking cracks, restoring concrete surfaces, and installing a new protective coating or lining to prevent further attack on the concrete. The structures requiring this repair work

Sika Repair 224 , a wet process shotcrete material was used to resurface the pitted concrete. Active cracks with moisture were sealed with SikaFix HH , a hydrophobic polyurethane grout. Structural cracks were repaired with the combination of structural epoxy systems such as Sikadur 35 Hi Mod LV and Sikadur 31 Hi Mod Gel. Deep concrete spalls were repaired with SikaTop 123 Plus, a two component polymer modified cement based material. Sika Armatec 110 was used as the bonding agent and as well as the reinforcement protection. For wider and challenging joints Sikadur Combiflex was used effectively and Sikaflex 2C was used in conventional joints. Sikagard 62, a potable water epoxy coating system was used to line the tanks as a protective coating. Sikalastic 720, a polyurethane based waterproofing system was used on walkways to seal and protect the concrete floor.
