CASE STUDY

EVANS HALL

Owner: University of California, Berkeley, Berkeley, CA

Project Engineer/Designer: Degenkolb Engineers, San Francisco, CA

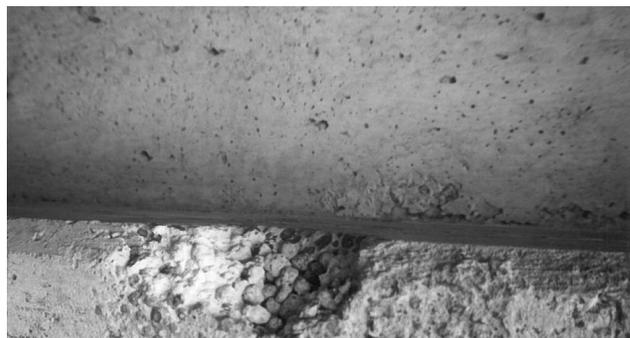
Honeycombing due to segregation of material

In 1999, safety concerns were raised regarding Evans Hall due to pieces of concrete falling from the building's façade. Poor initial concrete placement and concrete coverage over rebar combined with CO₂ and salt penetration from the San Francisco Bay air led to accelerated corrosion of the building's rebar. The entire exterior façade concrete was plagued with large spalled areas, bug holes, and honeycombing. The building also sits on a major seismic fault-line which further spurred the need for restoration.

Work on this building proceeded in two phases. The first phase of this project consisted mainly of spall repair and exterior concrete façade leveling. The concrete around any exposed metal was removed to the correct depth, cleaned of all signs of corrosion, and coated with an anti-corrosion coating Sika® Armatec® 110 specifically formulated to act as a bonding agent before any mortar was applied. The larger vertical spalls were repaired with a flowable polymer modified mortar SikaTop® 111 Plus. For the smaller spalls a polymer-modified, hand-applied mortar SikaTop® 123 Plus was used. A parge coat of Sika® MonoTop® 615 was sprayed on the entire surface of the building to achieve a level, contiguous surface by filling bug holes and air pockets and to increase the level of air tightness allowing for more efficient heating and cooling. This parge coat was then troweled and sponged to achieve a uniform yet sandpaper-like surface for better adhesion of the elastomeric top coat. In the second phase, a coat of Sikagard® 552W primer was applied to aid in the adhesion of the elastomeric top coat Sikagard® 550W Elastocolor as well as to seal the exterior surface against water ingress. However, before the elastomeric top coat was applied, a low modulus, polyurethane-based elastomeric sealant, Sikaflex® 15LM was applied to areas around windows, doors, and flashing to ensure waterproofing. Pigments were added into the coating to match the blues, greens and greys of the surrounding hills and bay area.

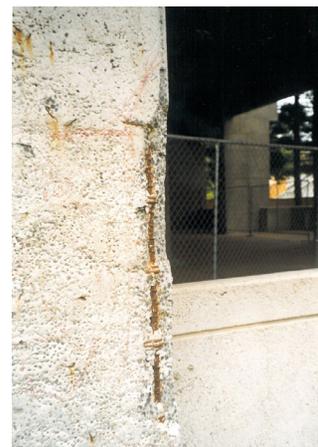
Spall revealing low cover on rebar

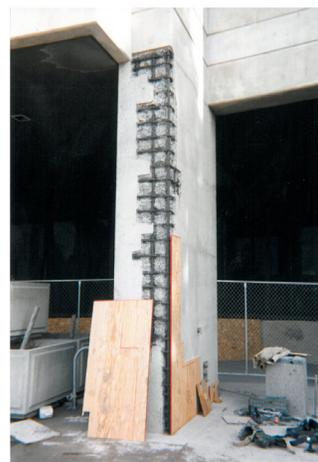
Form being put in place around surface prepped column

Sika Monotop® 611 - one component, polymer-modified, silica fume enhanced, cementitious pump and pour mortar
